Structural Engineering Reconnaissance of the August 17, 1999 Earthquake: Kocaeli (Izmit), Turkey

PEER Report 2000/09
Pacific Earthquake Engineering Research Center
College of Engineering
University of California, Berkeley
December 2000

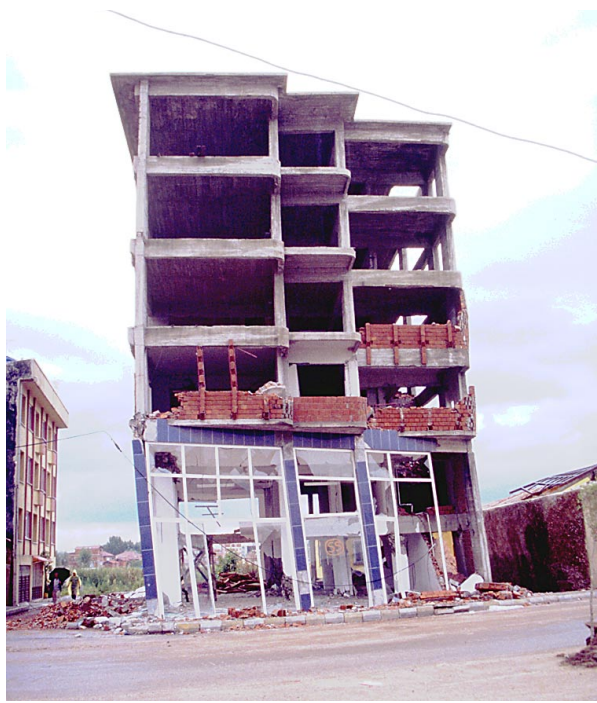
- 1 Large permanent drift in weak first story of reinforced concrete building
- 2 Collapsed and damaged reinforced concrete apartment buildings in Degirmendere
- 3 Fault trace through naval station building
- 4 PEER reconnaissance team in front of damaged fertilizer plant tanks
- 5 Damaged fertilizer plant storage tanks
- 6 Damaged electrical substation equipment
- 7 Aerial view of Tüpras refinery
- 8 Flooding and damage resulting from sinking coastline near Gölcük
- 9 Soil-bearing capacity failure
