# 1 Introduction

## 1.1 1999 Izmit Earthquake

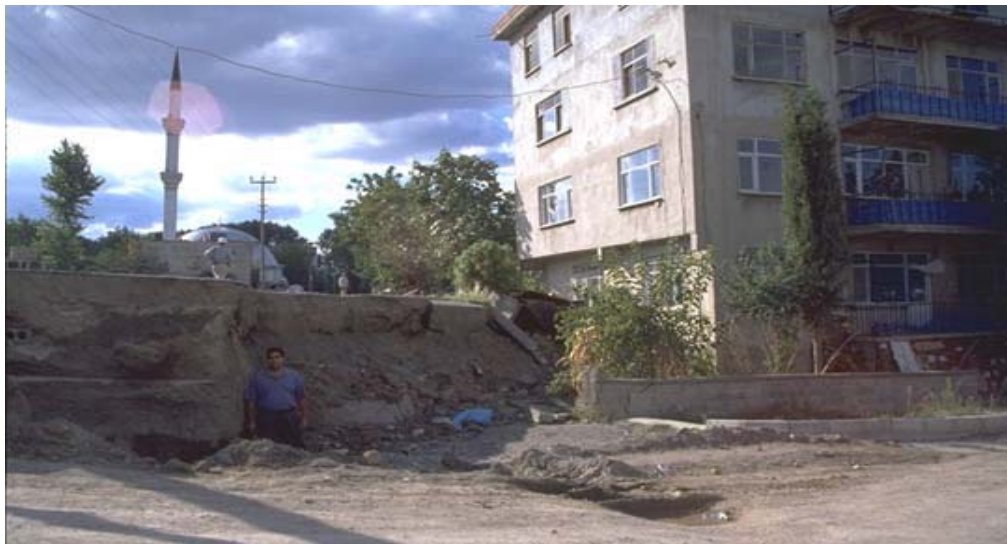
The 1500-km-long North Anatolian fault, which has many characteristics similar to the San Andreas fault in California, is one of the most extensively studied right-lateral strike-slip faults in the world. During the August 17 earthquake, approximately 110 km of the North Anatolian fault ruptured, with a maximum horizontal offset of 5.5 m (west of Golcuk) and a maximum vertical offset of more than 2.3 m (east of Golcuk). Figure 1-1 shows the measured horizontal and vertical offsets at selected locations. Figure 1-2 is a photograph of the vertical offset near the Ford plant in Golcuk; team member Atila Zeikoglu is standing in front of the ledge formed by the faulting.

**Figure 1-2 Vertical offset near Ford Plant in Golcuk**

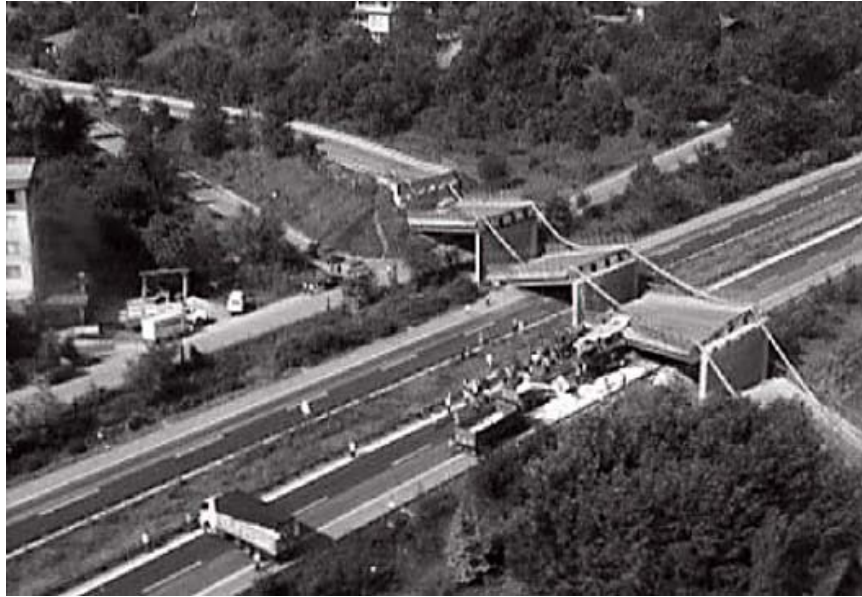
The reconnaissance team documented the collapse of two bridges. Each collapse was a result of fault rupture beneath the piers. Figure 1-5 shows the collapse of the bridge over the Trans-European Motorway. This bridge was composed of four 26-m-long simply supported spans. Each of the spans was positioned on elastomeric bridge bearings. Each span lost the support of at least one end. Figure 1-6 is a view of the bearings and an unseated span from one abutment. Another bridge near Akyazi collapsed (see Figure 1-7), reportedly due to movement of the supporting piers; much of the bridge is submerged in the photograph.

**Figure 1-5 Failure of a bridge over the Trans-European Motorway**

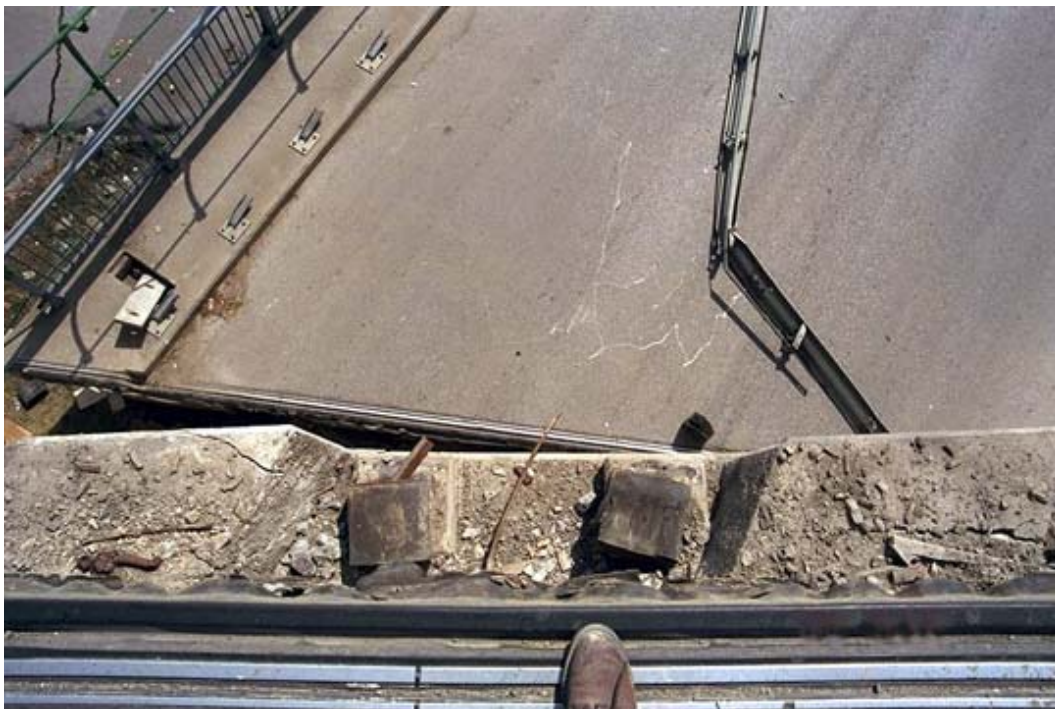
**Figure 1-6 Unseating of the simply supported span from the abutment-mounted bearings**

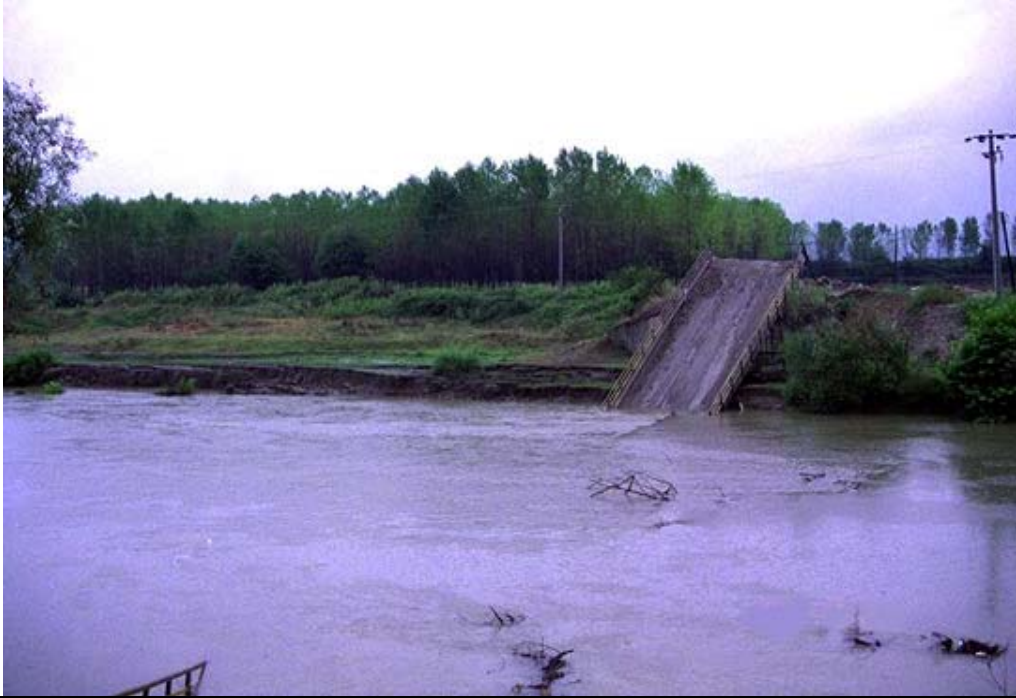
**Figure 1-7 Collapsed and submerged bridge near Akyazi**
