3 Reinforced Concrete Frame and Wall Buildings

3.1 Introduction

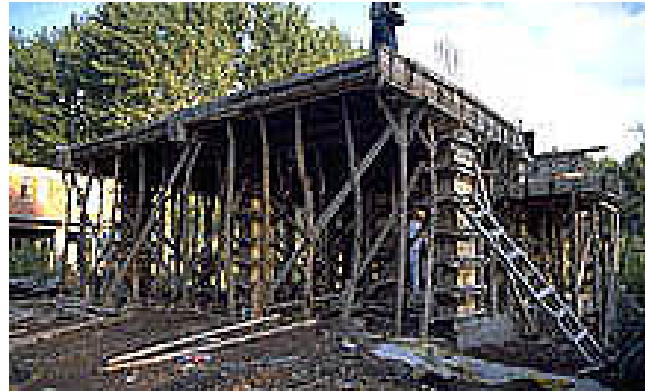
An example of residential apartment construction by a homeowner in a village outside of Gölcük is shown in Figure 3-3. The shoring is composed of cut and trimmed tree limbs. (In most instances, conventional steel and timber shoring is used for apartment construction over four stories.) Timber planks are used to form columns, beams, and slabs. Photographs of the second floor of the apartment building are presented in Figure 3-4. Slabs typically span in one-direction and are approximately 100 mm in thickness. Beams span 2 m to 4 m, range in depth up to 500 mm, and are typically 200 mm wide. Bent-up rebar can be seen in Figure 3-4. Transverse ties with 90° hooks are used. The beam rebar details are nonductile. Blade columns (long and narrow in plan) are routinely used in apartment buildings to

Figure 3-3 Homeowner apartment building construction

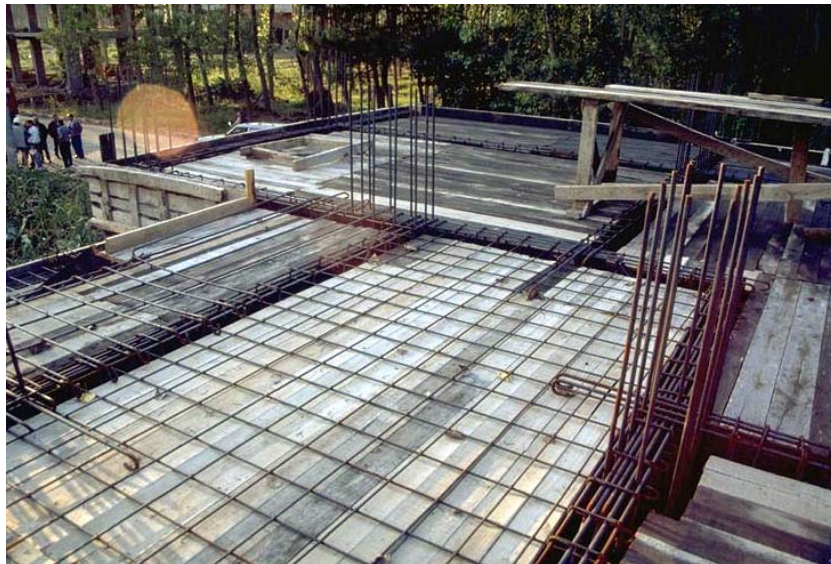
enable the builder to construct the columns within the thickness of the wall. Some column details can be seen in Figure 3-4. Vertical rebar are spliced at the floor level. Typical splice lengths are approximately 1 m and no additional ties are provided in the splice region. Transverse reinforcement with 90° degree hooks is typical. Joint shear reinforcement is not provided. The column rebar details are nonductile.

Figure 3-4 Typical gravity framing including beam and column details

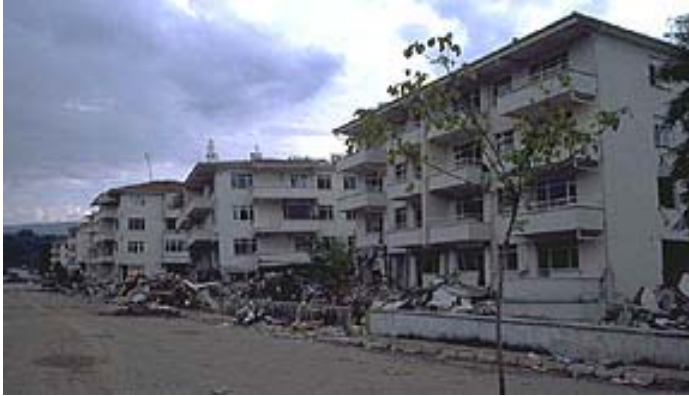
Figure 3-12 shows the collapse of six moment-resisting frame buildings in a village on the outskirts of Gölcük. Every moment-resisting frame building on this street collapsed, and 122 people died in these buildings. Nonductile details were observed in every (collapsed) moment-frame building on this street.

Figure 3-12 Collapse of moment frame buildings, Gölcük

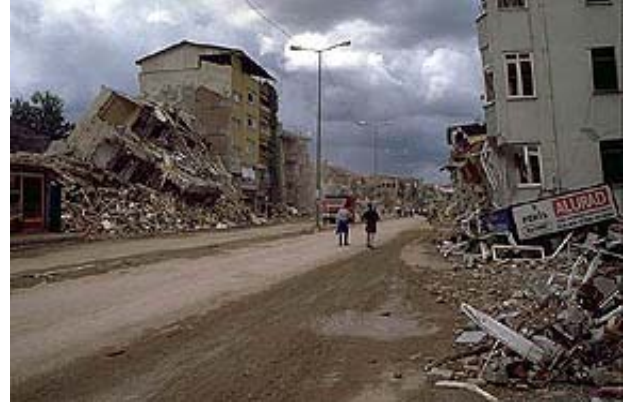
Figure 3-13 Collapse of moment-frame and wall buildings, Adapazari

Similar collapses were common in the epicentral region. Figure 3-13 shows the extent of the destruction in Adapazari, a major city approximately 10 km from the line of rupture. Many of these buildings were constructed with hollow clay tile infill in the frames perpendicular to the sidewalk. Because the buildings often housed shops and commercial space in the first-story, glass panels and not hollow clay tile infill walls were placed between the first story columns adjacent to the sidewalk, but tile infill was used in the upper stories. Such an arrangement of tile infill created stiffness discontinuities in these buildings, which may have contributed to their collapse.

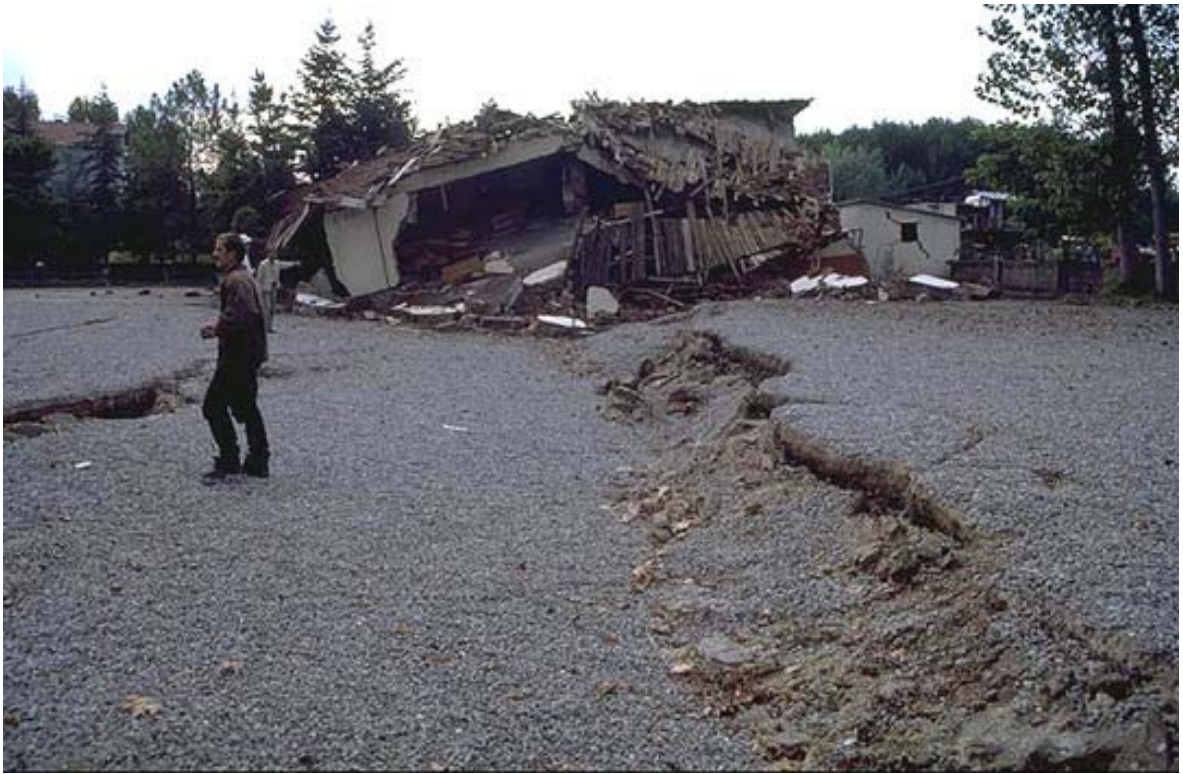
Figure 3-14 Collapsed school building that straddled the line of rupture

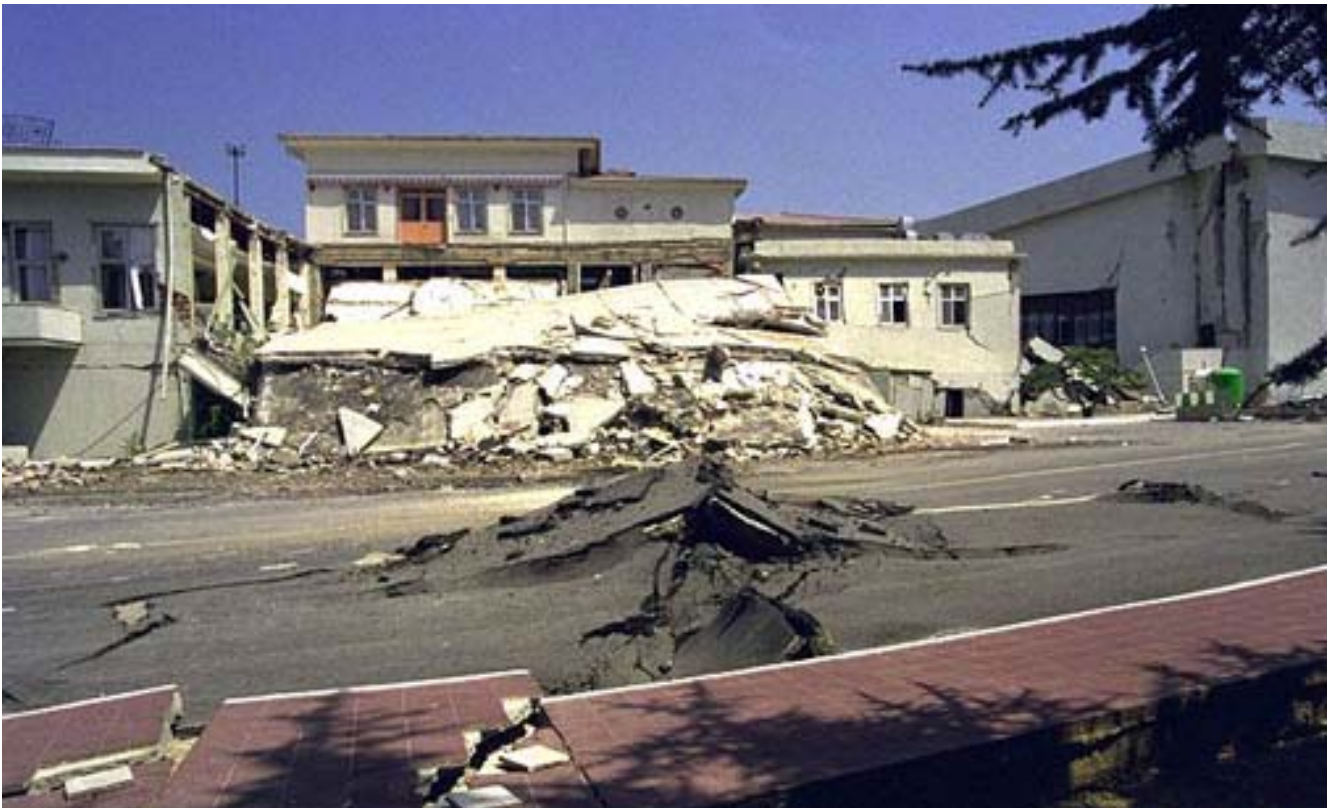
Figure 3-15 Collapsed and damaged moment-frame buildings on the Gölcük navy base

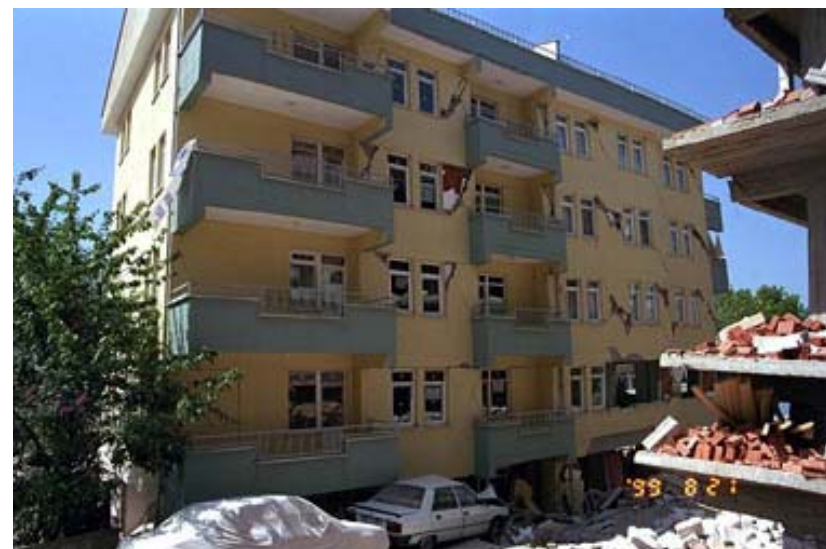
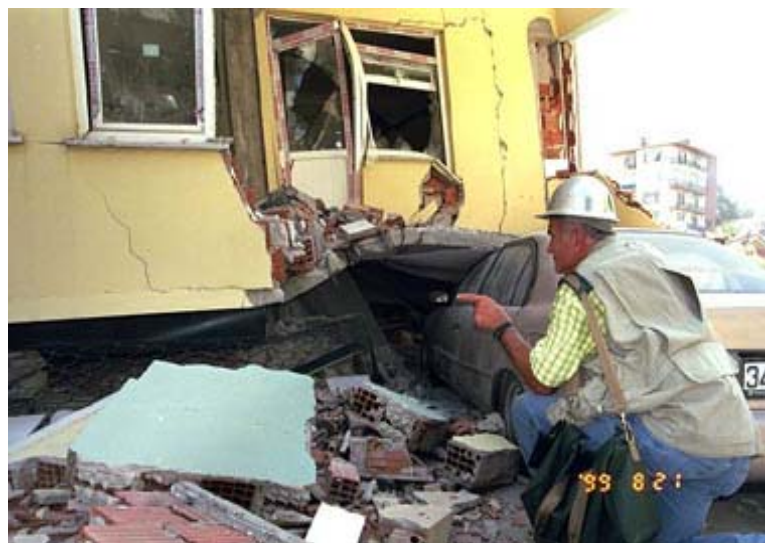
a. Collapsed building

b. View of failed first story

Figure 3-16 Collapsed building that straddled the line of rupture

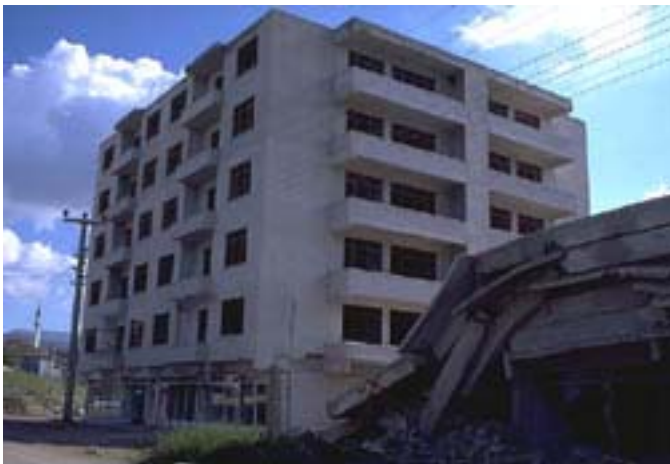
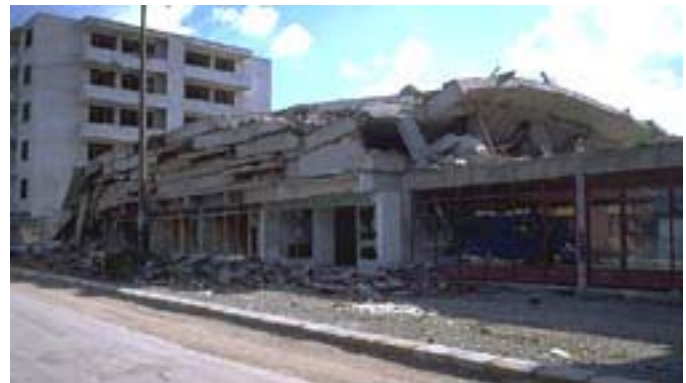
Figure 3-18 is a photograph of two six-story nonductile moment-frame buildings in Gölcük. One of the buildings collapsed completely, whereas the building immediately adjacent suffered only superficial damage in the form of minor cracking in the first-story columns. Much of the first story of the collapsed building was intact. Careful examination of the first stories in both buildings showed that the buildings had similar plan footprints and common construction details. It is likely that the two buildings were nearly identical and that the same contractor constructed both buildings. Both buildings were probably subjected to similar levels of earthquake shaking, yet one building remained in the elastic range and performed well, while the other collapsed. This raises many questions regarding limit states for nonductile moment-frames. Small differences in the strength of these nonductile buildings caused by the use of different construction materials and different construction practices and workmanship could account for the substantial difference in performance.

a. lightly damaged six-story building

b. collapsed six-story building

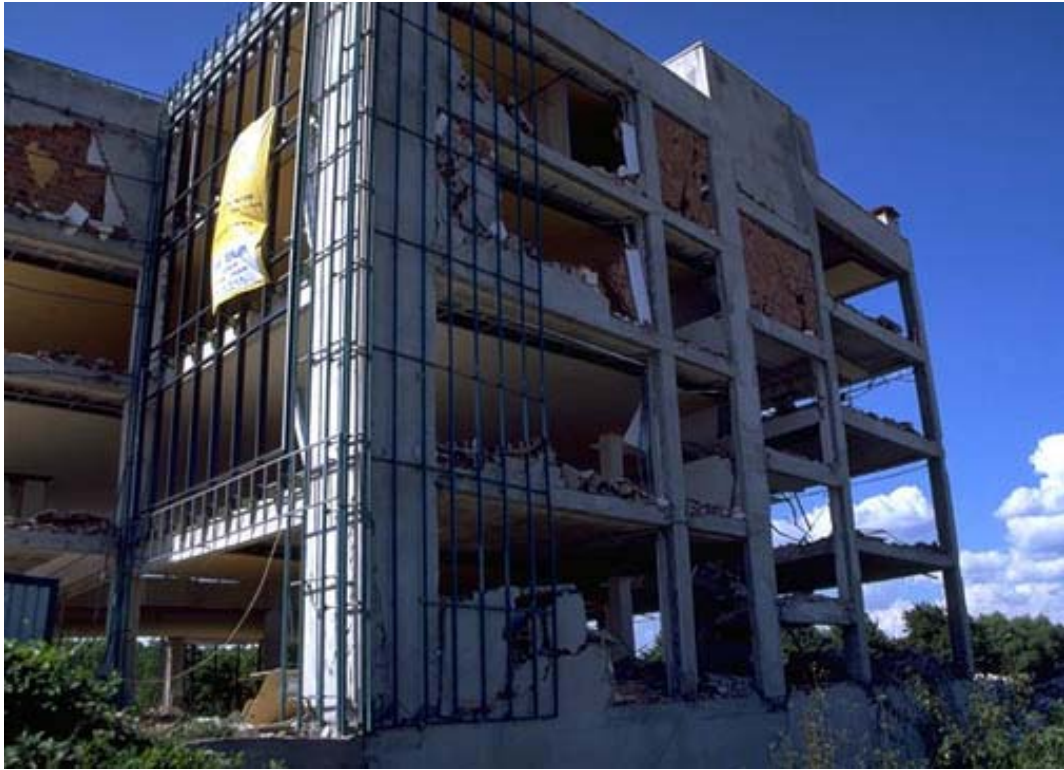
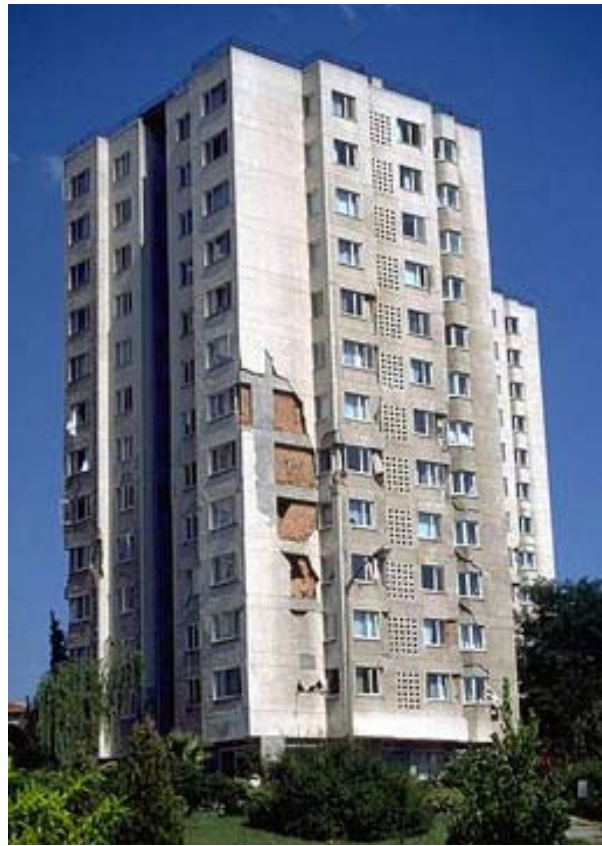
Hollow clay tile and gas-concrete masonry infill walls are widely used in the epicentral region. As noted in Section 3.3.2, these walls are unreinforced and nonductile. The walls abut the frame columns but are not tied to the frame. The high in-plane stiffness of the masonry infill that is developed by diagonal strut action can dictate the response of the more flexible moment-resisting frame. Figures 3-19a and 3-19b show complete and partial damage to hollow clay tile walls in four- and thirteen-story buildings, respectively. The four-story building was under construction at the time of the earthquake; the thirteen-story building was constructed in the early 1970s.

a. four-story building

b. thirteen-story building

Figure 3-19 Varying degrees of damage to infill masonry walls

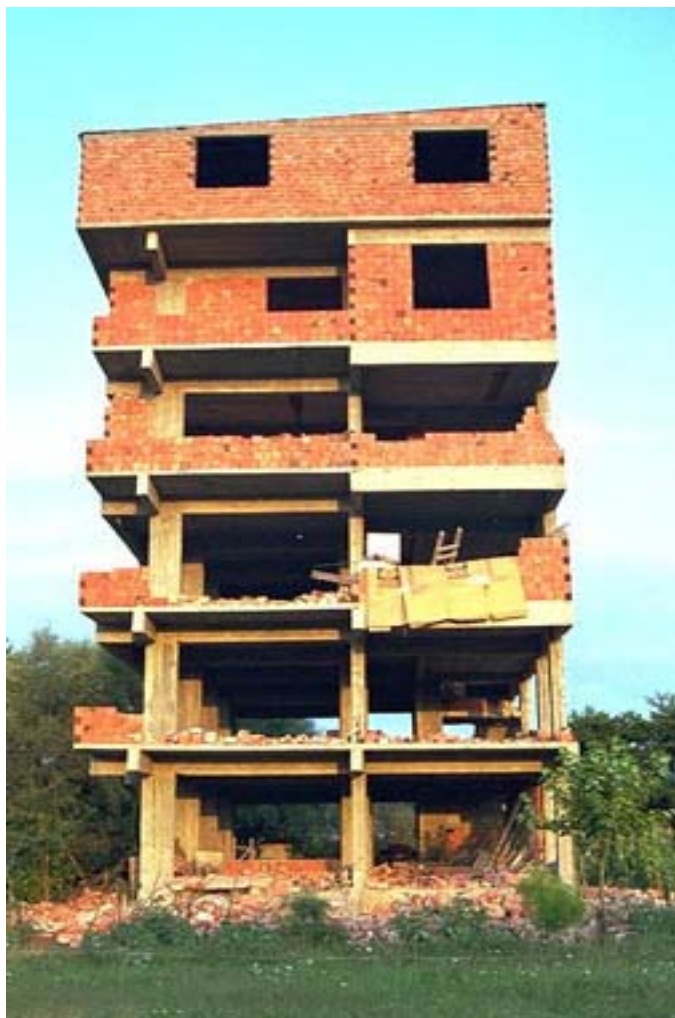
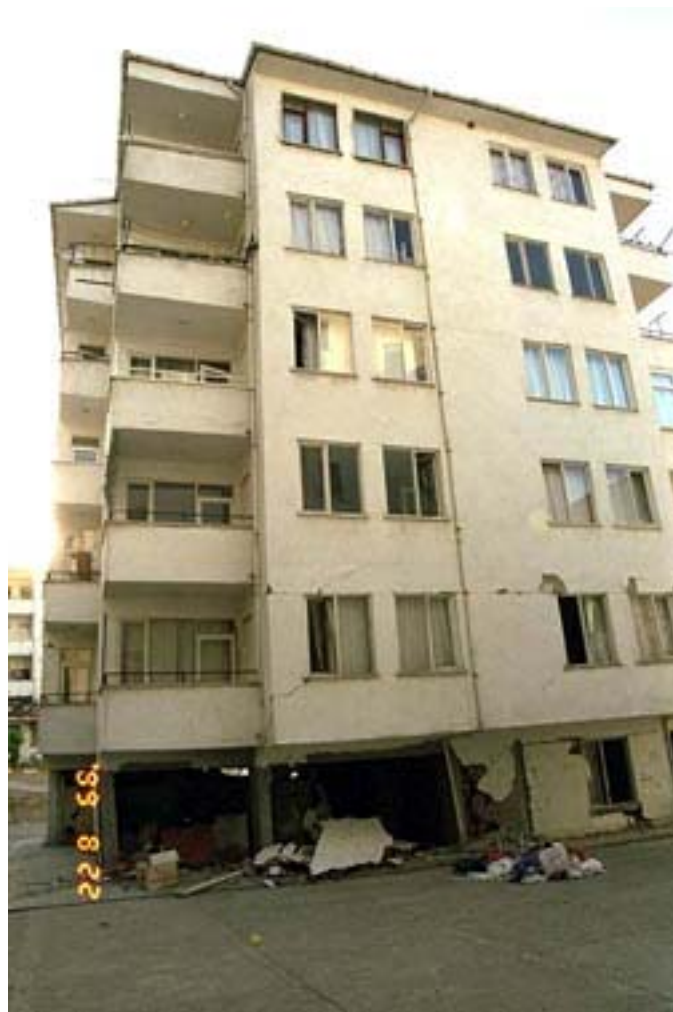
Damage to infill masonry walls was concentrated in the lower stories of buildings because of higher demands on the strength of the moment-frame-infill wall system. Figure 3-20 illustrates the distribution of damage to infill walls in two buildings, one near Gölcük, and one in Degirmendere. In these buildings, the lateral stiffness of the masonry infill walls is likely of the same order or greater than that of the moment-frames. For these buildings not to collapse following the failure of the infill walls the moment-frames must have possessed significant strength and some limited ductility.

a. infill wall damage in Gölcük

b. infill wall damage in Degirmendere

Figure 3-20 Damage to infill masonry walls

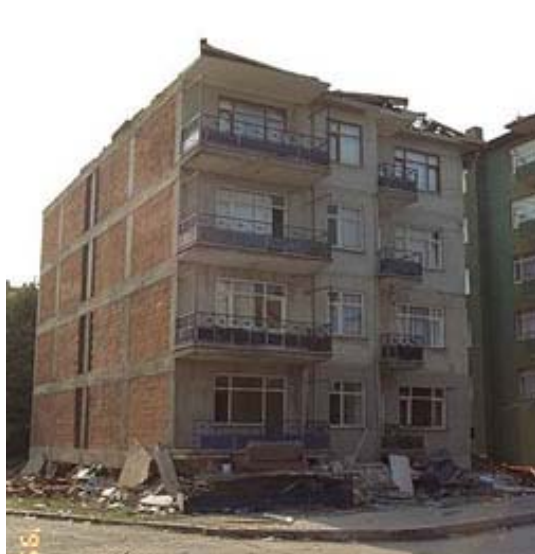
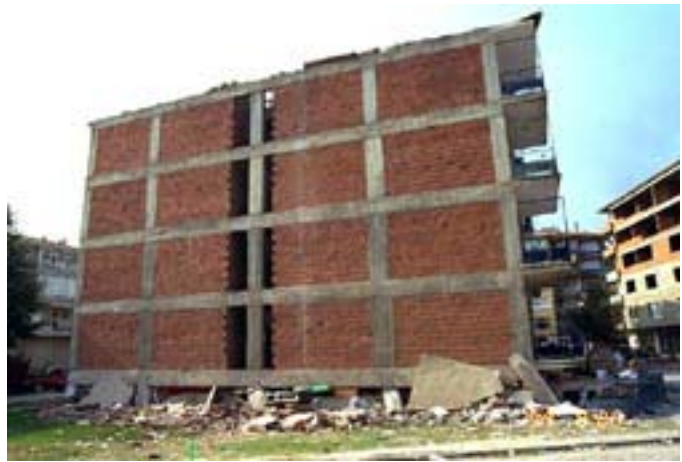
Figure 3-21 shows two views of a collapsed apartment building in Gölcük. The first two stories of this building failed completely but damage in the upper three stories was limited. The long infill walls in the upper three stories have significant elastic strength and stiffness—probably much greater stiffness and strength than the moment-resisting frame. If the infill walls in the upper three stories of the building are indicative of the infill in the failed stories, the first- and second-story infill walls likely played an important role in the collapse of the building. The brittle fracture of the first- and second-story infill masonry walls would have overloaded the nonductile first- and second-story frame columns, resulting in a complete failure.

a. view of front face of building

b. view of infill wall perpendicular to sidewalk

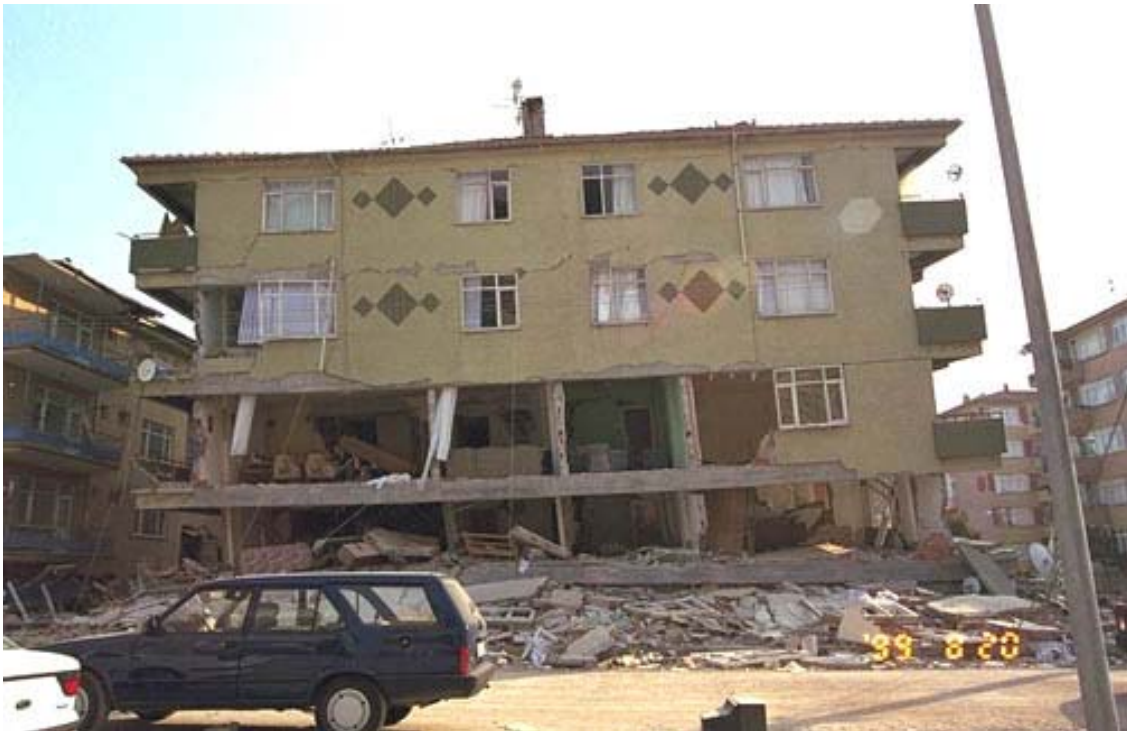
The first two stories of the building in Figure 3-22 collapsed. The infill masonry walls and moment-frame construction in the third and fourth stories (first and second stories of the collapsed building) suffered major damage. Damage in this building reduced with increased height above the sidewalk. Failure of the infill masonry in the first and second stories of the building likely precipitated the collapse of the building.

Figure 3-22 Failure of two stories of moment-frame building with infill masonry

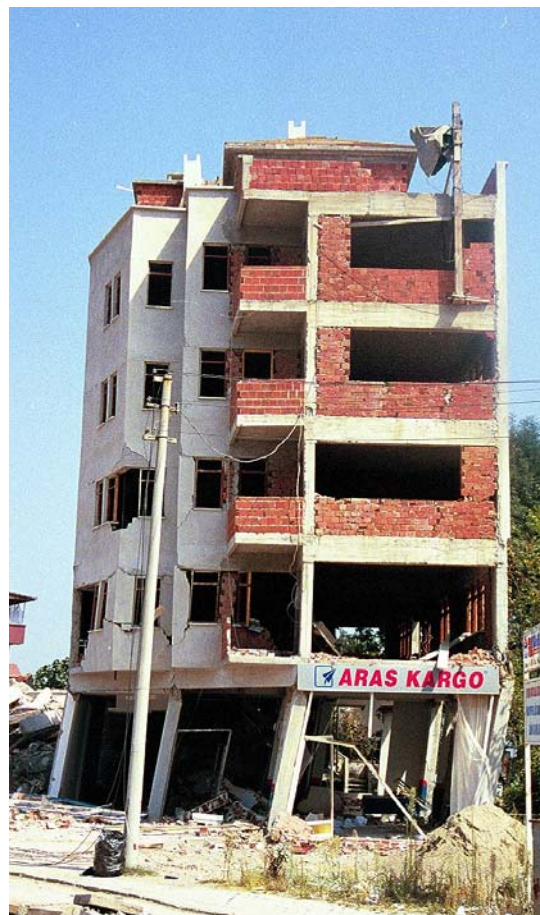
Irregular placement of infill masonry walls can produce discontinuities of stiffness in moment-frame buildings. Consider the building in which the moment-frame is both flexible and weak by comparison with the upper stories (Figure 3-23). In the first story of this building, infill masonry walls are present in the back face of the building and in the two faces perpendicular to the sidewalk. The front of the building was open in the first story. The lateral stiffness of the building was likely large in the direction perpendicular to the sidewalk and much smaller parallel to the sidewalk. Deformation is concentrated in the first story of this building, parallel to the sidewalk, due to the weakness and flexibility of the moment-frame and the lack of infill masonry in the front of the building. The first-story columns in this building were badly damaged and likely close to failure.

Figure 3-23 Formation of a soft and weak story

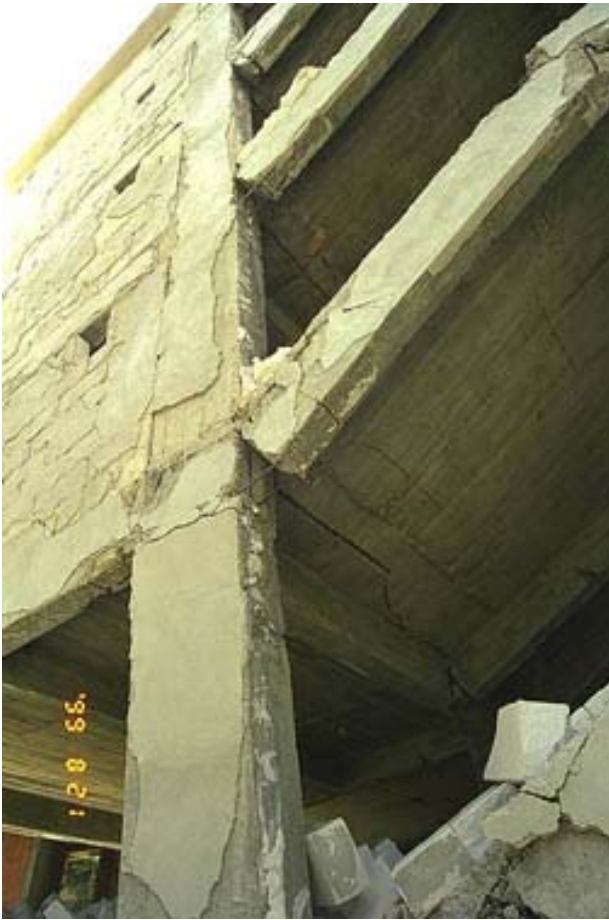
The reconnaissance team observed little damage to interior moment-frame beams because columns were generally weaker than beams. One type of beam damage is shown in Figure 3-24. The building in this figure suffered a partial story collapse because the fault ruptured beneath the building. The beams shown in the frame elevation were forced to accommodate the partial collapse and were badly damaged at the beam-column connection due to slip of the smooth longitudinal beam rebar. In many cases, beam bottom rebar was inadequately anchored in and through beam-column joints.

Figure 3-24 Damage to a nonductile reinforced concrete beam

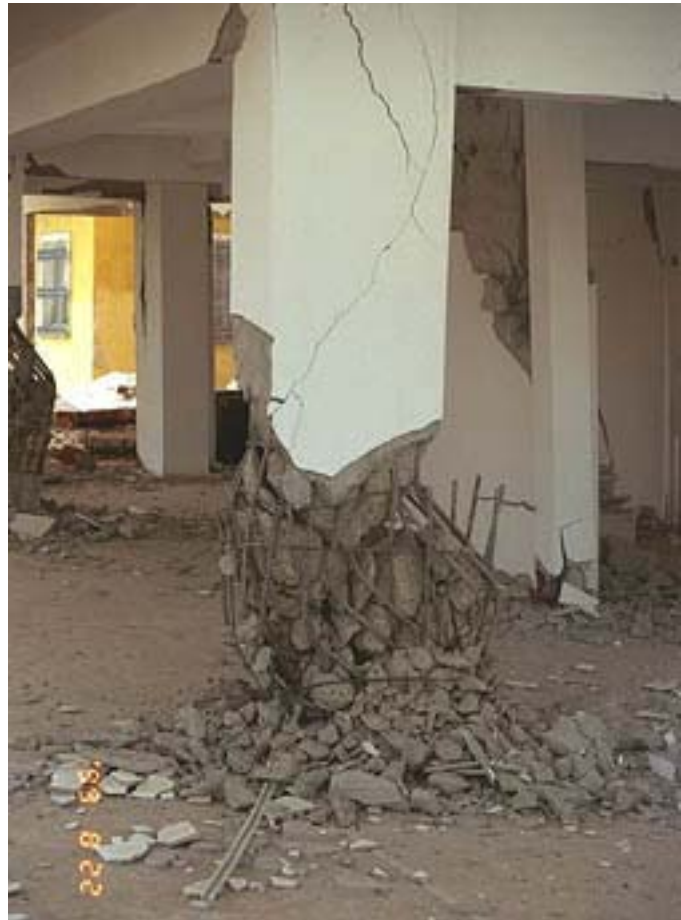
Figure 3-25 Failure of lap splices in a moment frame connection

Lap splices in moment-frame columns were typically made immediately above the floor framing or the foundation. The photograph of the exposed lap splice of Figure 3-25 is from a moment-

frame building in Adapazari. The lap splices in this column were approximately 35 bar diameters in length and were located in a plastic hinge zone. Widely spaced transverse ties with 90° hooks were used in this column; no cross ties were present. The 90° hooks on the ties opened during the earthquake, and the limited strength and confinement afforded by the ties were lost.

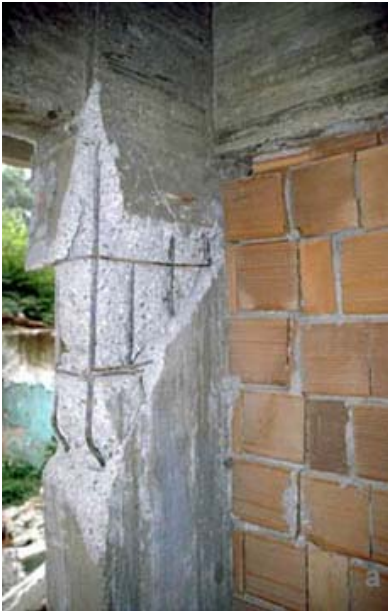
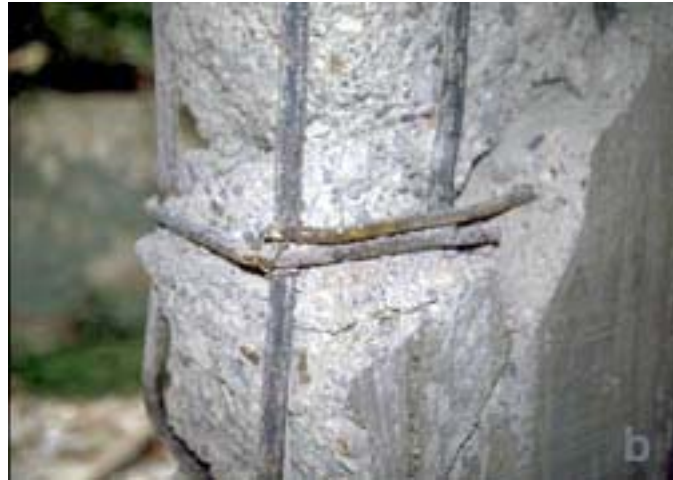
Figure 3 –26 Typical transverse reinforcement details in columns
a. view of damaged blade column
b. transverse tie details in blade column

Shear reinforcement was lacking in most damaged columns observed by the reconnaissance teams. The transverse tie details of Figures 3-26, 3-27, and 3-28 were common, namely smooth rebar, widely and often unequally spaced ties (200 to 250 mm), and 90° hooks. The wide spacing of the ties resulted in shear failures (Figure 3-26), buckling of longitudinal rebar (Figure 3-27), and poor confinement of the core concrete (Figure 3-28).

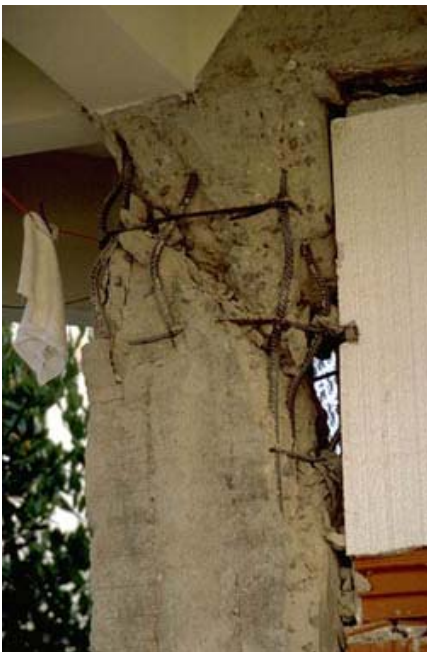
Figure 3-27 Shear failure of a moment-frame blade column

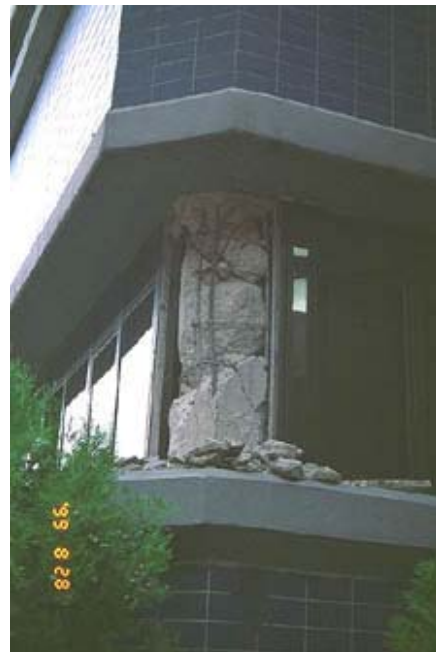
Figure 3-28 Lack of transverse reinforcement in moment-frame column

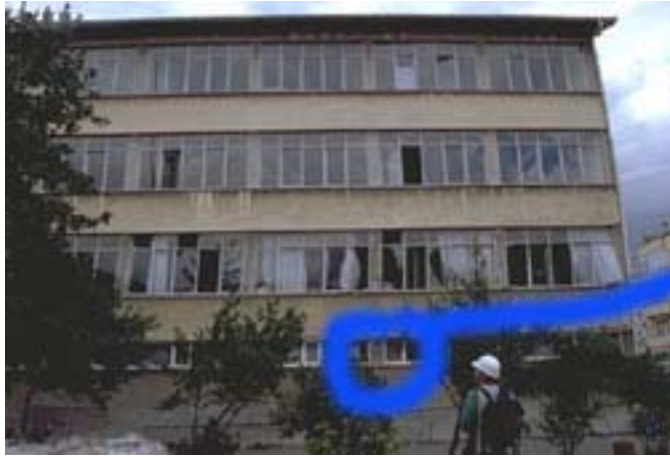
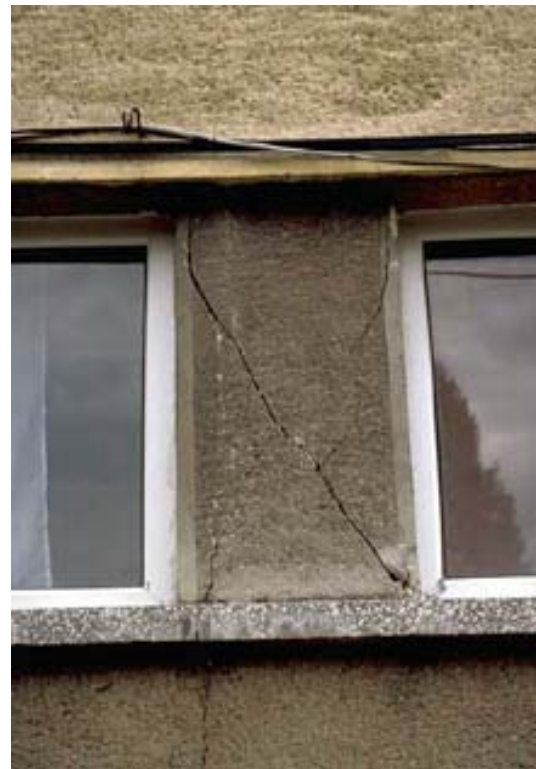
Shear failures in short columns were common. A typical example of such a failure is a school building in Adapazari, shown in Figure 3-29. The damaged column of Figure 3-29b is shown in Figure 3-29a in a blue circle.

Figure 3-29 Shear cracking in short columns

b. diagonal cracking in column

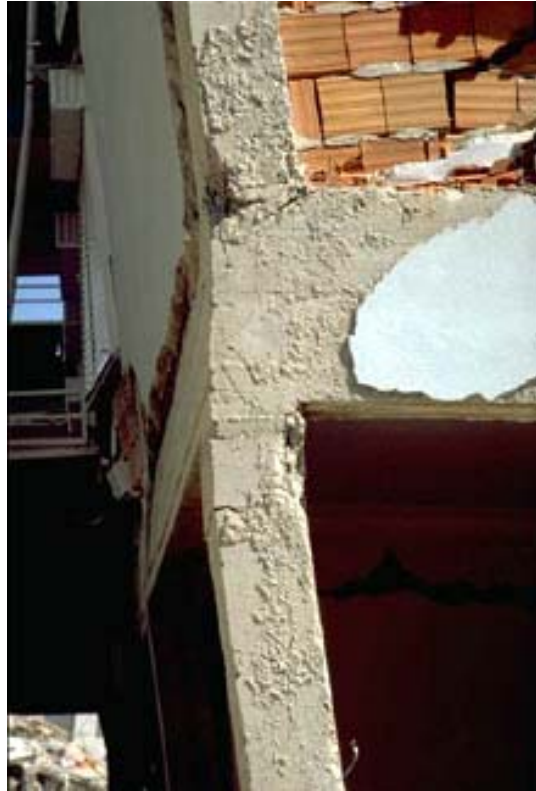
Concentrated damage at the ends of moment-frame columns was observed throughout the epicentral region. Examples of such damage are presented in Figures 3-31, 3-32, and 3-33. Large rotations at the ends of the columns (Figure 3-31) produced severe cracking and loss of concrete. (Note the relative proportions of the columns and the beam in this figure.) Out-of-plane deformations in the column of Figure 3-32a led to loss of cover concrete in the hinging zone. The transverse ties in this column were widely spaced (200 mm) and composed of

Figure 3-31 Concentrated damage at ends of moment-frame columns due to excessive drift

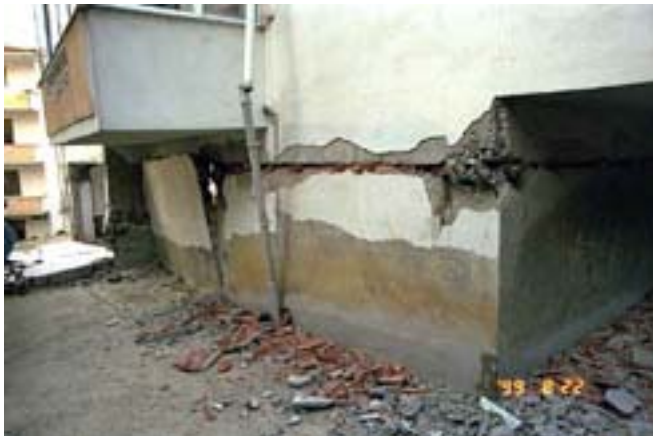
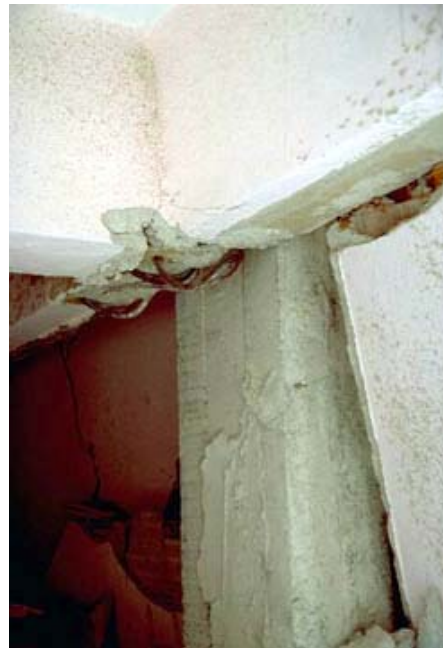
a. damage from out-of-plane deformation

b. unseating of beam-slab system from column

Figure 3-32 Damage and failures at ends of moment-frame columns

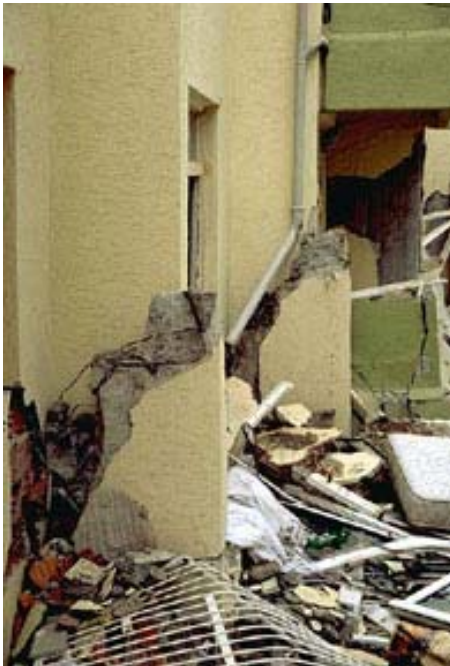
the column. The first-story columns of a collapsed building are shown in Figure 3-33; the second-story of the building is to the left of the columns. Note the smooth failure surface on the top right side of the columns.

Figure 3-33 Damage to moment-frame columns

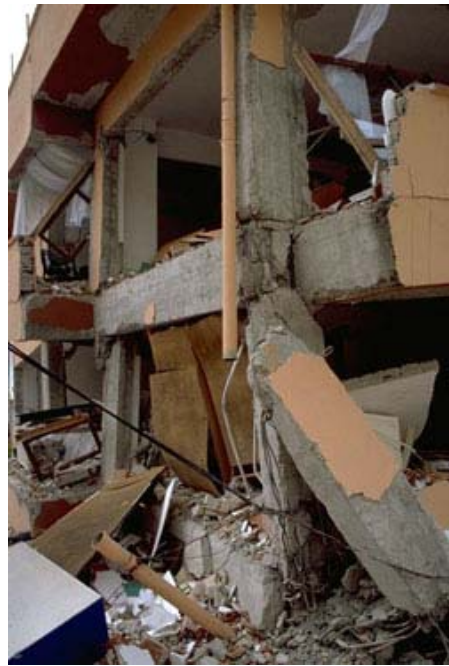
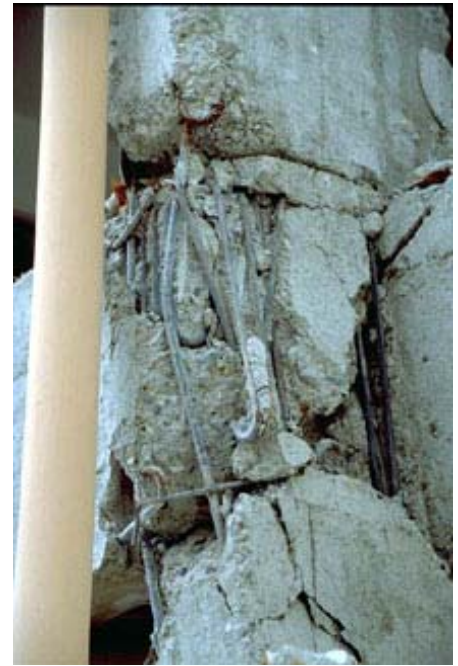
Typical damage to beam-column joints is shown in Figures 3-34, 3-35, and 3-36. The collapse of a building in Adapazari (Figure 3-35) was due to the failure of beam-column joints. Much of the framing (Figure 3-35a) is essentially intact but many of the beam-column joints are heavily damaged. One of the damaged joints is shown in Figure 3-35b. Beam rebar anchorage in the joint is inadequate and no transverse ties are present in the joint.

Figure 3-34 a. Damage to moment-frame beam-column joints

Figure 3-34 b. Damage to moment-frame beam-column joints, reinforcement in joint

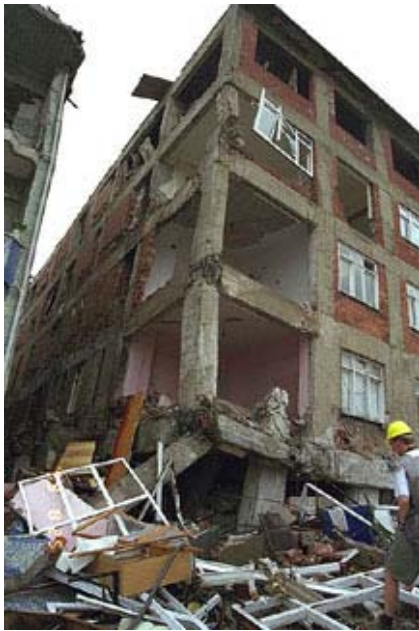
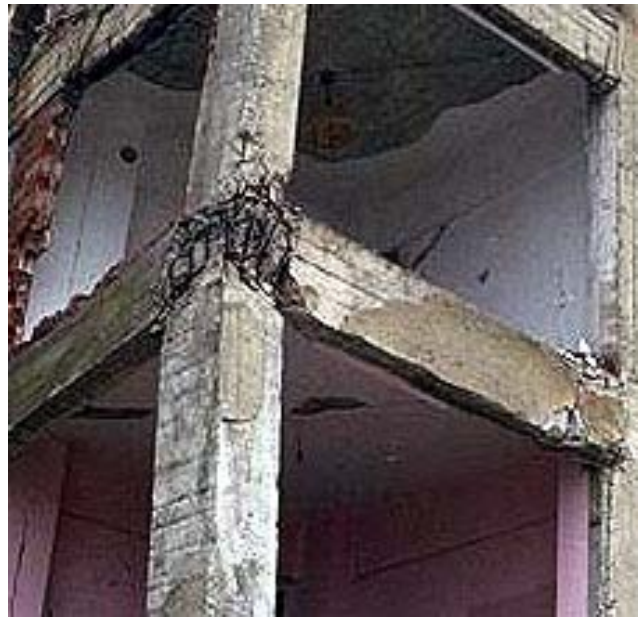
Figure 3-35 a. Building collapse due to failure of beam-column joints

Figure 3-35 b. Damage to one beam column joint

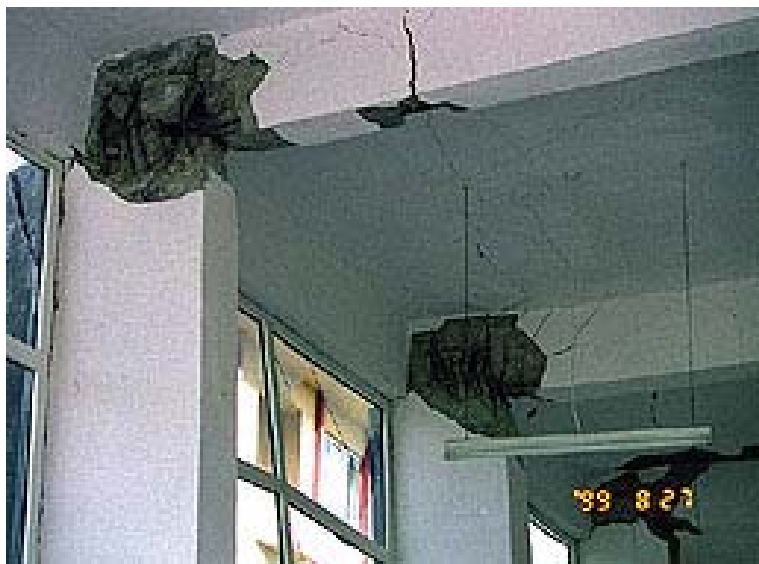
Figure 3-36 is a photograph taken in a building under construction in Adapazari at the time of the earthquake. Severe damage in the beam-column joints is evident, but horizontal transverse ties in the joints maintained the integrity of the joints. (See Section 3.7.3 for a more complete description of this building.)

Figure 3-36 Damage to a new moment-frame beam-column joint

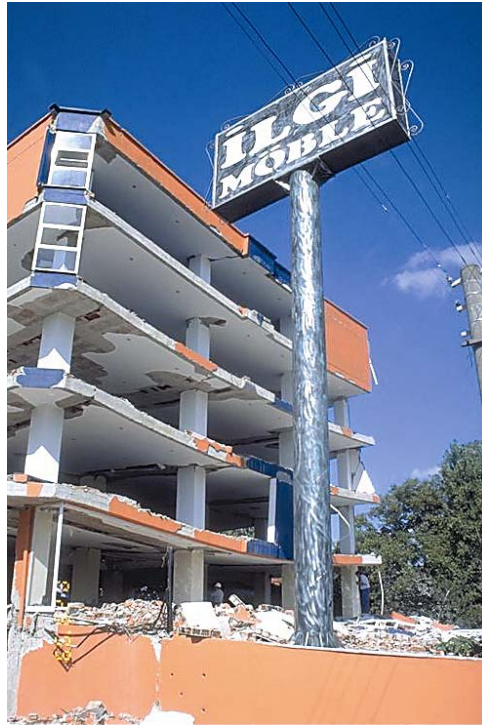
Figure 3-37 Typical damage to asmolen floor systems

Damage to such systems was widespread. Figure 3-37 shows typical damage to the asmolen floor system. Deformation of the joist-beam framing led to sections of the hollow clay tile formwork dislodging and falling to the floor below. Although failure of the hollow clay tile blocks in the floor system is not considered structural damage, falling tile blocks constitute a hazard to life.

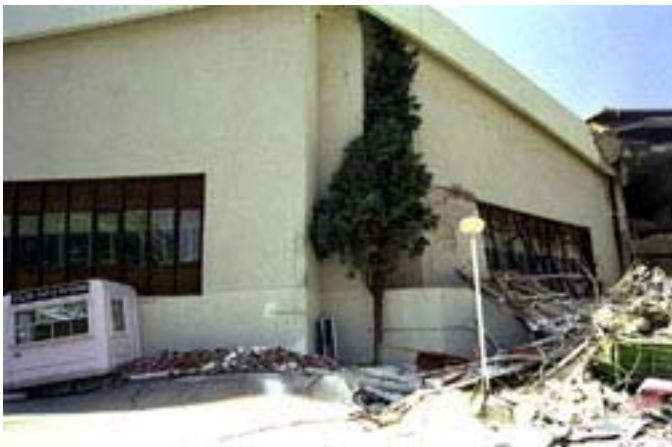
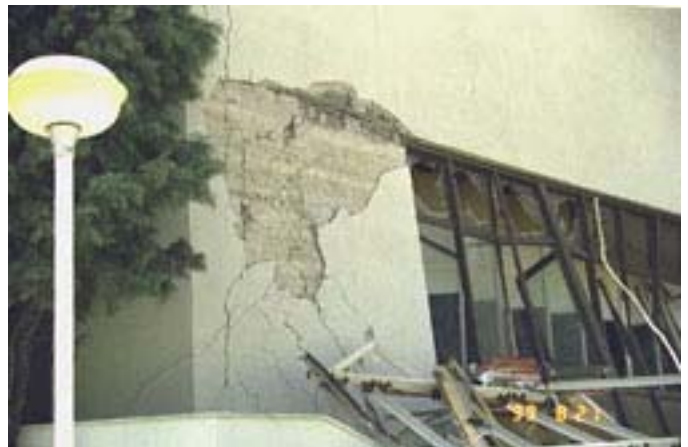
The building shown in Figure 3-40 experienced damage at the stiffness discontinuity in the shear wall. The fault ruptured directly beneath this building. The limited damage in this instance constitutes excellent performance.

Figure 3-40 a. Shear wall building damaged due to fault rupture

Figure 3-40 b. Close up of damage to a shear wall

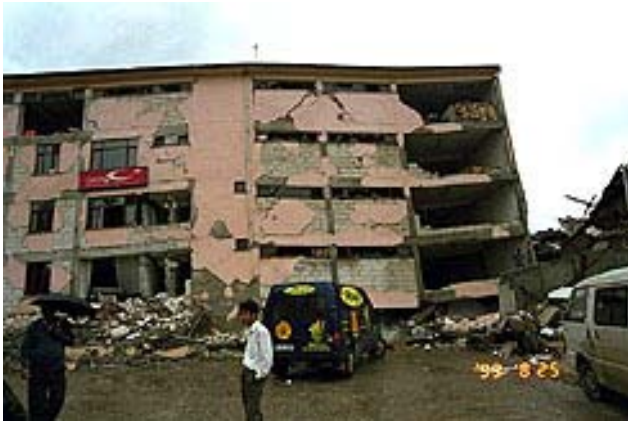
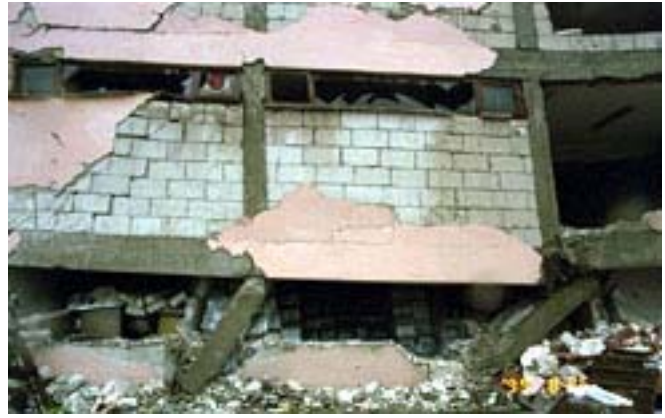
The reconnaissance team toured a number of buildings that would be classed as dual wall-frame systems in the United States. However, because design provisions for such systems did not exist in Turkey prior to 1997, these buildings would have been designed as either shear walls or moment-resisting frames. The most significant damage observed by the team in a dual wall-frame building is shown in Figure 3-41a. The wall and first-story exterior columns shown (Figure 3-41b) failed and shortened. These components displaced out of the plane of the wall, as seen in Figure 3-41b.

Figure 3-41 a. Collapse of dual wall-frame five story building, Adapazari

Figure 3-41 b. Close-up of failure of the shear wall and perimeter columns

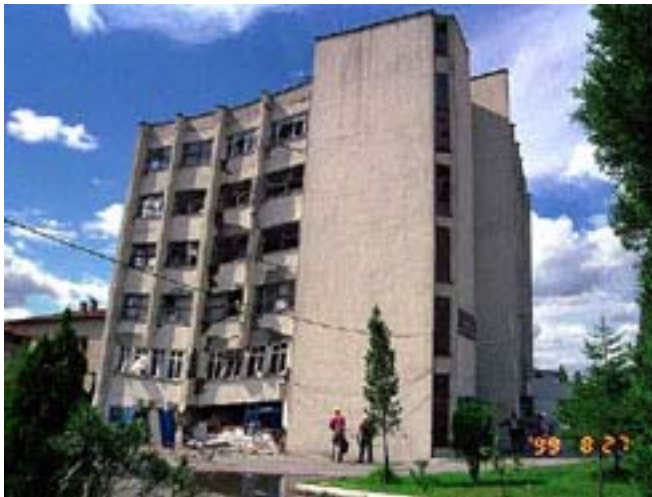
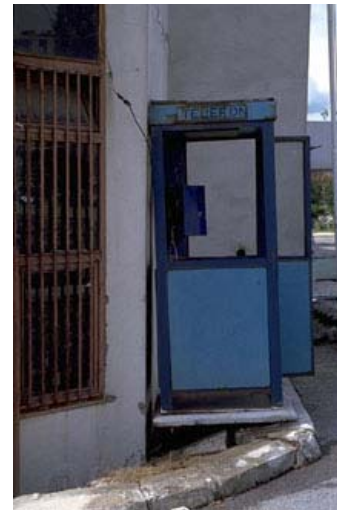
Figure 3-42 a. Damaged wall-frame building due to ground failure and wall rotation

Figure 3-42 b. shear wall settlement

Another example of damage to beams and columns in a dual wall-frame building is shown in Figure 3-42. No cracks were observed in the shear wall, but the right end of the wall settled approximately 0.5 m (Figure 3-42b) due to bearing failure of the supporting soils. Although the shear wall was likely sufficiently stiff to protect the nonductile frame, the rotation at the base of the shear wall and settlement of the footings beneath the moment-frame columns contributed to the failure of the first-story columns.

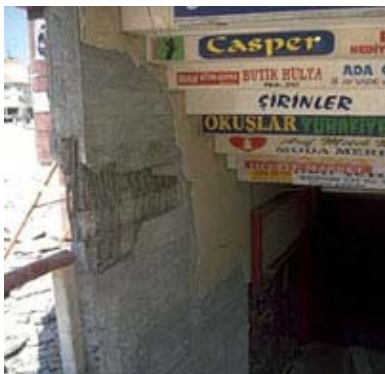
Blade columns or short shear walls were often constructed near stairwells (Figure 3-43). These walls or blade columns were detailed similarly to regular moment-frame columns with light transverse reinforcement with 90° hooks and no cross ties. The failures shown are similar to those observed in moment-frame columns.

Figure 3-43 Damage to short wall / blade column

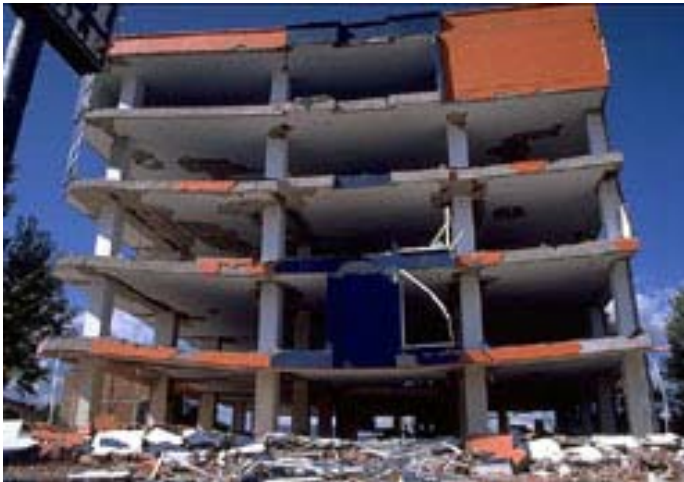
Figure 3-44 Front elevation of Building A

Building A, shown in Figures 3-44 and 3-45, was located at the eastern outskirts of Gölcük. Much of the first story of this moment-frame building (not seen in Figure 3-44) was located below grade. The grade level sloped down from the front to the back of the building. A sketch of the first-floor plan of the building is shown in Figure 3-46. Most of the hollow clay tile infill masonry failed during the earthquake but some remained intact at the rear of the building in the sixth story (see Figure 3-45).

After the columns in the first row failed in shear and shortened, the slab and beam framing deflected in the shape of a catenary (see the sag in the floor slabs in Figure 3-44) and gravity loads were carried to the adjacent undamaged columns by axial tension in the beams and slabs. Vierendeel truss action in the upper stories also likely transferred gravity loads to adjacent undamaged columns. Provision for such redundancy in framing systems would reduce the likelihood of building collapse and substantially uncouple system-level response from component-level response. The catenary and Vierendeel truss mechanisms may be very effective in stabilizing the structure when interior columns are lost. To ensure that beams and slabs are able to maintain catenary deflections, bottom reinforcement should be continuous through any columns that may fail under lateral loads.
