3 Reinforced Concrete Frame and Wall Buildings

3.1 Introduction

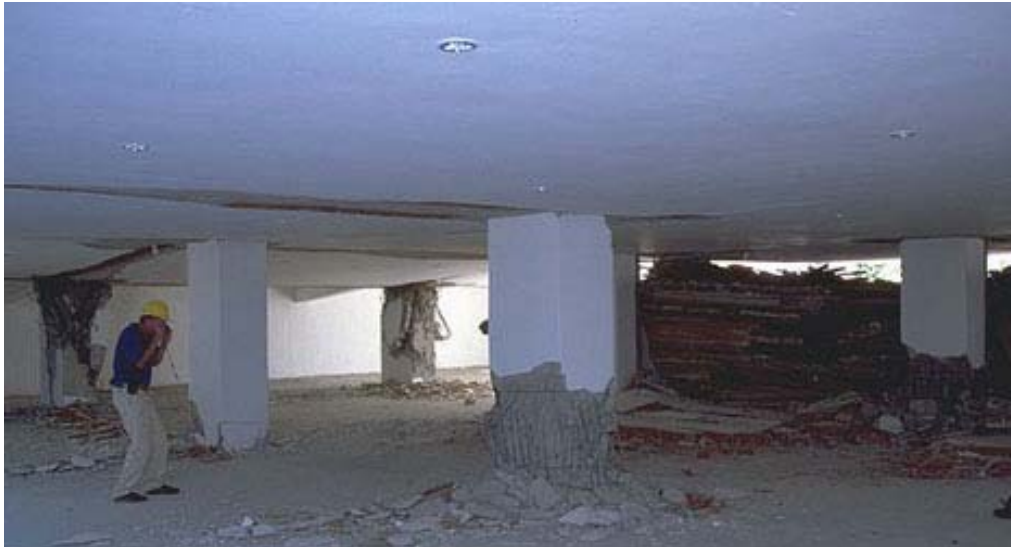
Structural damage was concentrated in the first-story columns at the front of the building (Figure 3-47) and around the stairwell at the rear of the building (Figure 3-48). Nonductile detailing was evident in each damaged component viewed by the reconnaissance team.

Figure 3-47 Damage to first story columns

As shown in Figures 3-46 and 3-47, the first and third rows of columns were badly damaged but the second row of columns suffered no significant damage. All columns in the first three rows were the same size; rebar in the first and third rows of columns were essentially identical. If the interior columns in the first row failed initially, conventional approaches would suggest that lateral forces were redistributed to other stiff components (including the second row of columns) and gravity loads were transferred to the undamaged columns in the first and second rows. The increase in the gravity and earthquake effects should have been greater on the second-row columns than on the third-row columns, yet the columns in the third row failed and the columns in the second row were undamaged. New knowledge regarding the transfer of lateral loads and gravity from failed components to other components of a building frame is needed to obtain accurate estimates of building performance.

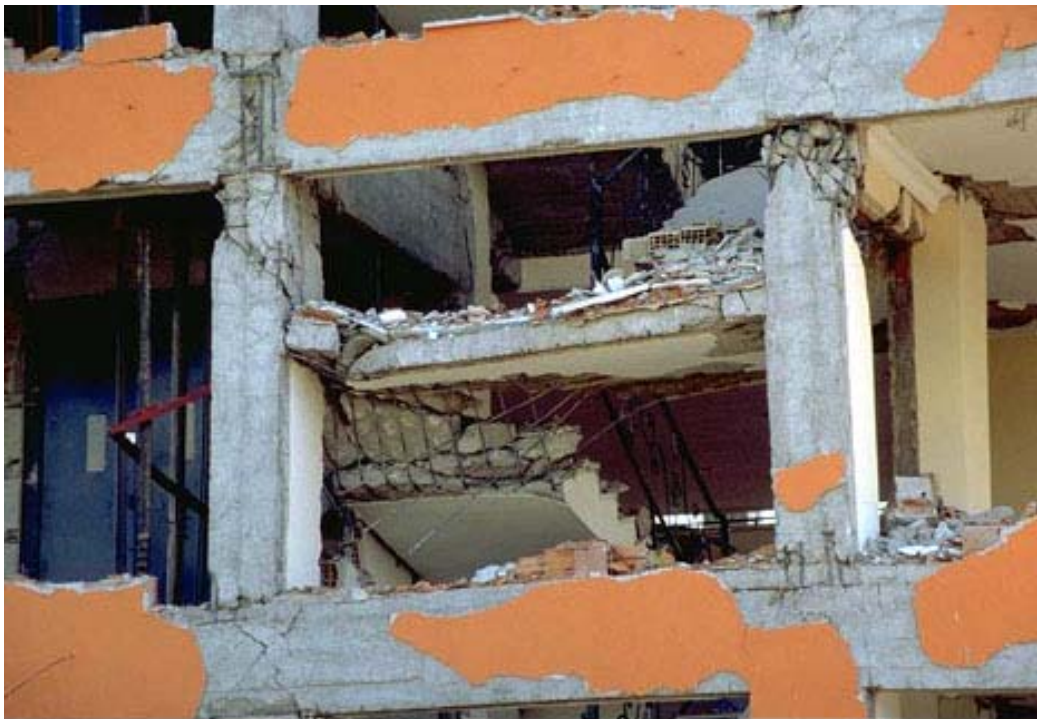
Figure 3-48 Damage at the rear stairwell

The staircases in the rear stairwell were cast integrally with the exterior columns. The landings were located approximately 1 m below the beam-column joints (Figure 3-48). No transverse reinforcement was present in these joints. The lateral support provided by the landings and the staircases resulted in short column construction and led to shear failures immediately above the landings. Figure 3-48 shows severe damage to the staircases that suggests that the staircases resisted significant lateral forces during the earthquake via strut action. The lateral stiffness of the staircases is

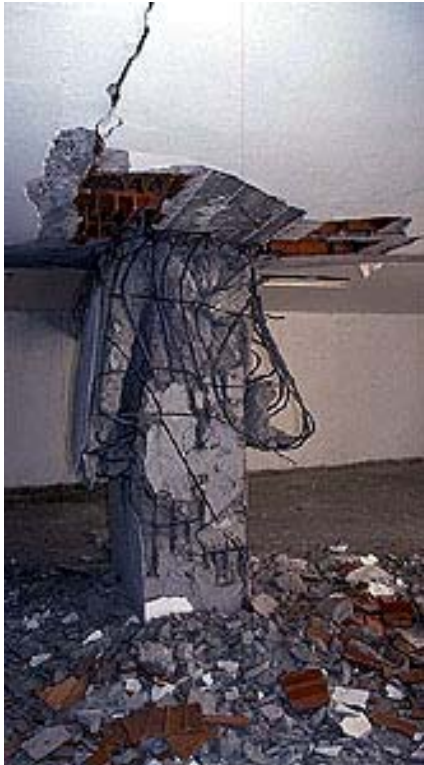
The distribution of damage to columns in the first story is shown in Figure 3-46. Figures 3-49, 3-50, and 3-51 show column failures. Nonductile detailing is evident, including widely spaced perimeter transverse ties with 90° hooks and no cross ties, and lap splices located at the floor level with no confining transverse reinforcement.

Figure 3-49 Shear failure of Column A (See Figure 3-46)

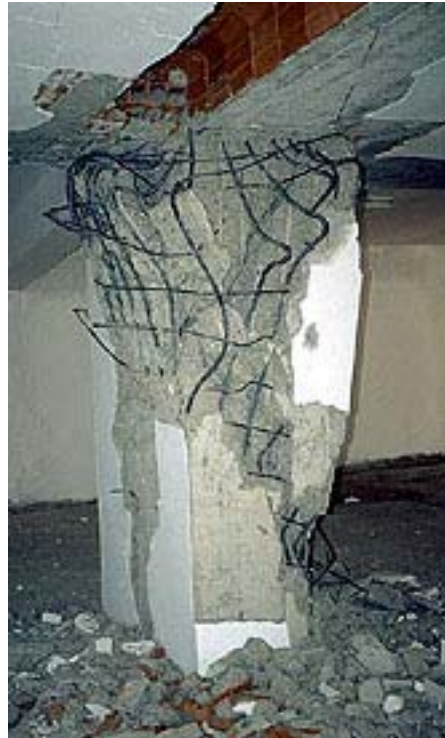
Figure 3-50 Axial failure of column B (See Figure 3-46)

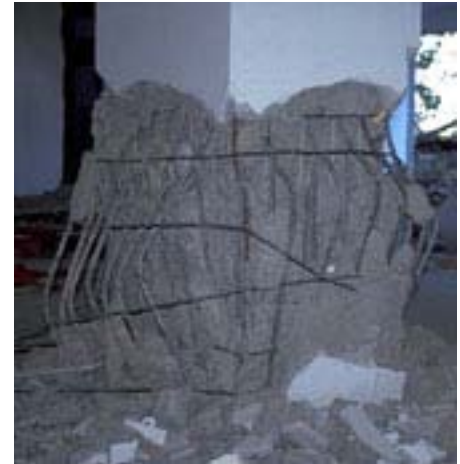
Figure 3-51 Axial failure at lap splice in Column C (See Figure 3-46)

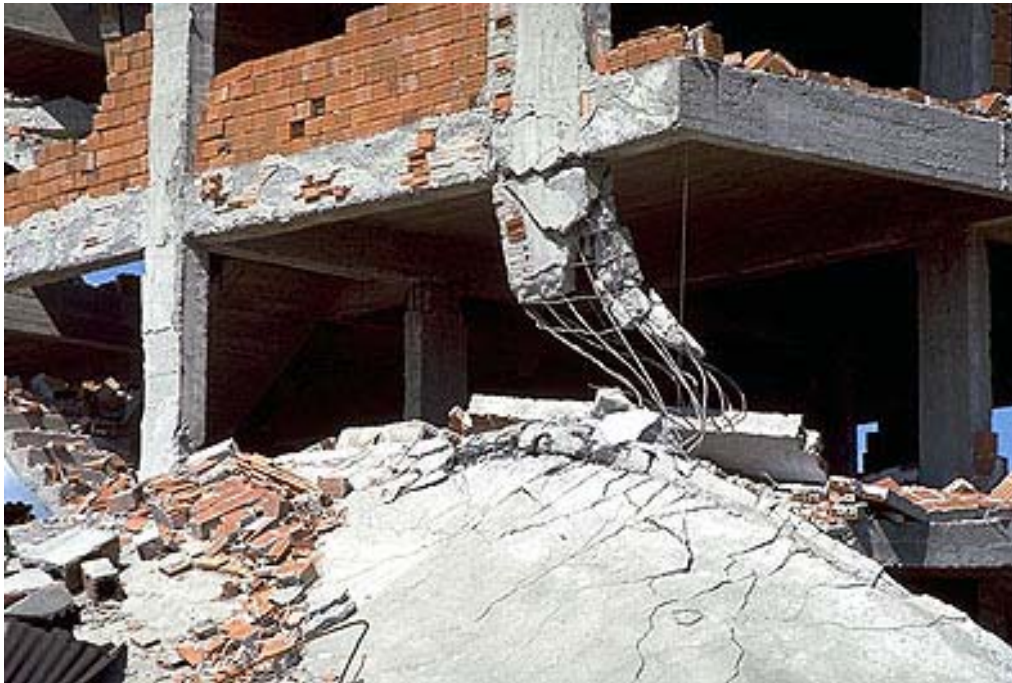
A corner column in the third story of Building B failed during the earthquake, as seen in Figure 3-52. Part of the roof framing of the adjacent building can be seen immediately below the failed column, indicating that the third-story column failed due to the impact of the adjacent building. Figure 3-53 shows more details of the failed column and the roof slab of the adjacent building.

Figure 3-53 Details of damage to third-story column of Building B

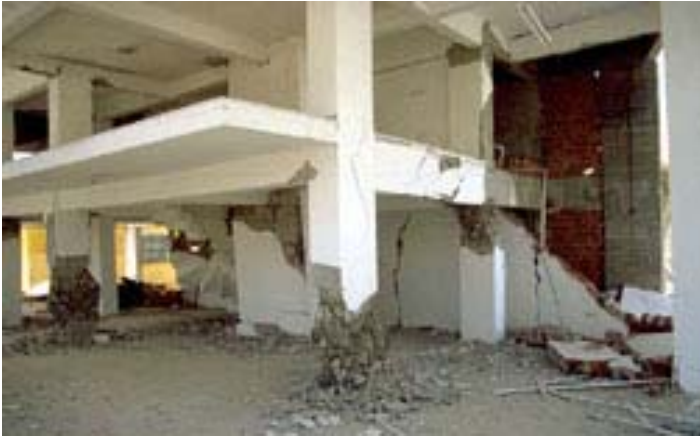
Most of the first-story columns connected to the mezzanine level failed in shear (Figure 3-55). The mezzanine level reduced the clear length of the columns, resulting in shear failures before the moment capacities of the columns could be developed. Damage to the stair framing and short shear wall connected to the mezzanine level can also be seen.

Figure 3-55 View of retail space in the first story of the Building C

damaged or failed components is needed. The severely damaged interior columns of Figure 3-55 could support little or no gravity load. This observation suggests that much of the gravity load in the building must have been distributed to the perimeter first-story columns by Vierendeel truss action in the upper stories. Many of these perimeter columns suffered damage to their beam-column joints, but the use of transverse reinforcement prevented joint failure and gravity load resistance was maintained.

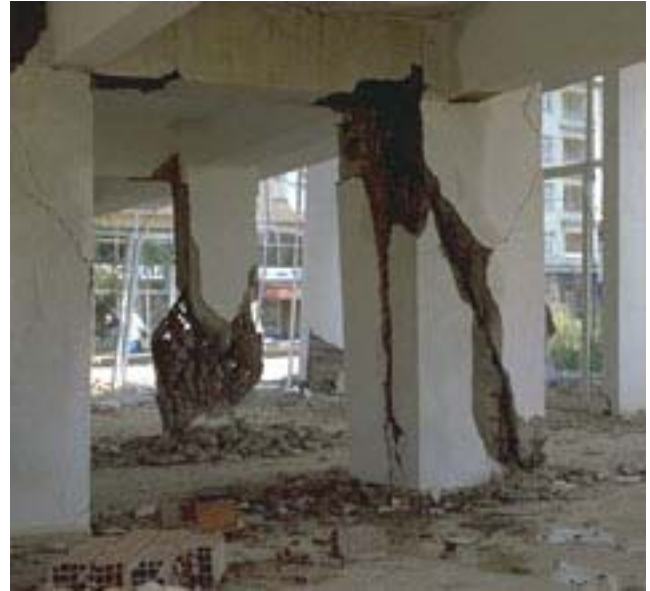
One of the failed columns at the rear of the building had a very steep shear crack (Figure 3-56) that suggested that the column was carrying high axial loads. Following a more detailed inspection of the building, the reconnaissance team concluded that the column was part of a two-story addition, which was separated from the five-story building by an expansion joint. No plausible explanation for the steep shear crack is proposed. The beam-column joints at the top of the first-story columns on the eastern façade were damaged but did not fail because transverse reinforcement was provided in the joint region; see Figure 3-57. The beam-column joint at the north-east corner of the first story was heavily damaged, as shown in Figure 3-58, but continued to carry gravity loads.

Figure 3-56 Shear crack in the first story column in the rear of Building C

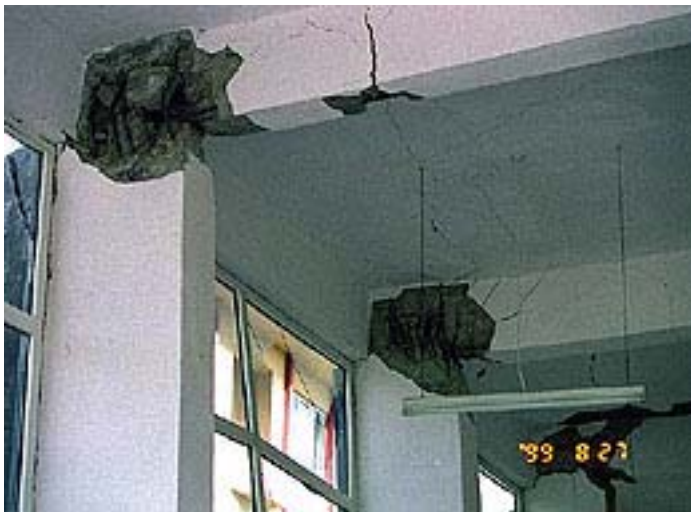
Figure 3-57 Damaged beam-column joints at top of first story columns, Building C

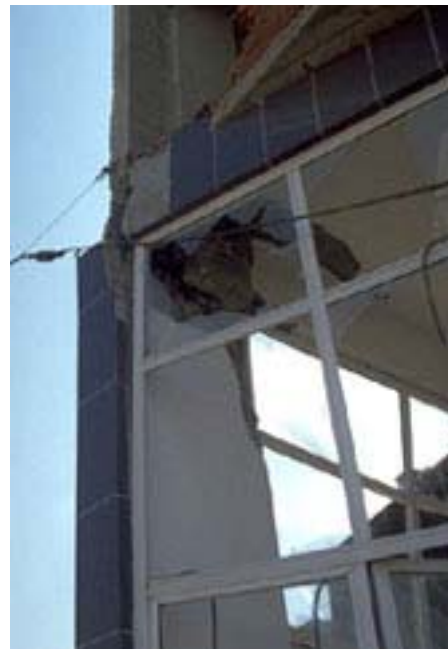
Figure 3-58 Damaged beam-column joint at top of first-story corner column, Building C.

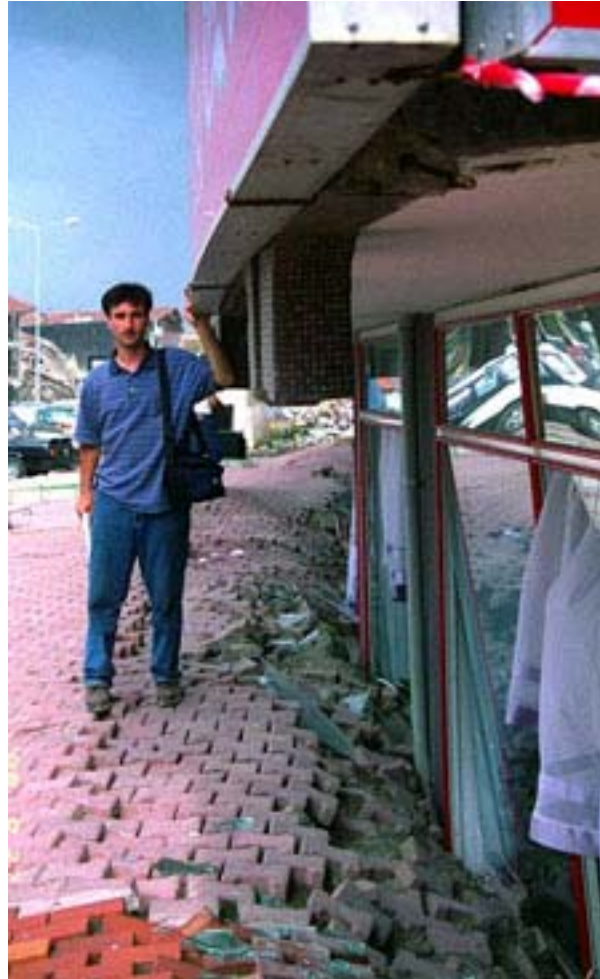
Figure 3-60 Settlement of Building D due to liquefaction and soil-bearing failure
