4 Industrial Facilities

4.1 Overview of Construction and Damage

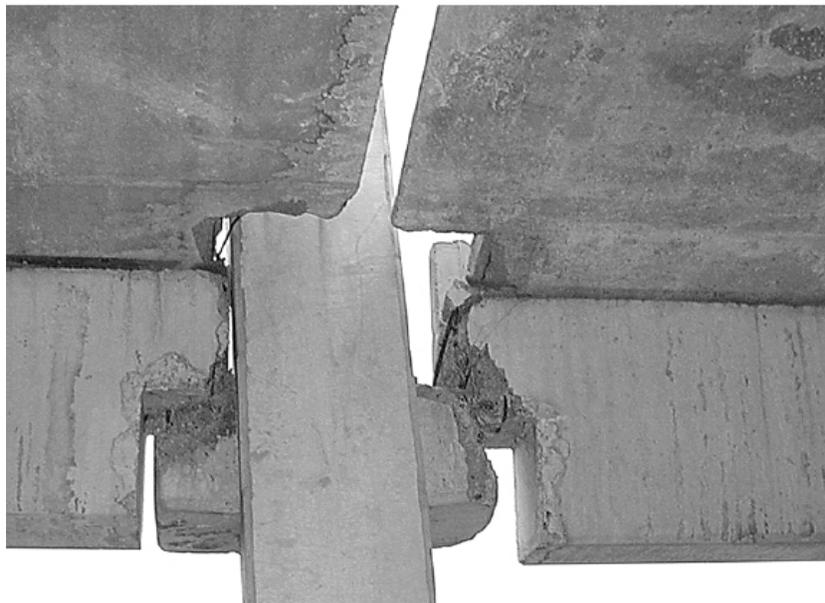
Figure 4-4 Typical plank roof construction and damaged doveled connections

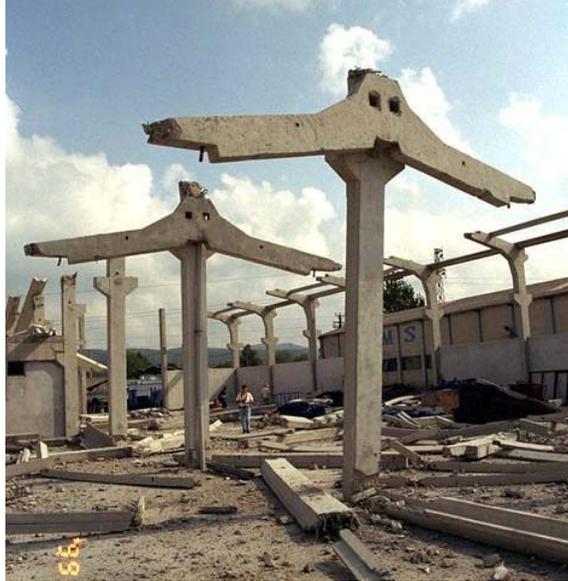
many of the columns acted as cantilevers and hinged at their bases during the earthquake. The precast T-units of Figure 4-3b rotated off the top of the two central columns in the middle of the photograph Figure 4-6 and are upside down. There was minimal reinforcement joining the T-shaped units to the columns below.

a. failed central columns and T-shaped units

Figure 4-6 Damaged precast reinforced concrete framed building

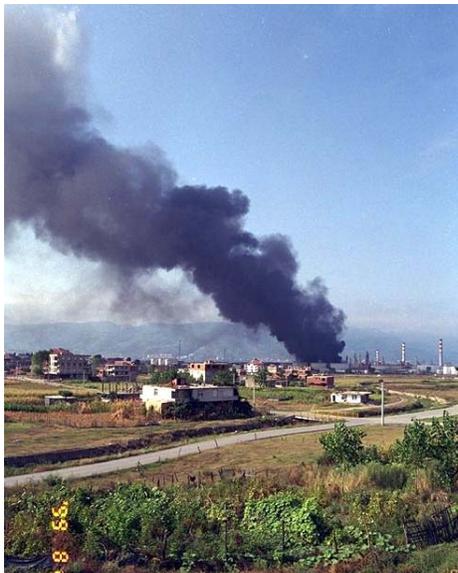
Figure 4-8. Tank farm fires at Tüpras refinery

Because fires burned out of control for several days in the tank farms, international attention was focused on the Tüpras refinery immediately following the earthquake. Refinery staff reported that the first major fire ignited in a floating-roof tank that contained naphtha, which is a highly volatile flammable liquid mixture distilled from petroleum. The fire reportedly spread quickly because the refinery staff had on site only sufficient foam to fight a small fire, not fires associated with the breaching and ignition of a fuel tank.

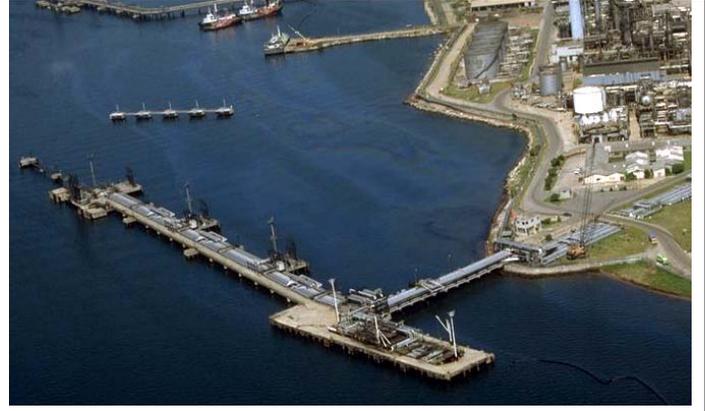
Figure 4-11. Loading and unloading jetty at Tupras refinery

The loading and unloading jetty shown in the aerial photograph (Figure 4-11) serviced the refinery only. Failure of this jetty prevented the loading and unloading of all fuel-oil products at the refinery. Ships tied up to the long arm of the T-shaped jetty (oriented north-west to south-east in the figure, where the top of the page is north). The jetty was composed of a reinforced concrete deck that was supported on steel piles. Modest ground failure was observed around the approach to the jetty. The support to the crude-oil pipeline (Figure 4-12) that ran along the seawall near the jetty was lost. Figure 4-13 is a photograph of the damaged jetty from point A of Figure 4-11. Gross damage to the jetty and the elevated pipeway and pipes is evident to the left of the tug. These pipes transferred fuel oil and other products between the refinery and ships tied to the jetty. Figure 4-14 is a photograph of the damaged jetty, from point B of Figure 4-11, that resulted from the failure of some of these piles. The loading and unloading jetty was separated from the vertical leg of the jetty. Refinery staff told members of the reconnaissance team that the heavy steel grating joining the two components of the jetty dropped into the water, indicating that the two components moved independently during the earthquake. The reconnaissance team observed steady leaks from one of the pipes at ground level, which was filled with volatile gasoline, more than ten days after the earthquake.

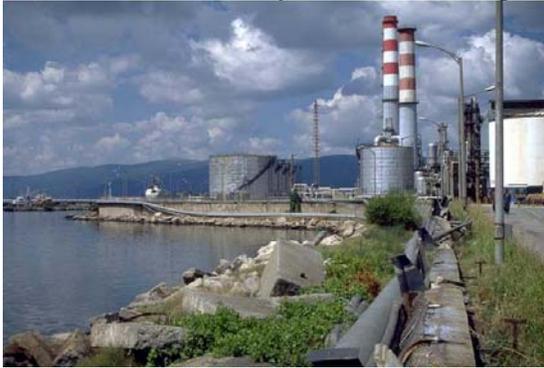
Figure 4-12. Failed crude oil pipeline along the sea wall at the Tupras refinery

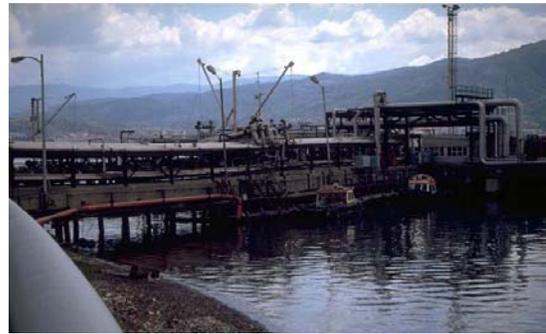
Figure 4-13. Damaged loading and unloading jetty

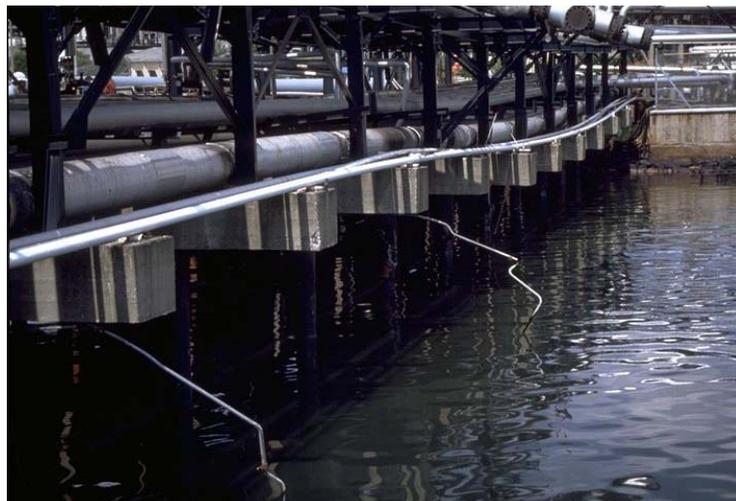
Figure 4-14. Damage to jetty and elevated pipeway in Tupras refinery

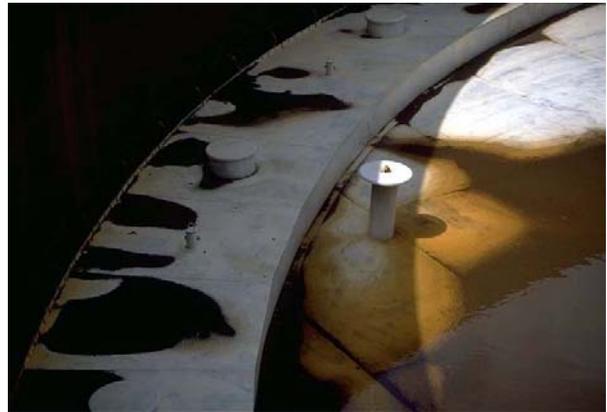
Many of the 100+ tanks in the Tüpras refinery farm were constructed with floating roofs. Figures 4-15, and 4-17 are photographs of Tank 211, which is located immediately adjacent to many of the burned tanks (see Figure 4-18). Figure 4-17 is a photograph of the detail at the junction of the edge of the floating roof and perimeter wall, showing the perimeter seal. Sloshing of the fluid in the tank likely damaged the perimeter seal, which permitted the fluid to escape from the containment. Such observations have been made in other earthquakes (ASCE 1997). Oil evident on the top of the floating roof (Figure 4-17) spread over much of the roof. Danis (1999) reported substantial damage to a large number of tanks (30+) in the farm; the inability of perimeter seals to retain the sloshing fluid in the tanks resulted in failure or sinking of these floating roofs. Each of these damaged floating roofs required repair or replacement before the tanks could be returned to service. Repair of the damaged or sunken roofs would have involved draining the tanks, decontamination of the roof, and replacement of the perimeter seals.

Figure 4-17. Perimeter seal of floating roof in Tank 211

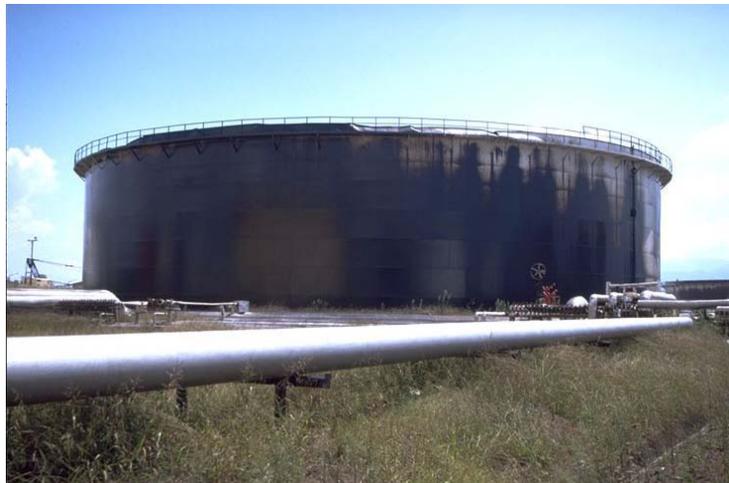
Sloshing of fluid produced overtopping in several tanks (see Figure 4-19) and gross damage to the tank wall near the tops of walls in other tanks (see Figure 4-20). The oil lost from these tanks was contained within the earthen berms surrounding the tanks.

Figure 4-19. Overtopping of tank wall due to sloshing and failure of perimeter seals

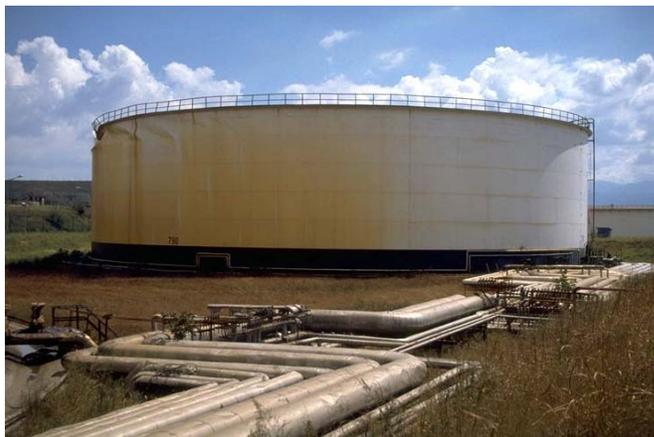
Figure 4-20. View of tank wall damage

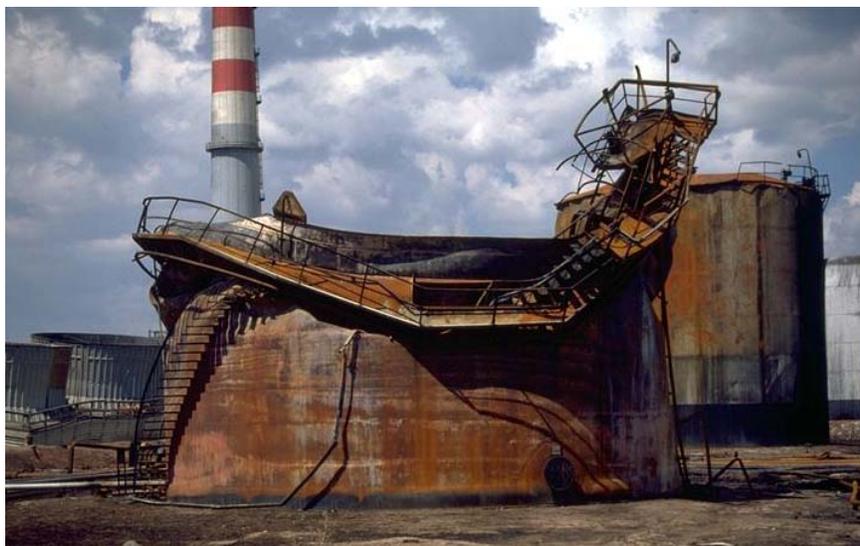
Figure 4-23. Tank destroyed by fire in burn zone

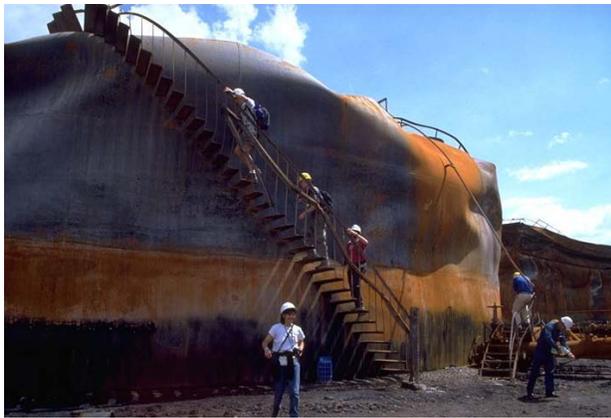
Figure 4-24. Tank destroyed by fire in burn zone

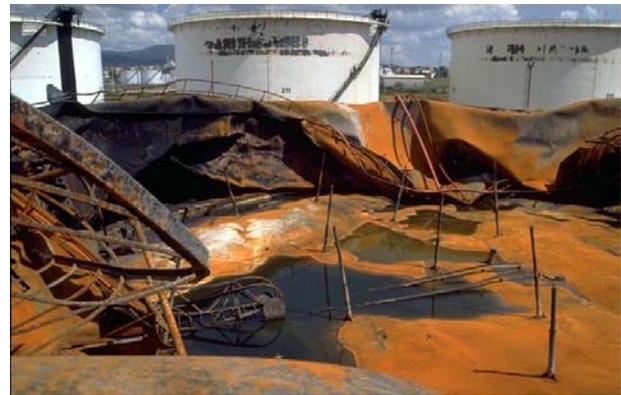
Figure 4-25. Destroyed walls, walkways and floating roof of tank in Figure 4-24

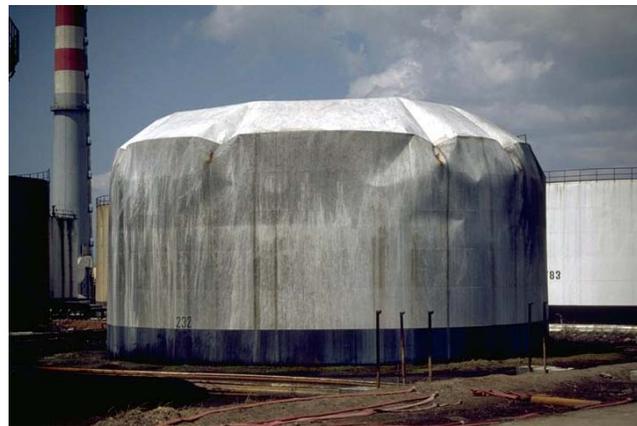
Figure 4-26. Gross expansion of fixed roof tank adjacent to tank of Figure 4-24

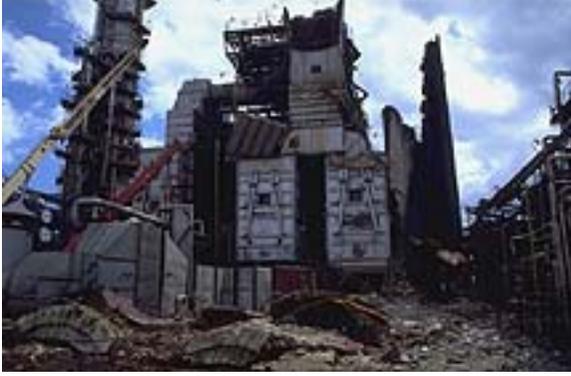
The main processing facility is composed of three crude-oil processing units. Constructed in 1983, one of the three units was destroyed by the collapse of an approximately 110-m-tall reinforced concrete heater stack in the middle of the unit. Figure 4-27, a photograph of the failed heater stack, was taken from the end of the loading and unloading jetty. The upper two thirds (approximately) of the heater stack collapsed. Failure of the stack likely initiated at a stiffness discontinuity in the reinforced concrete stack where large-size ductwork entered the stack. (See the undamaged heater stack to the left of the collapsed stack. Large-size ductwork enters this stack at approximately the same level at which the collapsed stack failed.) The top of the stack fell into a heater unit (Figure 4-28) and the lower portion of the failed stack collapsed onto pipework at the perimeter of the facility (Figure 4-29). Refinery staff reported that some pipework was fractured by the collapsing heater stack, which ignited fires in the crude-oil unit. These fires buckled structural components that supported the furnace and the pipeways.

Figure 4-28. Damage to heater unit caused by collapse of heater stack

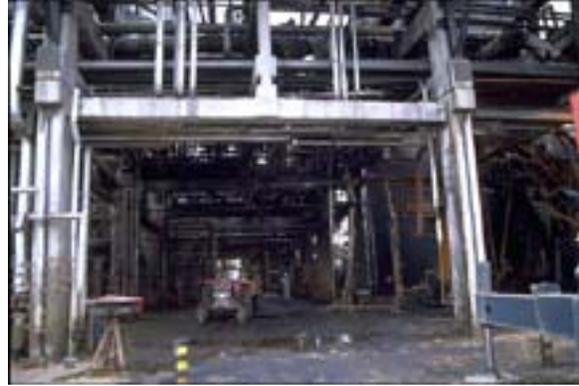
Figure 4-29. Damage to pipework caused by collapse of heater unit

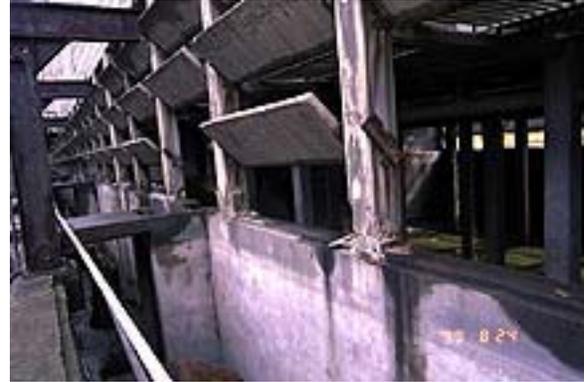
Figure 4-32. Damage to nonductile reinforce concrete in Petkim cooling tower

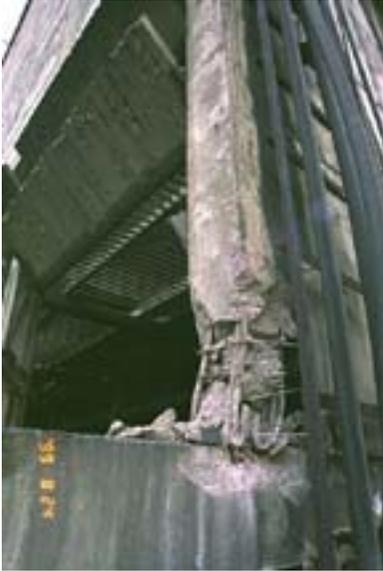
Parts of the Petkim facility were severely damaged. Maximum accelerations of approximately 0.32g were recorded at the YPT station (see Chapter 1), which was located within 200 m of the collapsed three-cell tower. Figure 4-31 shows the complete collapse of an older three-cell wooden cooling tower; but a four-cell tower adjacent to the collapsed tower suffered no damage. A reinforced concrete cooling tower approximately 400 m from the YPT station was badly damaged. Nonductile reinforced concrete columns at the perimeter of the cooling tower and atop a continuous reinforced concrete perimeter were severely damaged at the bases (Figure 4-32). Figure 4-33 shows typical damage and rebar details at the base of one column. The column in this figure was constructed with round longitudinal rebar. The transverse ties were widely spaced and 90° hooks were employed. It is evident in the figure that the transverse ties failed leading to dilation and failure of the core concrete in the *hinge* zone.

Figure 4-33. Rebar details and damage in reinforced concrete cooling tower at Petkim

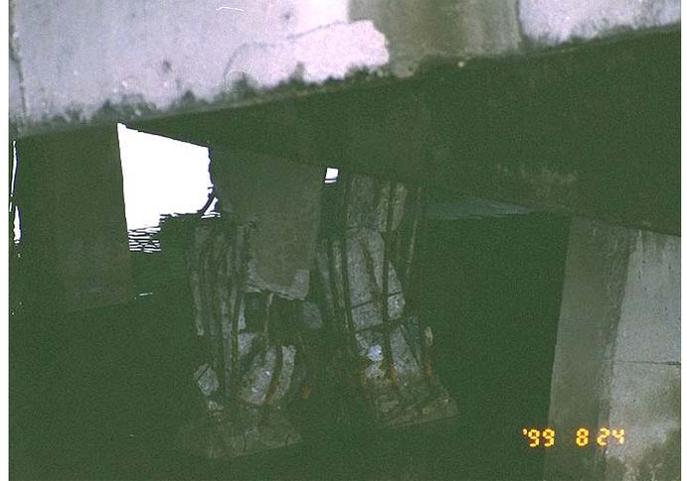
Figure 4-35. Failure of battered reinforced concrete piles beneath jetty, Petkim facility

The Petkim petrochemical plant, similar to the Tüpras refinery, had a dedicated port facility through which much of the plant's raw material and processed product passed. Ground failure was observed near the jetty entrance. This port, like the port that serviced the Tüpras refinery, was badly damaged by the earthquake and was not operational afterward. Many of the battered piles beneath the jetty (Figure 4-34) were badly damaged. Typical damage to these battered piles is shown in Figure 4-35.

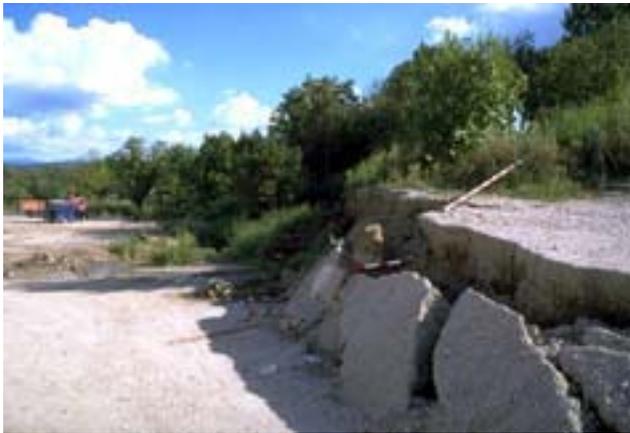
This building was damaged during the earthquake by a combination of shaking and fault rupture and ground failure beneath the building. Figure 4-37 shows the degree of ground movement within 100 m. Damage included permanent deformations in the building frame, hinges in the cantilever columns (Figure 4-36), badly cracked and separated floor slabs, and collapse of some wall panels. Figure 4-38 shows the damaged building.

Figure 4-37. Ground movement near Ford plant, Golcuk

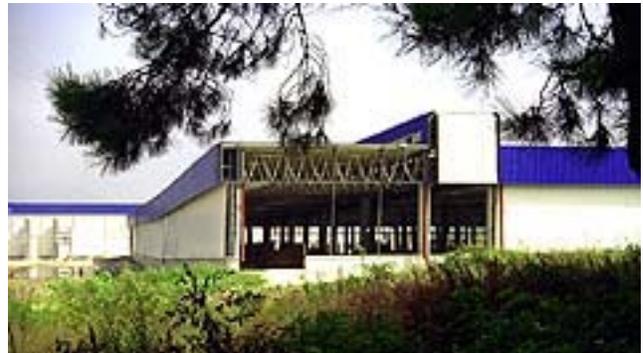
Figure 4-38. Exterior view of damaged Ford body shop

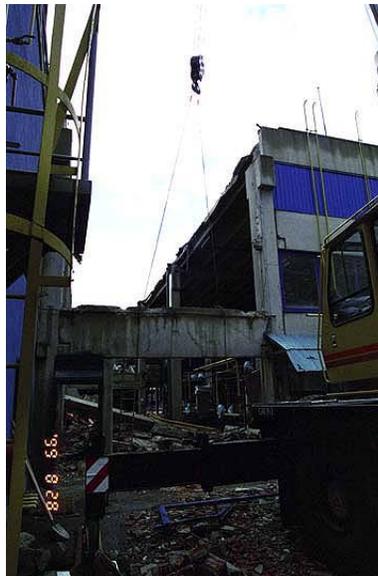
Figure 4-40. Damage to the DuSA main plant building

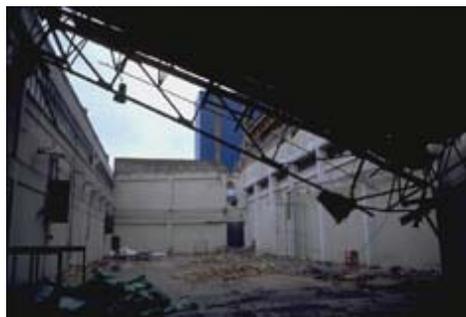
A product storage area was added to the main plant after the original construction. The light steel-framed roof of this storage area collapsed (Figure 4-43), likely due to the differential movement of two parallel walls, also visible. A number of the *short* columns in the wall to the right failed in shear. The masonry infill above these short columns fell through the roof of the storage area.

Figure 4-43. Roof collapse in storage area of KordSA plant

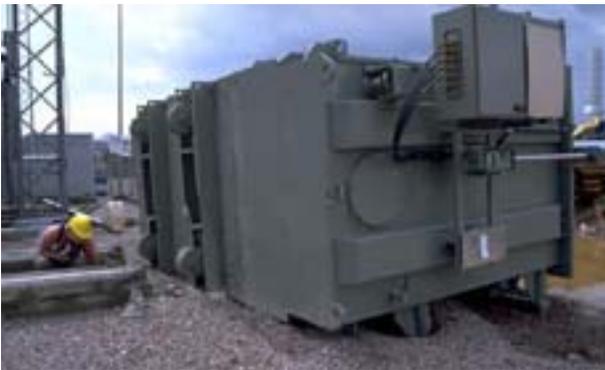
Figure 4-45. Topped transformer in EnerjiSA transformer yard

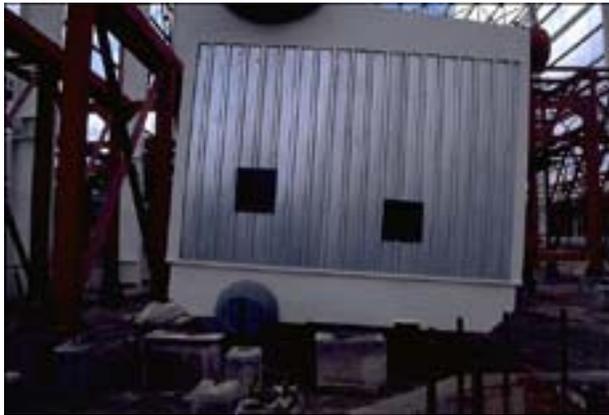
A heat-recovery steam boiler (Figure 4-46a) that had been installed but not brought online at the time of the earthquake slipped off its foundation during the earthquake. The fillet welds joining the boiler framing to the base plates atop the reinforced concrete foundation failed (Figure 4-46b); these welds were small and of very poor quality.

Figure 4-46a. Damaged boiler, EnerjiSA plant

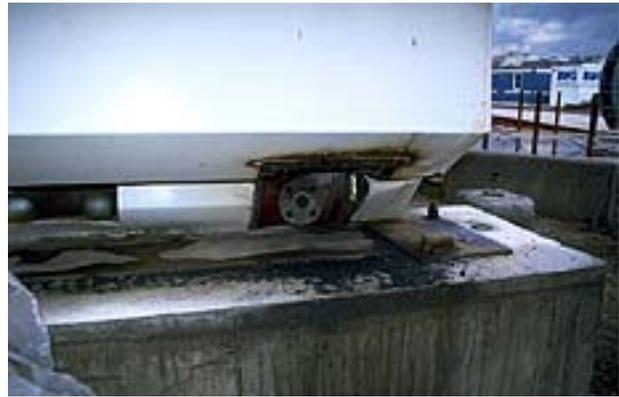
Figure 4-46b. Failed fillet-weld connection of boiler framing to baseplate

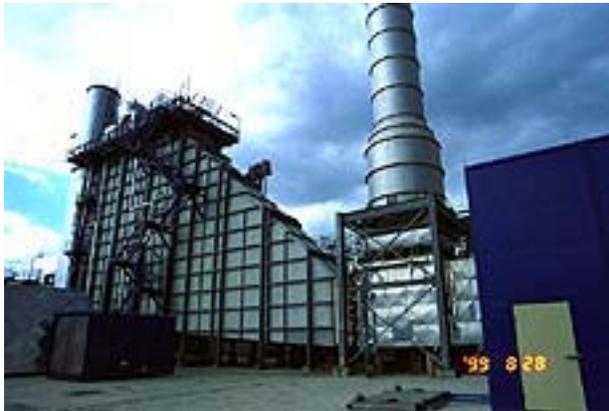
The base plate connections of steel framing to components of both the existing and the new steam generation systems failed. Figure 4-47a shows two-level framing to an in-service chimney. Figure 4-47b shows the damage at the base plate connection. Figure 4-48a is a photograph of

Figure 4-47a. Damage to steel framing to EnerjiSA in-service steam generator

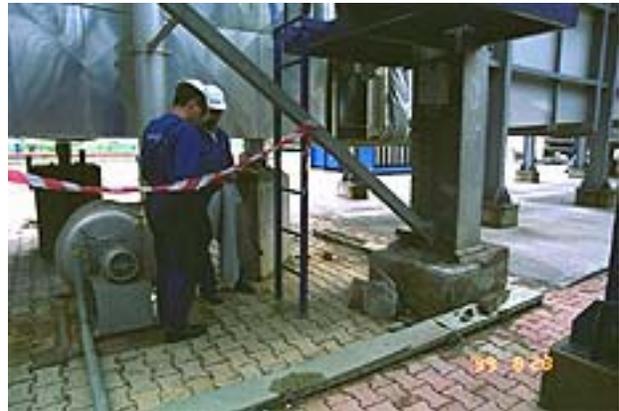
Figure 4-47b. Damaged baseplate connection, EnerjiSA in-service steam generator

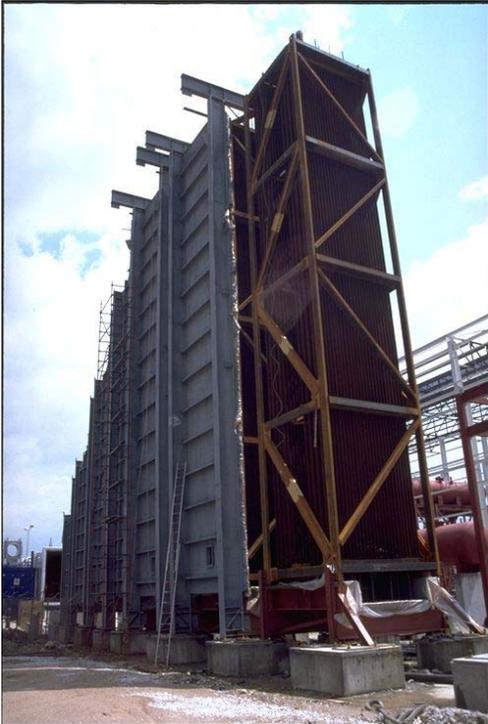
Figure 4-48a. Damaged framing to new steam generator, EnerjiSA

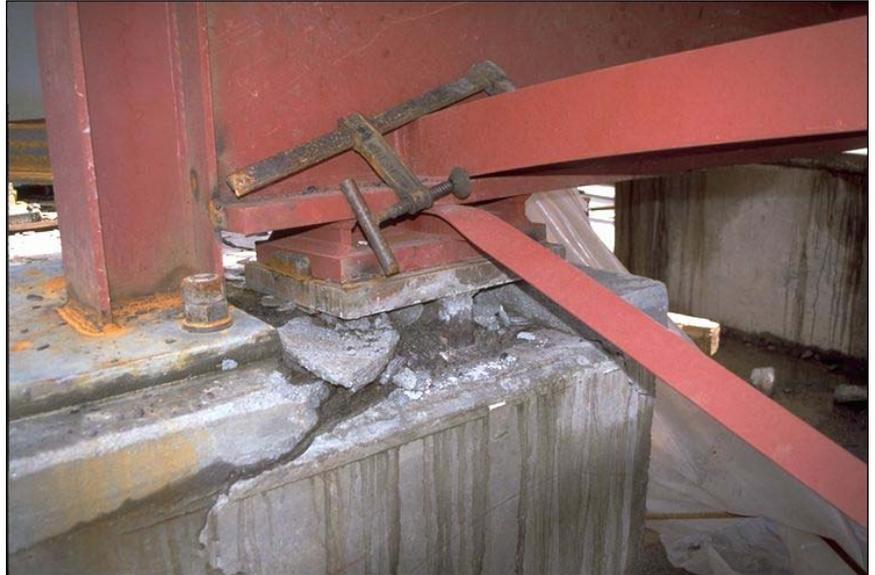
steel braced framing in the new steam-generation system. Figure 4-48b shows damage to the grouted base plate connection and steel brace that was located on the far side of the steel bracing in Figure 4-48a. The shear key (Figure 4-48b) was not embedded in the concrete pedestal beneath the grout pad but in the grout pad only.

Figure 4-48b. Failed fillet weld connection of new boiler framing to baseplate, EnerjiSA

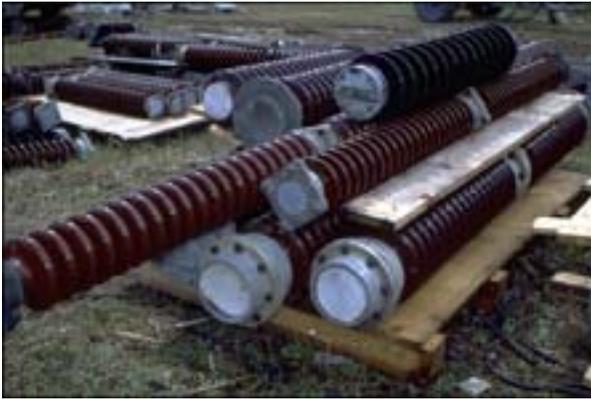
An aerial photograph of the substation is shown in Figure 4-49. Much switching gear and two power transformers can be seen in the photograph. Numerous porcelain insulators failed during the earthquake; some of the fractured units can be seen in Figures 4-50a and 4-50b. Figure 4-51 is a view of pre- and post-earthquake-installed circuit breakers in the substation; rigid bus connectors span the service road. The V-headed shaped circuit breakers were in service at the time of the earthquake. The T-headed circuit breakers replaced the failed V-headed circuit breakers and had been installed well prior to the visit by the reconnaissance team. Those V-

Figure 4-50a. Failed porcelain insulators

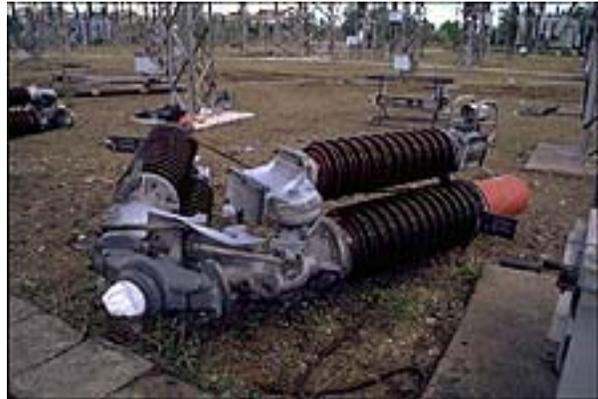
Figure 4-50b. Failed porcelain circuit breakers

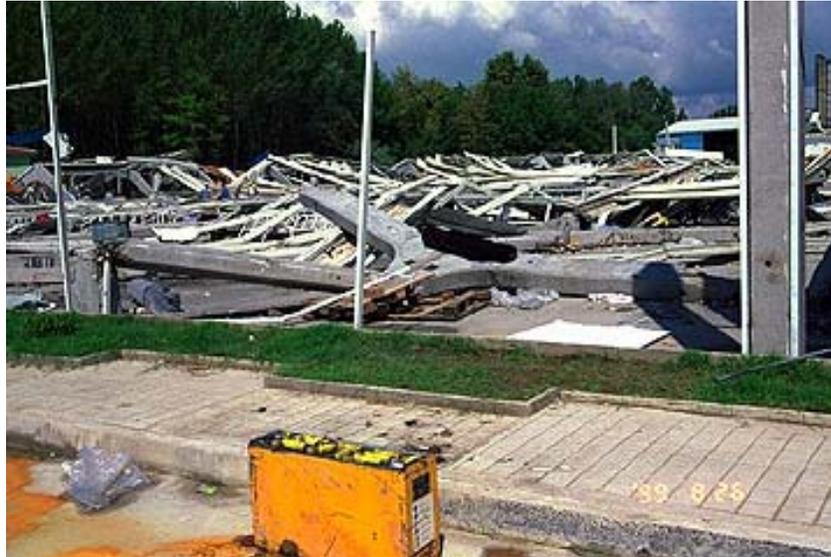
Figure 4-54 Collapsed precast reinforced concrete building, Çap textile plant.

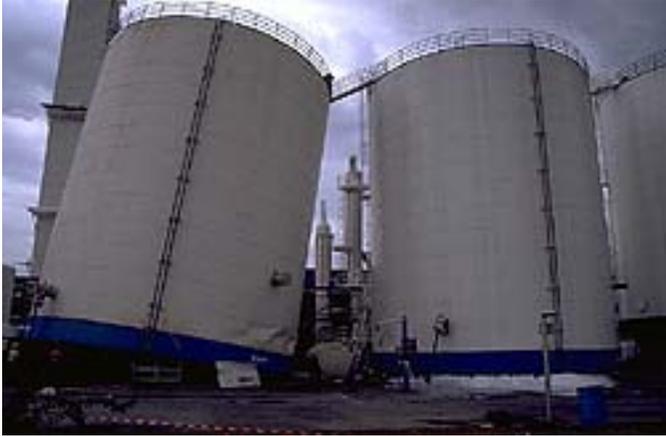
The two tanks containing liquid oxygen collapsed as seen in Figure 4-57. The tank and supporting structure containing liquid nitrogen was undamaged except for some hairline cracks in the columns. Habas representatives reported that the liquid oxygen tanks were 85% full, and the liquid nitrogen tank was 25% full at the time of the earthquake. The outer shells of the collapsed tanks buckled (Figure 4-58). Photographs of some of the failed columns beneath one of the liquid nitrogen tanks are presented in Figure 4-59.

Figure 4-57. Collapse of liquid oxygen tanks

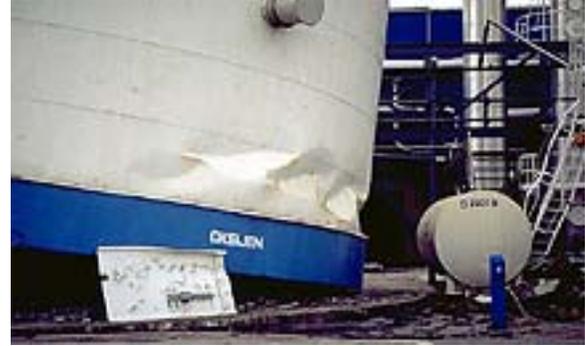
Figure 4-58. Buckling of the outer stainless steel shell in liquid oxygen tank

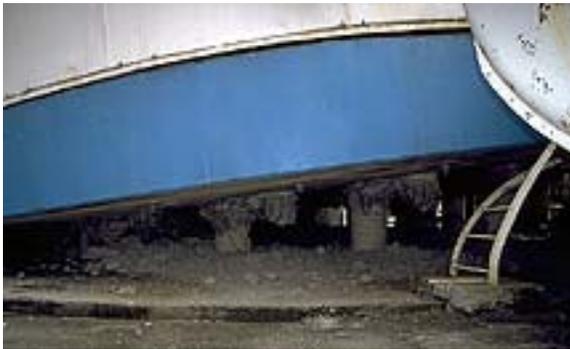
Figure 4-59a. Failed columns beneath slab under liquid oxygen tank, Habas facility

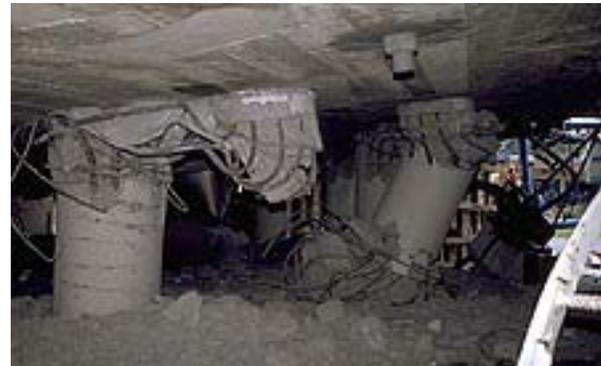
Figure 4-59b. View of failed columns beneath liquid oxygen tank, Habas facility

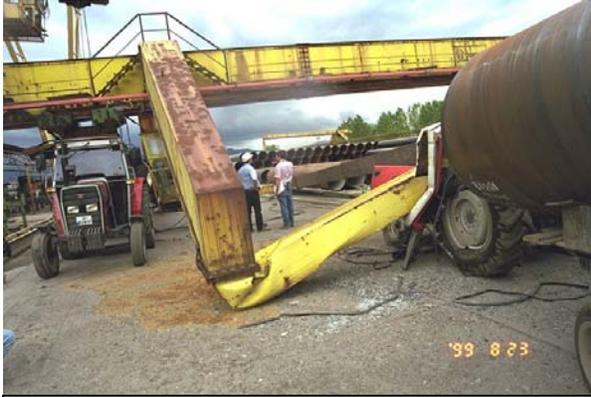
Figure 4-60b. Collapsed crane leg, Mannesmann Boru pipe storage facility

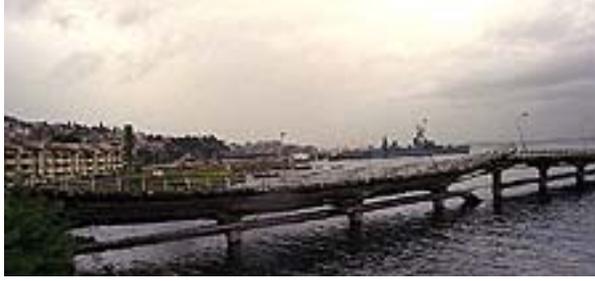
Figure 4-61a. Failure of hammerhead reinforced concrete jetty piers, SEKA paper mill

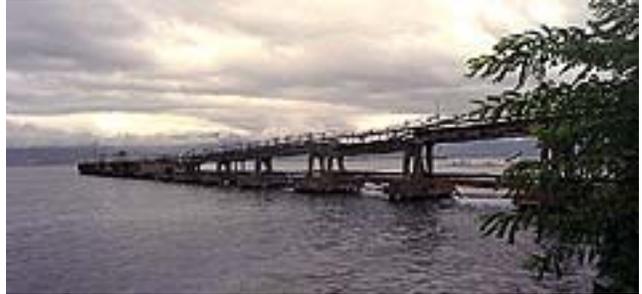
Figure 4-61b. View of failed jetty, SEKA paper mill

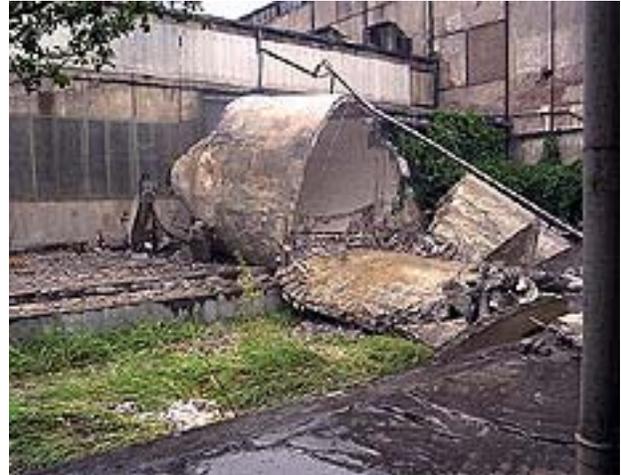
Three reinforced concrete silos containing water collapsed. Figures 4-62a and b are photographs of an undamaged and a collapsed silo, respectively. The diameter of the silos was approximately 6 m. The collapsed silos were supported on six small square nonductile columns with minimal longitudinal reinforcement. The undamaged silos of Figure 4-62a were supported on larger (square) columns than those of the collapsed silos.

Figure 4-62b. Collapsed silo, SEKA paper mill

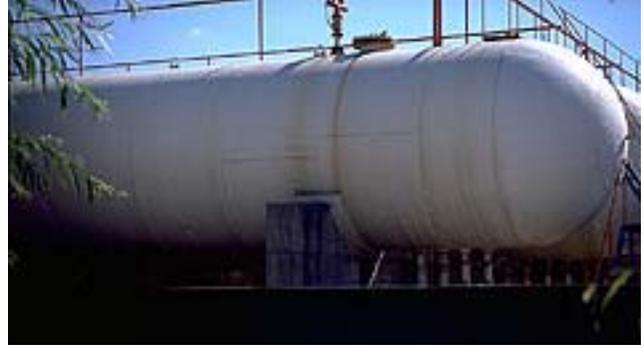
Figure 4-63b. Typical damage to liquid gas tanks
