# Appendix: Performance of the Adapazari City Hall

## A.1 Introduction

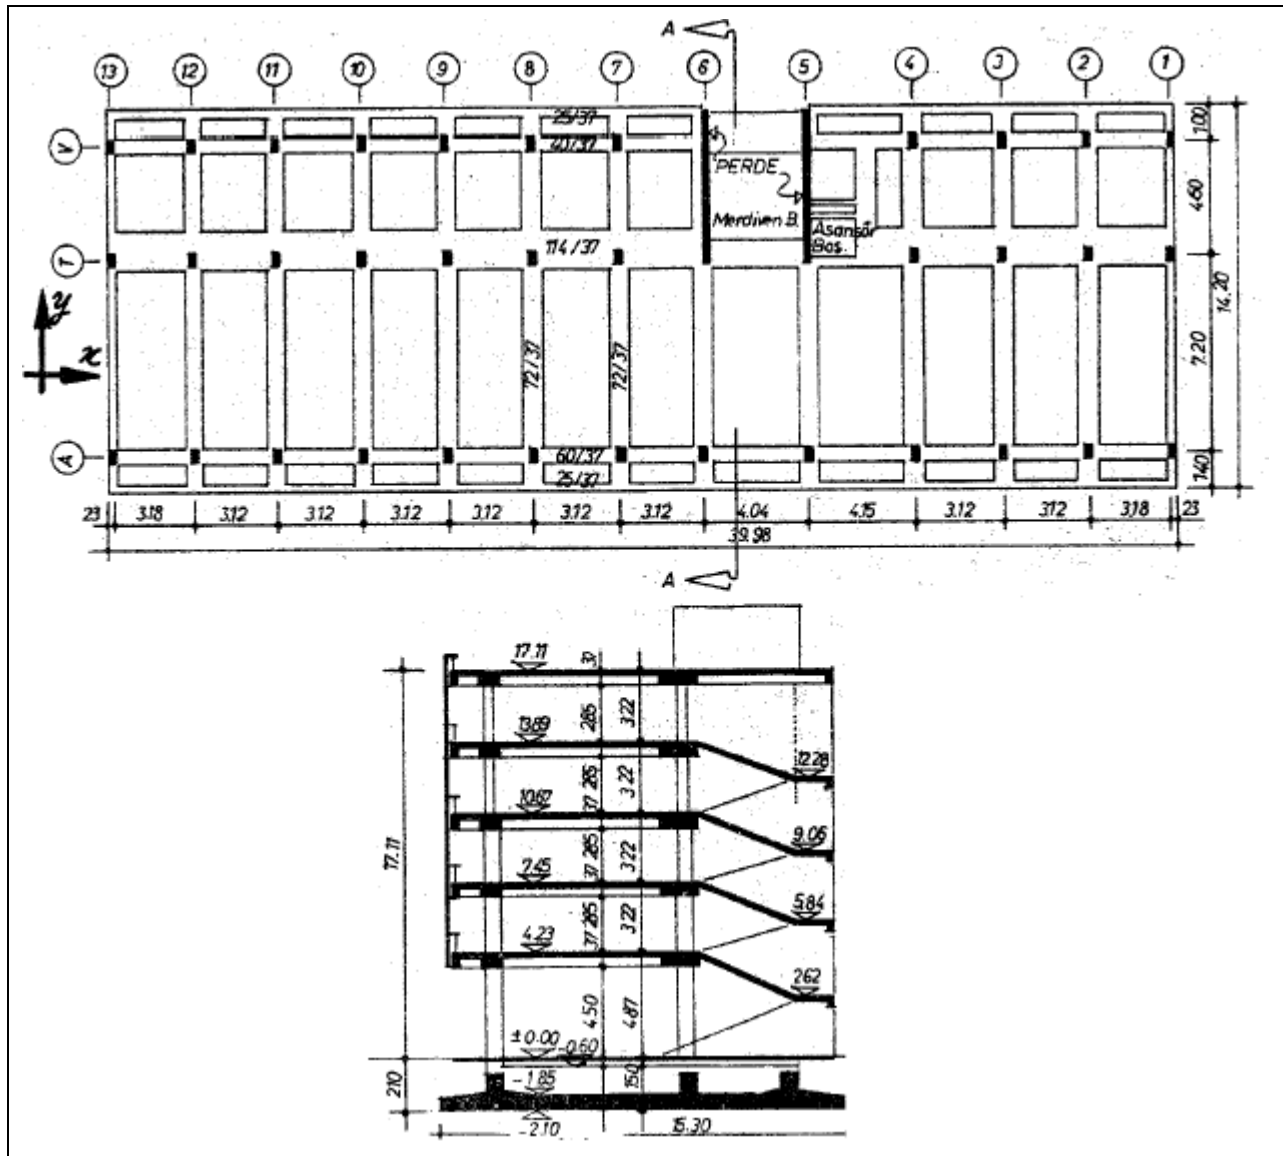
Like most other buildings in Adapazari, the City Hall building does not have a basement, since the water table lies 1 to 2 m below grade. The building is located on relatively soft soil deposits (Anadol et al. 1972). The foundation is composed of tapered footings (Figure A-1) connected with 400 mm by 900 mm grade beams in the x (longitudinal) direction and 500 mm by 1500 mm base beams in the y (transverse) direction.

Figure A-1 Typical plan and elevation of the original building (Anadol et al. 1972)

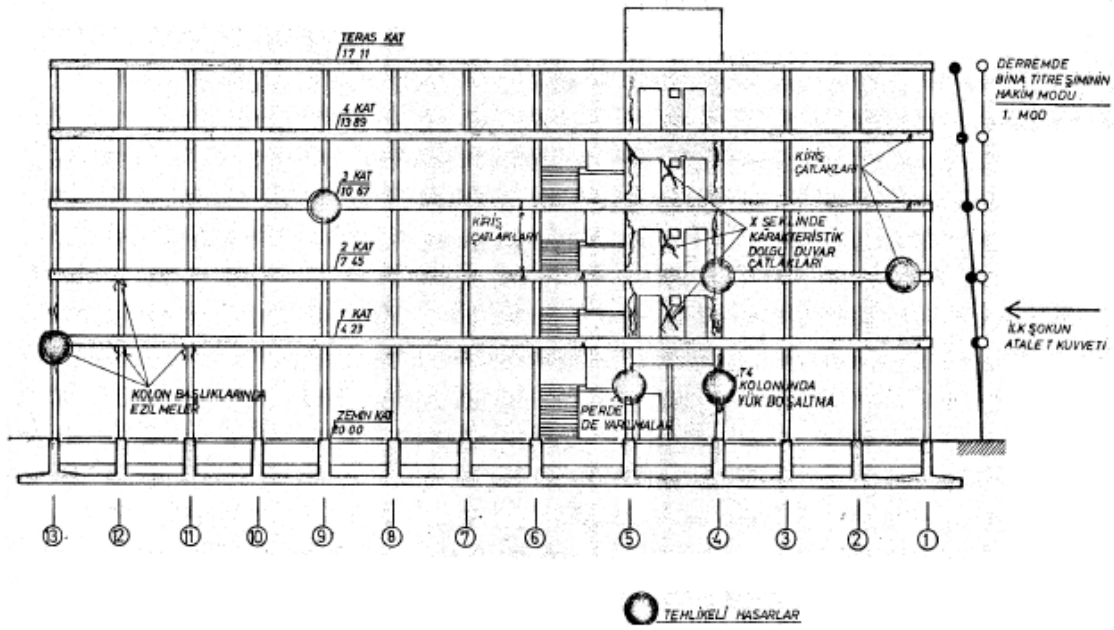
The damage observed after the 1967 M7.1 Akyazi earthquake was concentrated in the shear walls (Figure A-2) and columns in the lower stories. As shown in Figure A-3a, no ties were observed in one column (Grid A-1 in Figure A-1). In this figure "Etriye yok" translates as "No tie." Figure A3b shows shear failure in a column; this column was located at Grid T4 in the basement. Damage to stairwells, slabs, and beams was also reported at several floors. Large shear cracks were observed in many of the infill walls.

Figure A-2 Building damage after the 1967 Akyazi earthquake

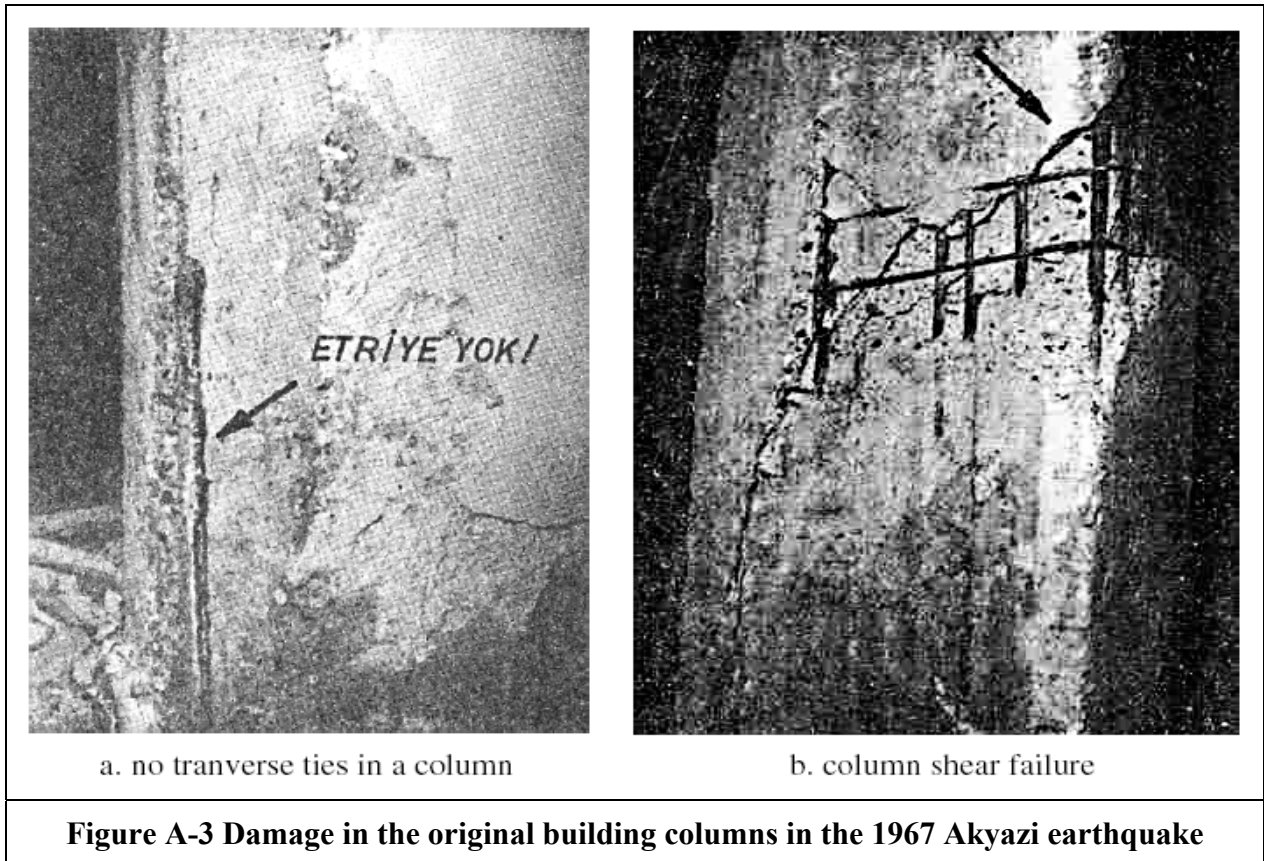
Figure A-3 Damage in the original building columns in the 1967 Akyazi earthquake

a. no transverse ties in a column

b. column shear failure

The 1967 retrofit program included repair and strengthening of damaged slabs, beams, columns and shear walls, and the addition of new beams and shear walls. Columns were typically retrofitted by the addition of transverse reinforcement and an increase in the column size by 140 mm to 180 mm. New transverse perimeter shear walls were added on Grids 1 and 13, and transverse interior shear walls were added on Grids 8, 9, and 10 to match existing walls on Grids 4, 5, and 6. Short longitudinal walls were placed in the four corners of the building. Figure A-4 shows the locations of the new reinforced concrete shear walls. ("B.A. perde" translates as "RC shear wall"). Existing perimeter longitudinal beams were retrofitted and new perimeter longitudinal beams were added as indicated in Figure A-5. The new longitudinal walls are shown hatched in this figure.

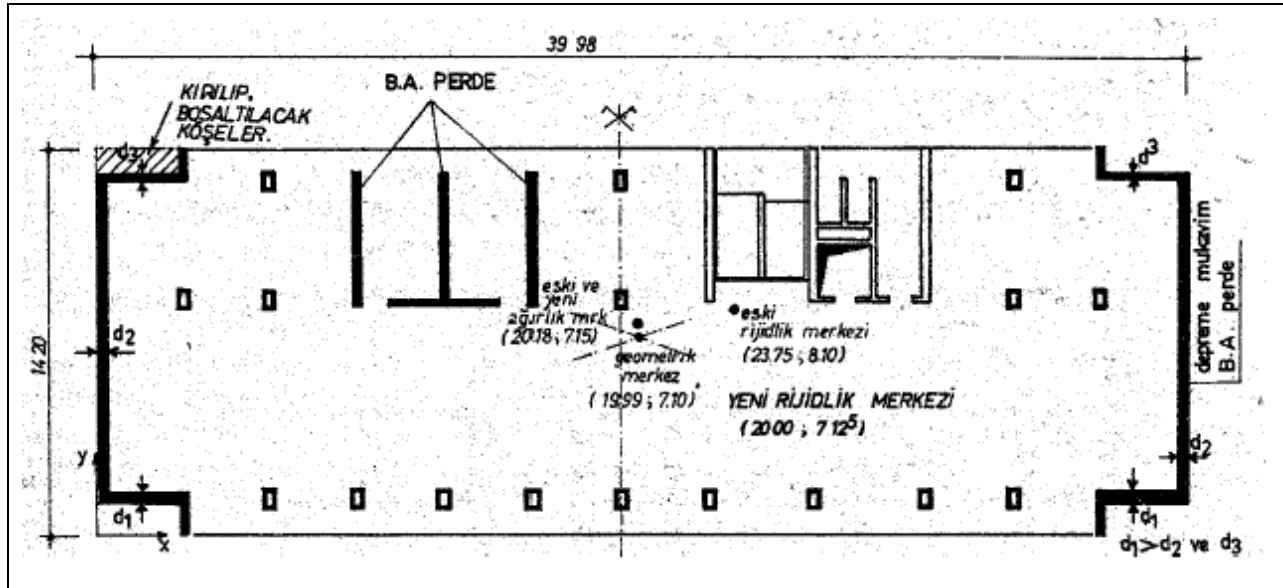
Figure A-4 Typical floor plan after retrofit showing the location of new shear walls (Anadol et al. 1972)

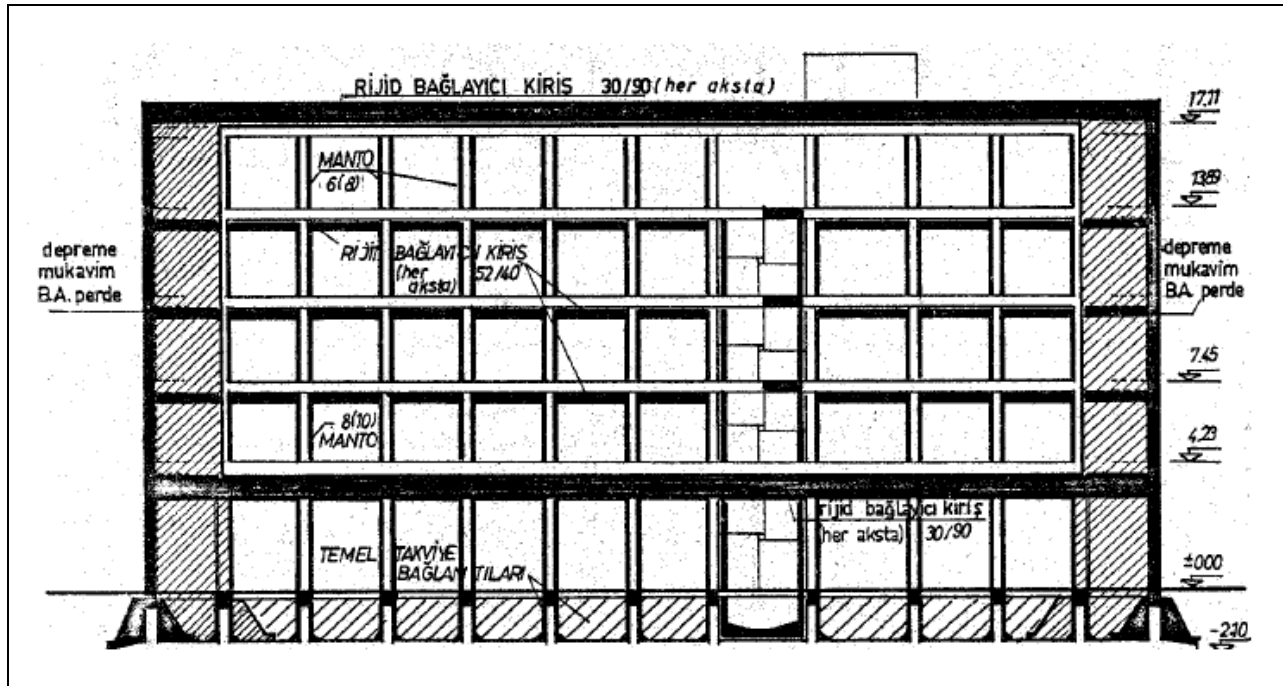
Figure A-5 Front elevation after the retrofit in 1968 (Anadol et al. 1972)

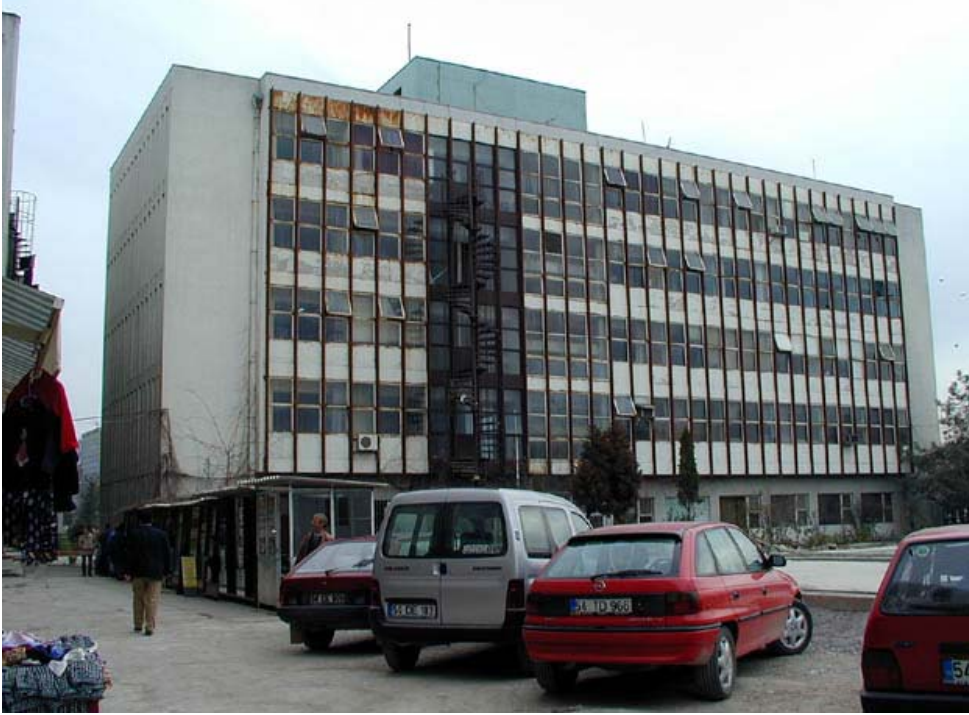
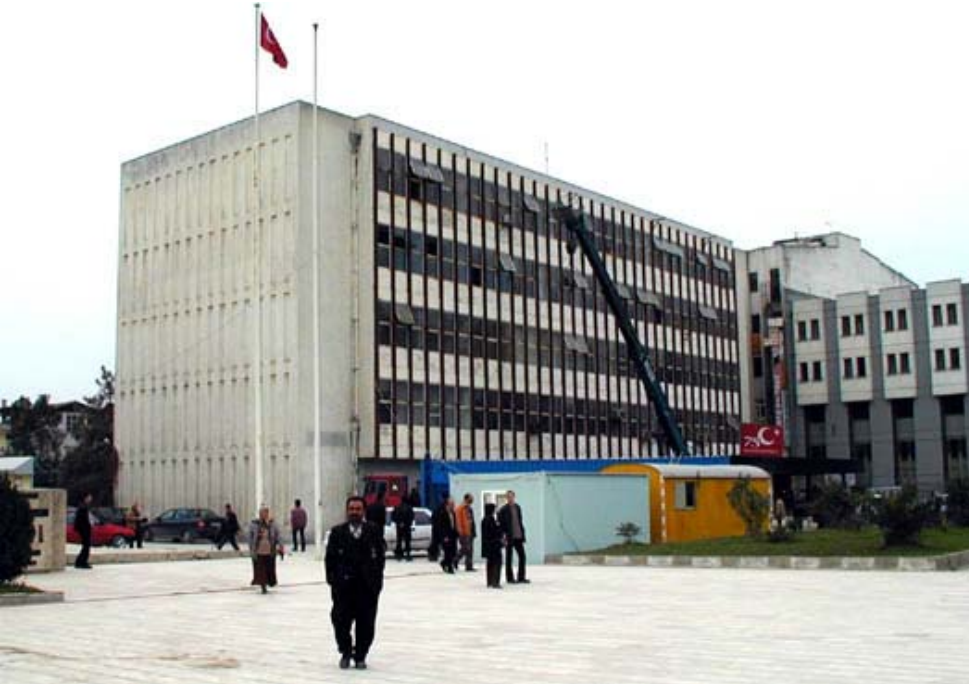
**Figure A-6 City Hall after the November 12, 1999, Duzce earthquake**

The North Anatolian fault ruptured within 10 km of the City Hall and devastated many reinforced concrete moment-frame buildings in the immediate vicinity of the City Hall, but this retrofitted building sustained negligible structural damage. The nonstructural components and contents suffered only modest damage. Because the City Hall was one of the few buildings in downtown Adapazari that suffered little to no structural damage, it was used as an Emergency Crisis Center to direct response and recovery after the earthquake. Figure A-6 presents two photographs of the City Hall taken in mid-November 1999.

**a. back view (V and 1 axes on plan, Fig. A-1)**

**b. front view (A and 13 axes on plan, Fig. A-1)**

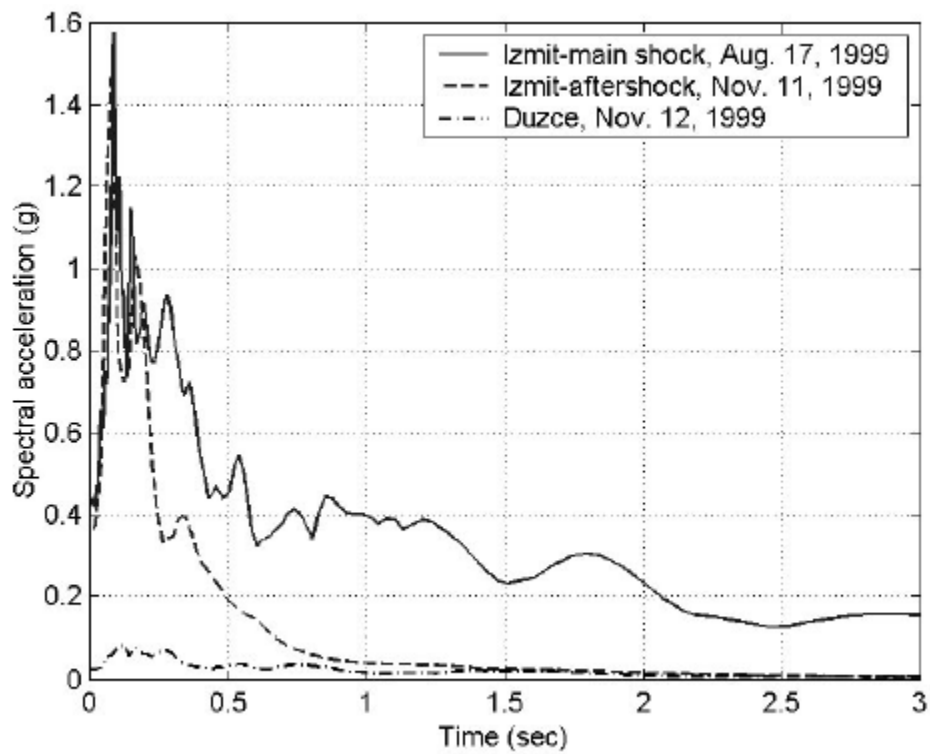
The solid line in Figure A-7 presents the 5% damped pseudo-acceleration response spectrum prepared using the east-west ground acceleration history recorded a few kilometers from the City Hall during the August 17, 1999, earthquake. The zero-period acceleration for this recorded ground motion was 0.41g. The spectral acceleration at 1 sec, the approximate period of the City Hall building, was 0.4g. Because the building sustained little to no structural damage, and assuming that the strength of the building was no greater than 15% of the weight (calculated by doubling the allowable-stress-design lateral-force coefficient of 0.07), the intensity of shaking at the site of the building was likely substantially less than that indicated by the solid line in the figure. Parenthetically, the elastic spectral demands associated with the earthquake shaking in Adapazari were large, and it is not surprising that many nonductile reinforced concrete moment frame buildings in this city collapsed because the spectral demands greatly exceeded the lateral strength of these buildings that likely did not exceed 5% to 10% of their weight.

On November 11, 1999, an aftershock of the August 17 earthquake produced substantial shaking in Adapazari. The dashed line in Figure A-7 is the 5% damped pseudo-acceleration response spectrum prepared using the east-west ground acceleration history recorded at the site described in the previous paragraph. The zero-period acceleration for this motion was 0.35g. Additional damage to structural and nonstructural components in the City Hall was reported.

**Figure A-7 Acceleration spectra for the August 17, 1999, Izmit main shock; the November 11, 1999, Izmit aftershock; and the November 12, 1999, Duzce main shock**
