## **CHAPTER 4**

# **INDUSTRIAL DAMAGE AND LOSSES OBSERVED IN PAST EARTHQUAKES IN TURKEY**

## **4. INDUSTRIAL DAMAGE OBSERVED IN PAST EARTHQUAKES**

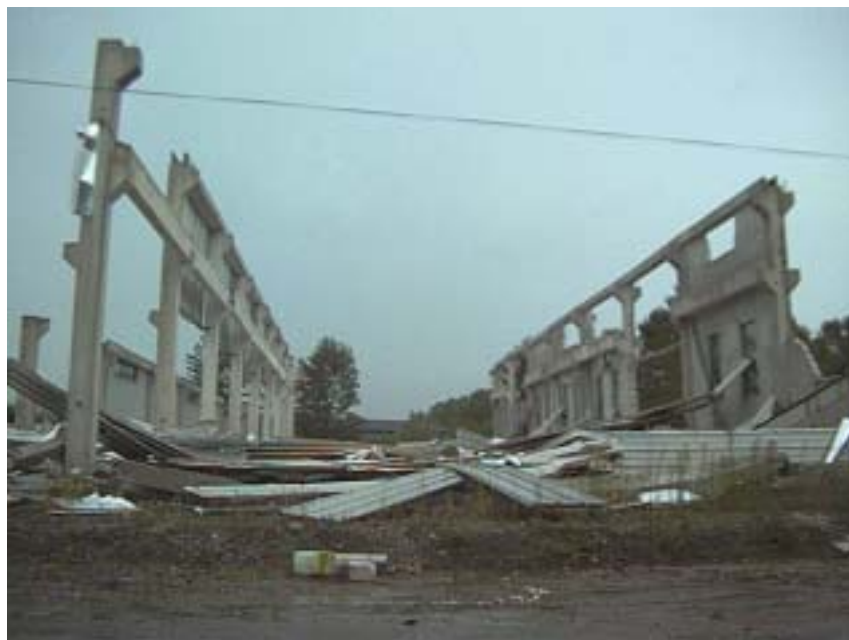
The main problem was due to failure of weak joints between the roof beams and columns. Some prefabricated buildings collapsed because of the lack of bracing due to flexible or missing peripheral walls or roof diaphragm (Figure 4.1 and Figure 4.2).

Figure 4.1. Collapsed prefabricated structure.

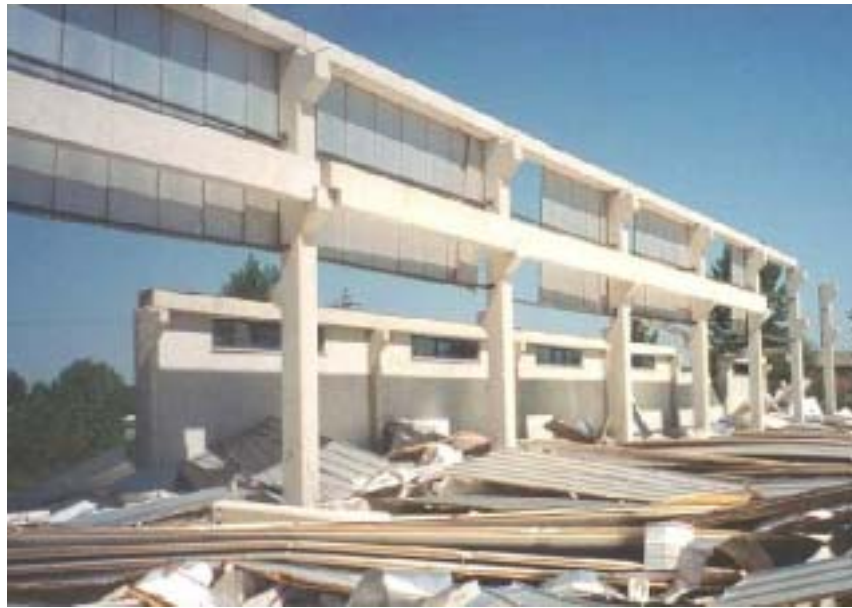
Figure 4.2. Damaged prefabricated frame system.

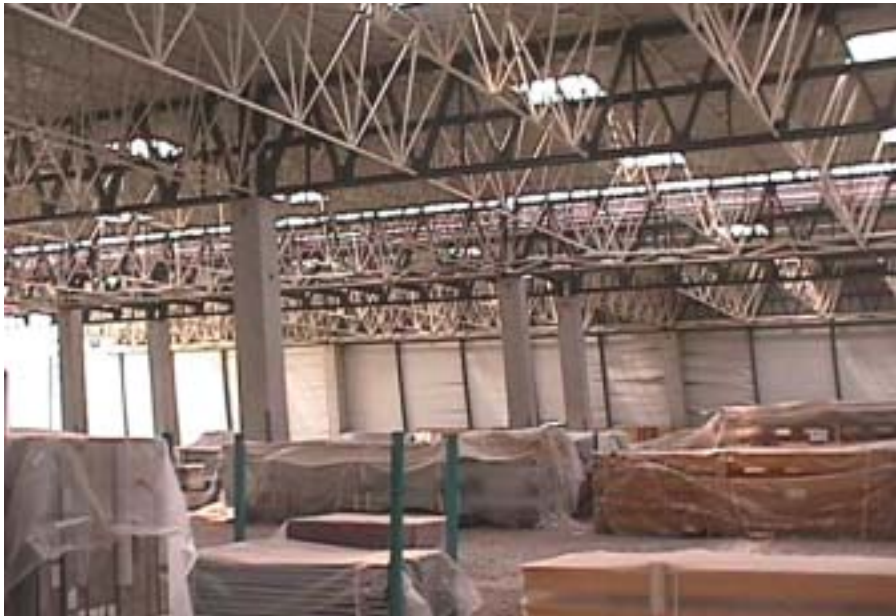
Figure 4.3. Damaged prefabricated building at Ford Otosan Plant.

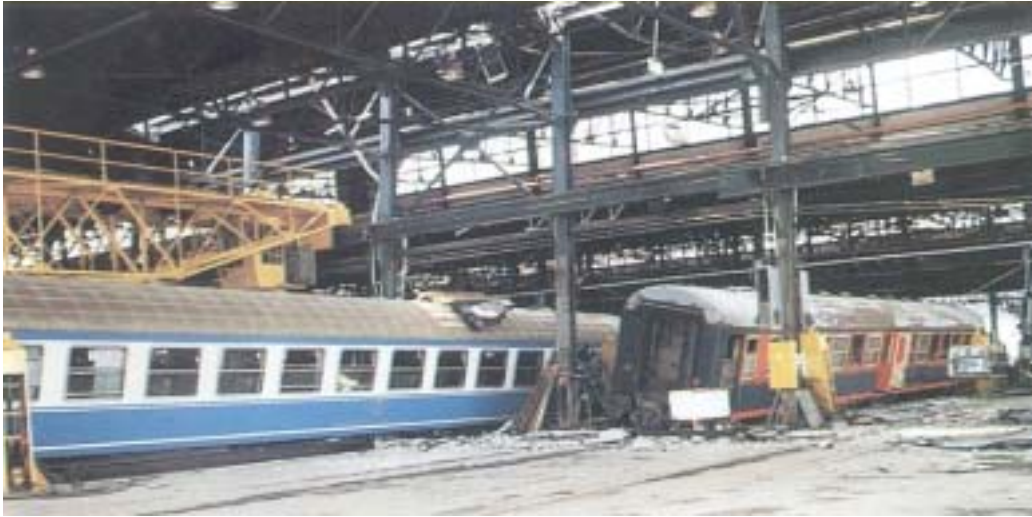
In 1999 Kocaeli and Duzce earthquakes steel buildings performed much better than the RC frames. Only a few collapsed (Figure 4.4). Typical causes for collapses include failure of anchor bolts at column bases and roof trusses and structural instability under overturning forces. Other evidence of damage includes fracture of brace connections and buckling of braces.

Figure 4.4. Damaged steel structure at Adapazari rail car factory.

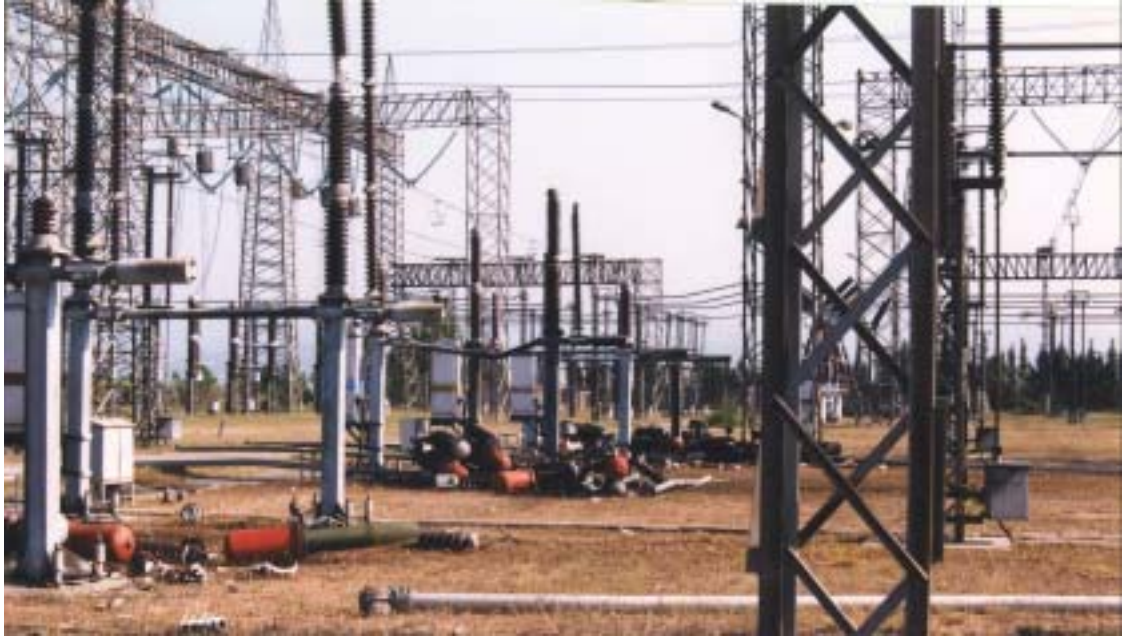
Figure 4.5. Adapazari substation.

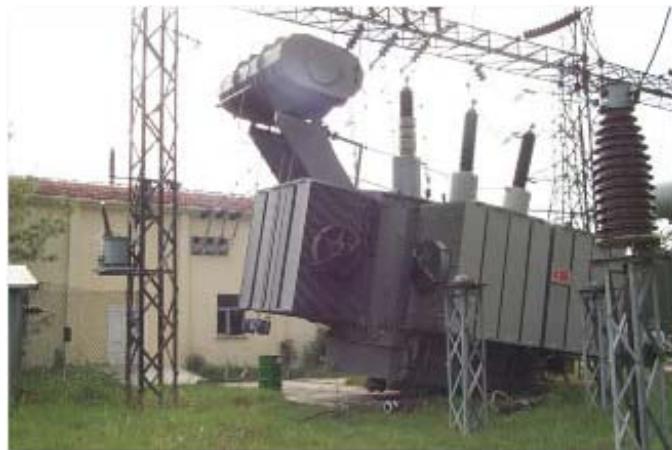
Figure 4.6. Damaged transformer at Izmit-1 substation.

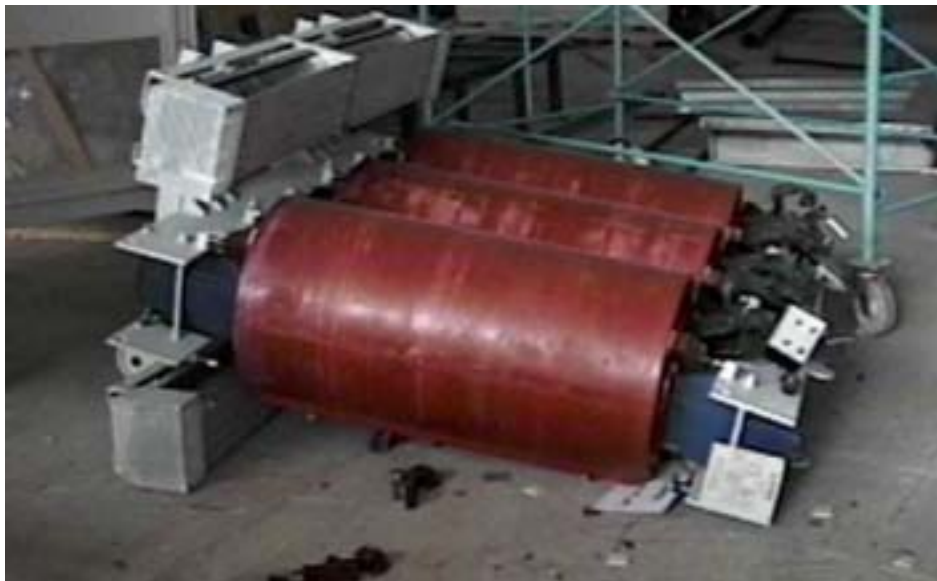
Figure 4.7. Damaged electrical equipment.

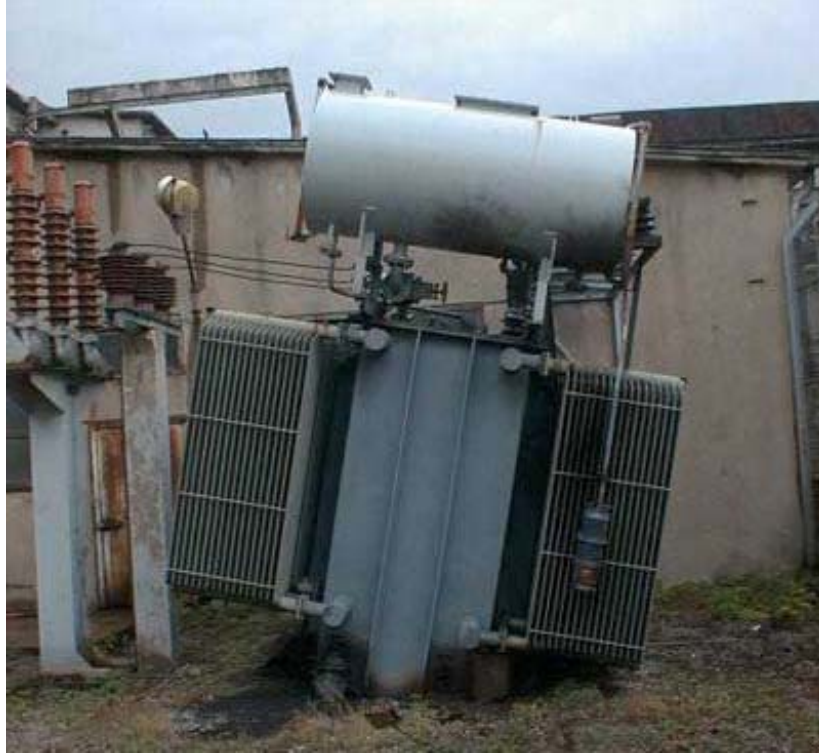
Figure 4.8. Damaged transformer at SEKA paper factory.

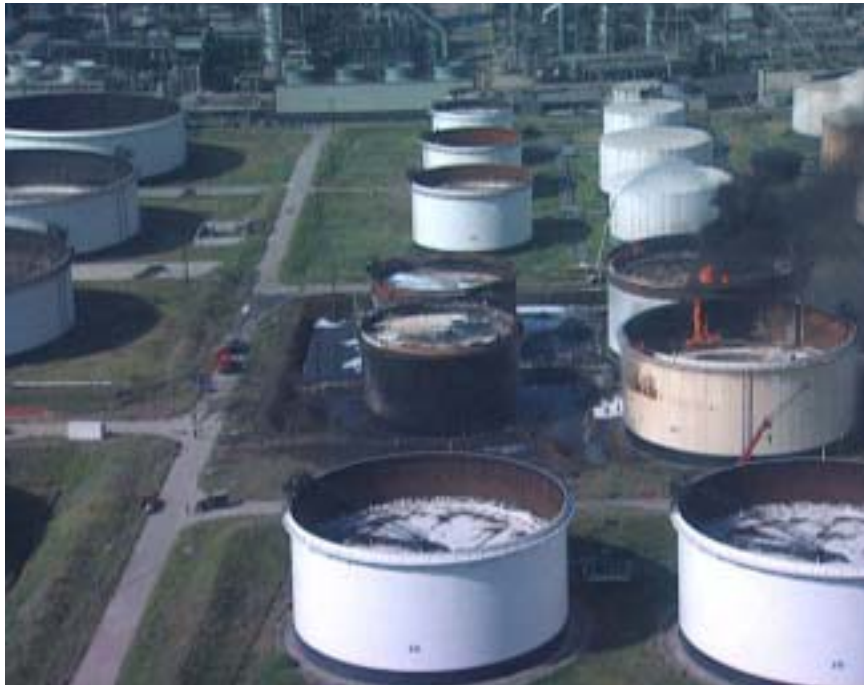
The majority of damage at the Tupras Refinery was concentrated at the storage tank farm area (Figure 4.9). The tank farm has more than 110 tanks of varying sizes containing water, crude oil, and other oil substances. Sizes range from 1,200 m<sup>3</sup> to 135,000 m<sup>3</sup> and roofs are both floating and fixed.

Figure 4.9. Damaged tanks at TUPRAS tank farm.

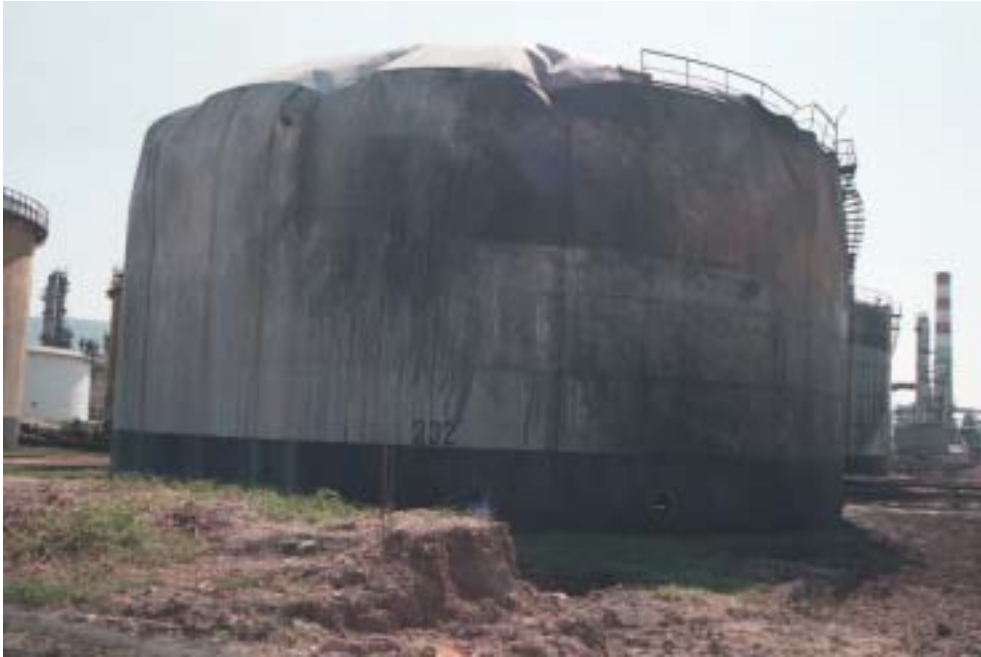
The sloshing of fluid damaged the perimeter seal producing overtopping and gross damage in near the tops of walls. The shell buckling at tank bases also caused oil leakage. The oil lost from these tanks was contained within the earthen berms surrounding the tanks. The vertical movement of the floating roof created sparks (metallic seals) which led to the fire ignition of the oil leakage. The extreme heat caused substantial deformation and damage in approximately 20 steel tanks. No substantial sliding of the anchored tanks no evidence of pipe failure in the rest of tanks at the tank farm was observed (Figure 4.10 and Figure 4.11).

Figure 4.10. Tank failure at TUPRAS Refinery due to fire caused pressure increase.

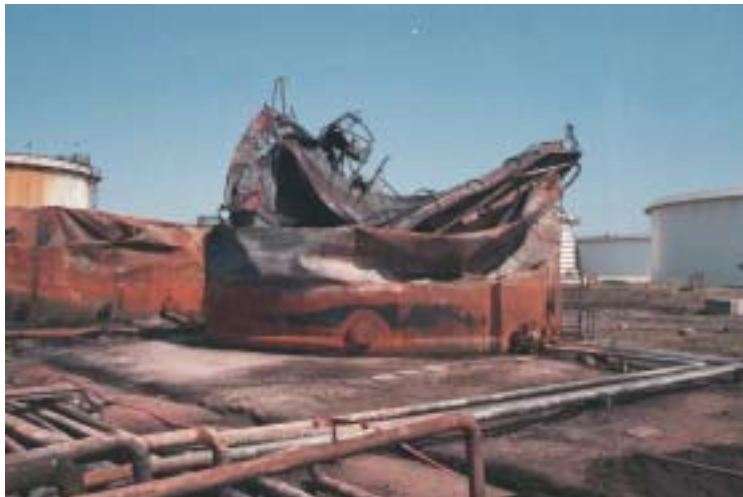
Figure 4.11. Fire caused buckling of a tank at TÜPRAŞ Refinery.

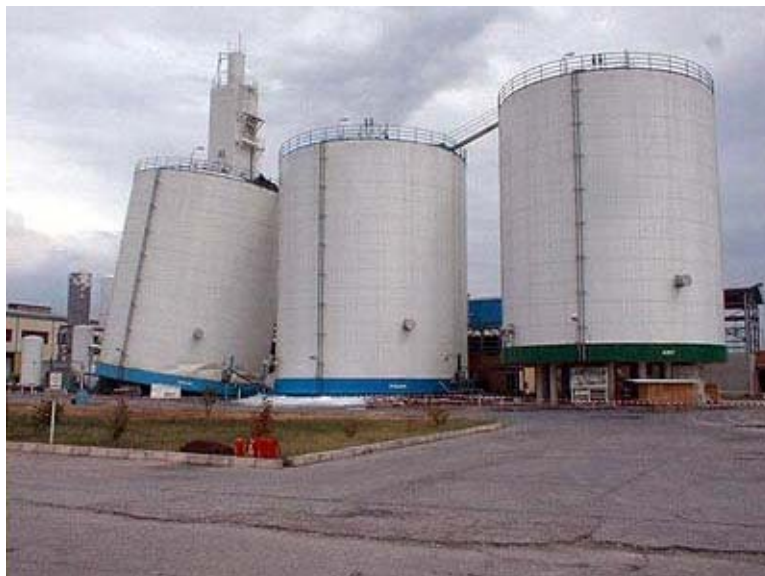
Two of the three 14.63-m-diameter liquid gas storage tanks at Habas Facility were collapsed due to ground shaking (Figure 4.12). Each insulated tank consisted of two concentric stainless steel shells. Both shells were supported by sixteen 200-mm-diameter 2.5m high reinforced concrete columns.

Figure 4.12. Damaged insulated tanks at HABAŞ Facility.

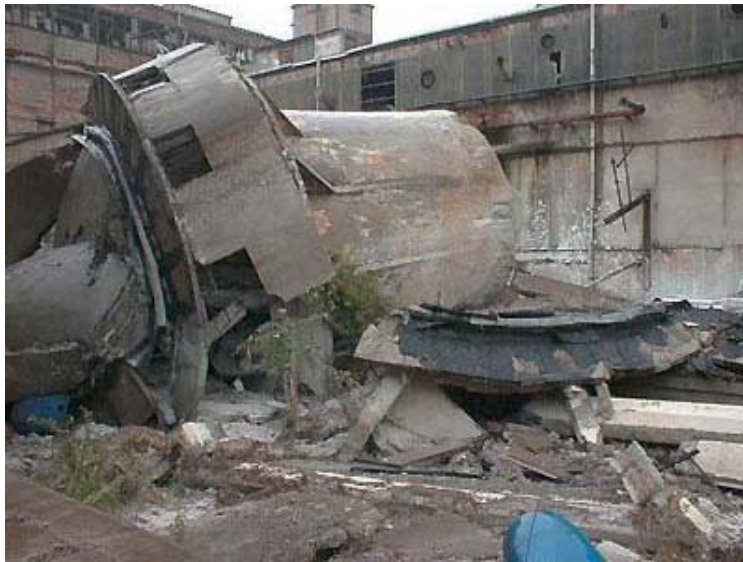
Figure 4.13. Collapsed silo at SEKA Paper Factory.

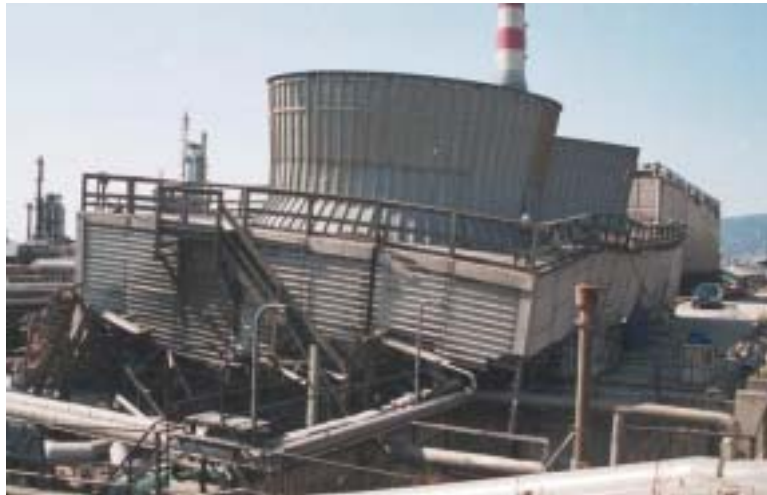
Cooling towers at TÜPRAŞ Refinery and PETKİM Facility were damaged (Figure 4.14 and Figure 4.15).

Figure 4.14. Collapsed cooling tower at TÜPRAŞ Facility.

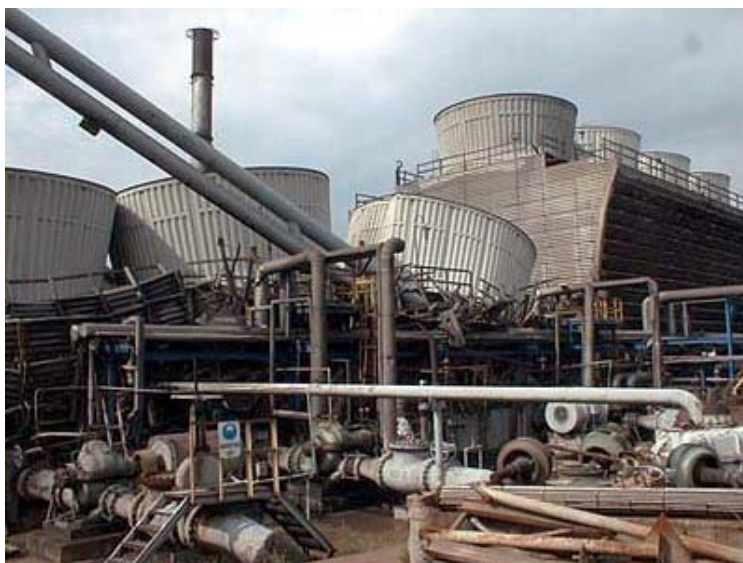
Figure 4.15. Collapsed cooling tower at PETKİM Facility.

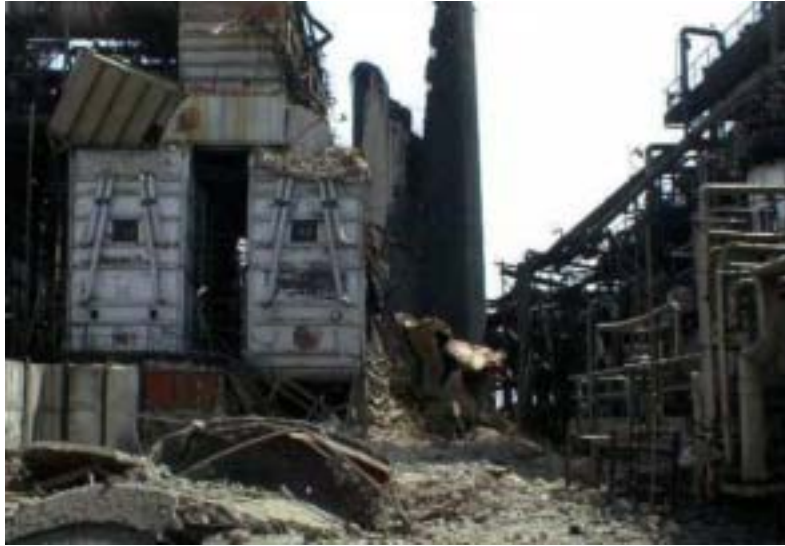
In TÜPRAŞ Facility the upper two thirds of an 110-m-tall reinforced concrete heater stack fell into one of the of three crude-oil processing units, igniting fire and creating total damage (Figure 4.16). Failure of the stack probably initiated at a stiffness discontinuity used for the entrance of a large-size ductwork.

Figure 4.16. Collapsed stack at TÜPRAŞ Refinery.

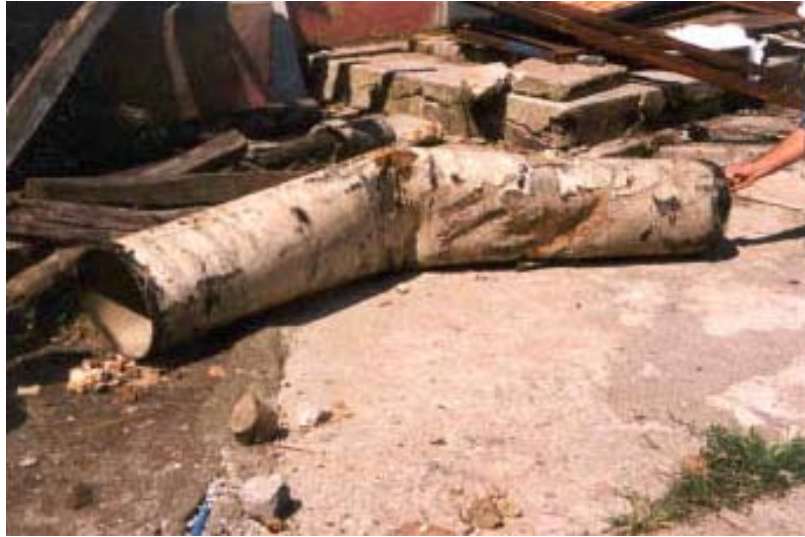
Figure 4.17. Steel pipe damaged due to fault effect at Arifiye.

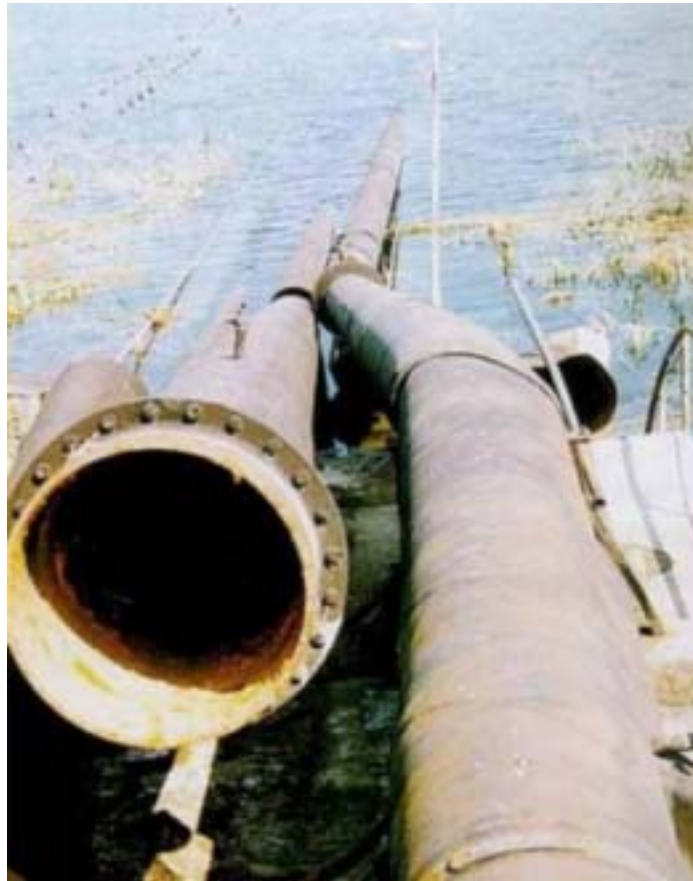
Figure 4.18. Damaged water pipes.

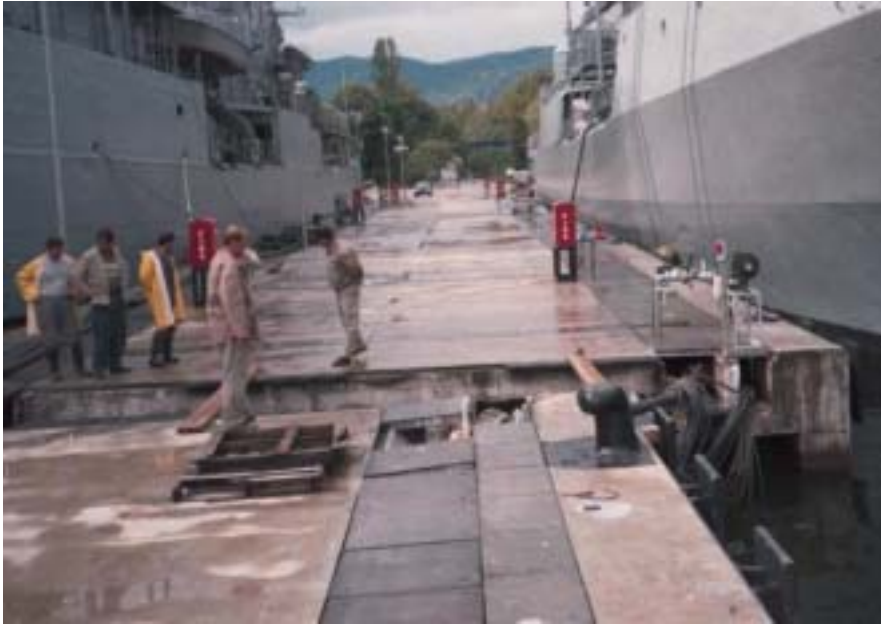
Extensive damage was observed at fault crossings, for example, at the navy base (Figure 4.20). It included failure of steel piers and piping systems and the collapse of cranes (Figure 4.21 through

Figure 4.20. Fault offset on the navy port at Golcük.

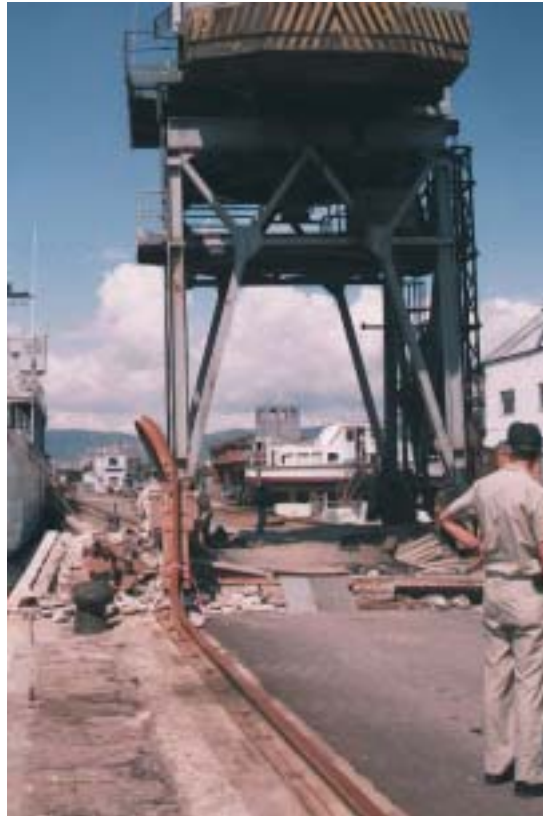
Figure 4.21. Crane and rail damage at Gölcük navy port.

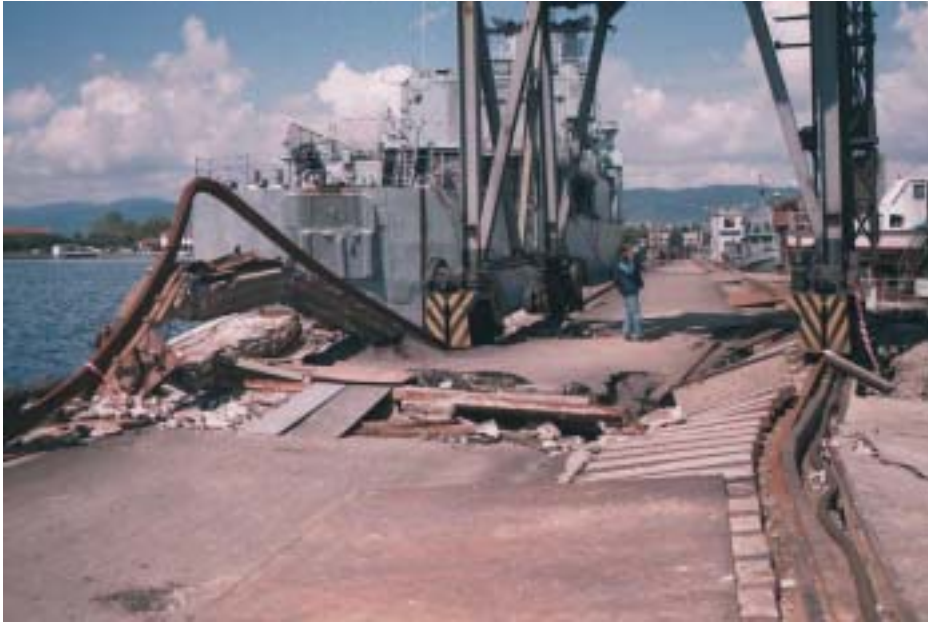
Figure 4.22. Damage at navy port in Gölcük.

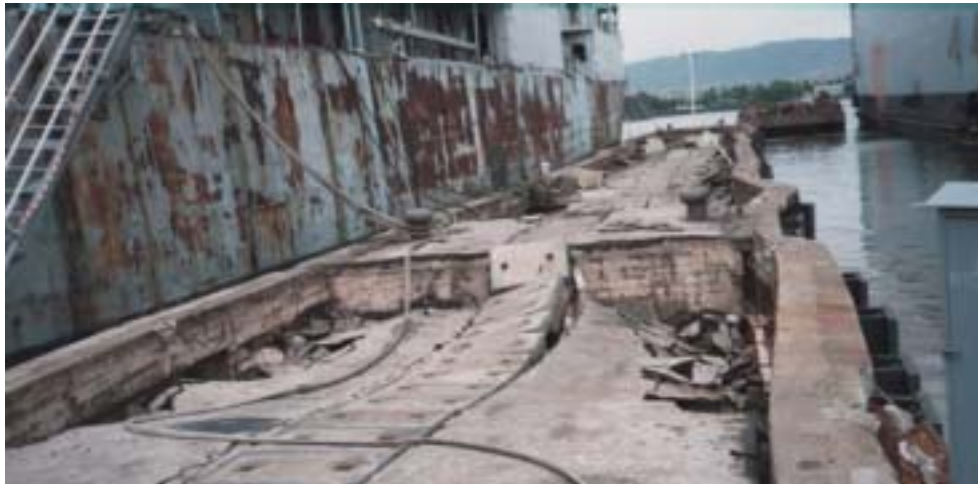
Figure 4.23. Damage at navy port in Gölcük.

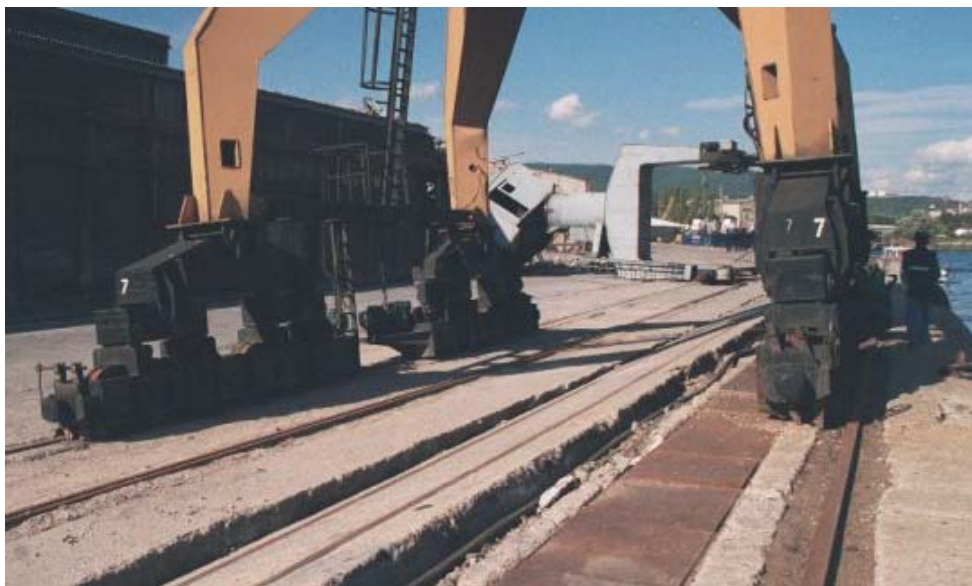
Figure 4.23). In Derince general cargo and grain port, which handles some 2 million tons of cargo annually, suffered heavy damage to docks, cranes and warehouses, including cracks and severe subsidence (Figure 4.24). The concrete caisson type bulkhead, with a length of about 1.5 km, shifted away from the wharf up to 0.7m horizontally and 1m vertically, due to liquefaction-induced deformations, settlements and lateral spreading. Two of the three rail mounted main portal cranes were nonfunctional and some old steel warehouses were damaged. A new wharf constructed on piles had no problems.

Figure 4.24. Damage at Derince Port in Kocaeli Earthquake.

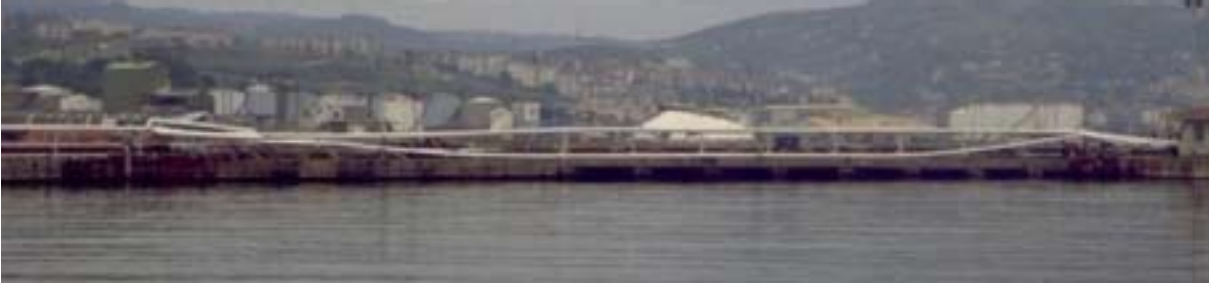
Figure 4.25. Settlement at Petrol Ofisi pier.

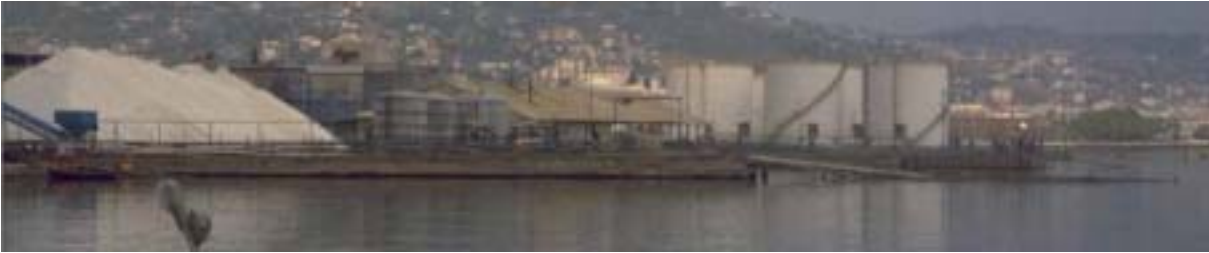
Figure 4.26. Damaged pier at Shell and Trans Turk facilities.

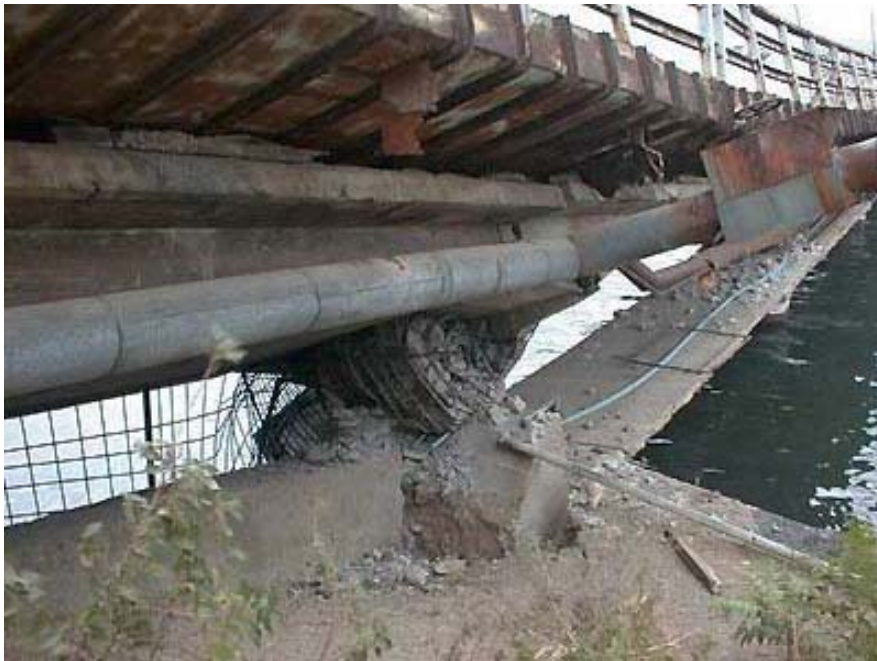
Figure 4.27. Failed supporting column at SEKA port.

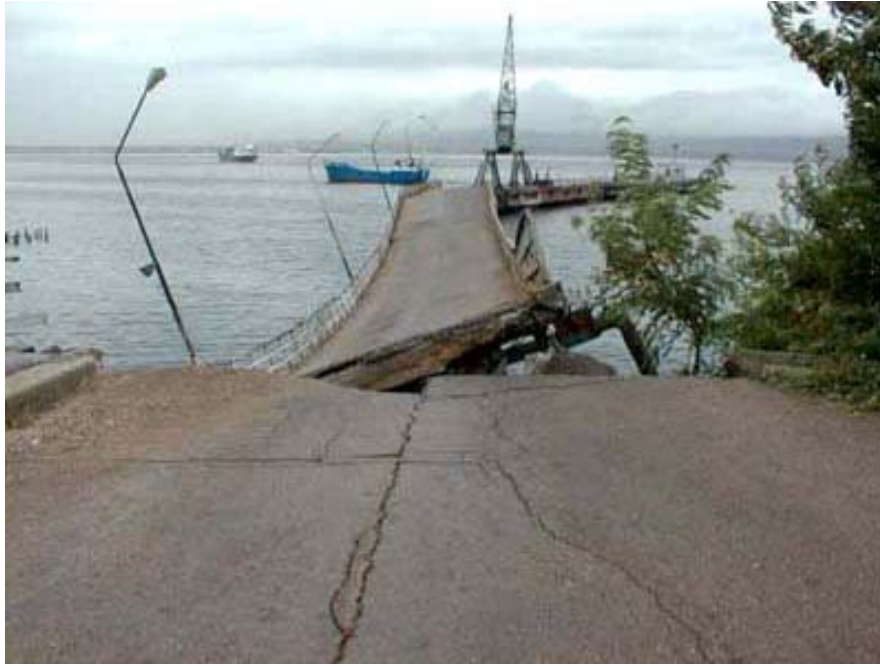
Figure 4.28. Damage at SEKA pier.

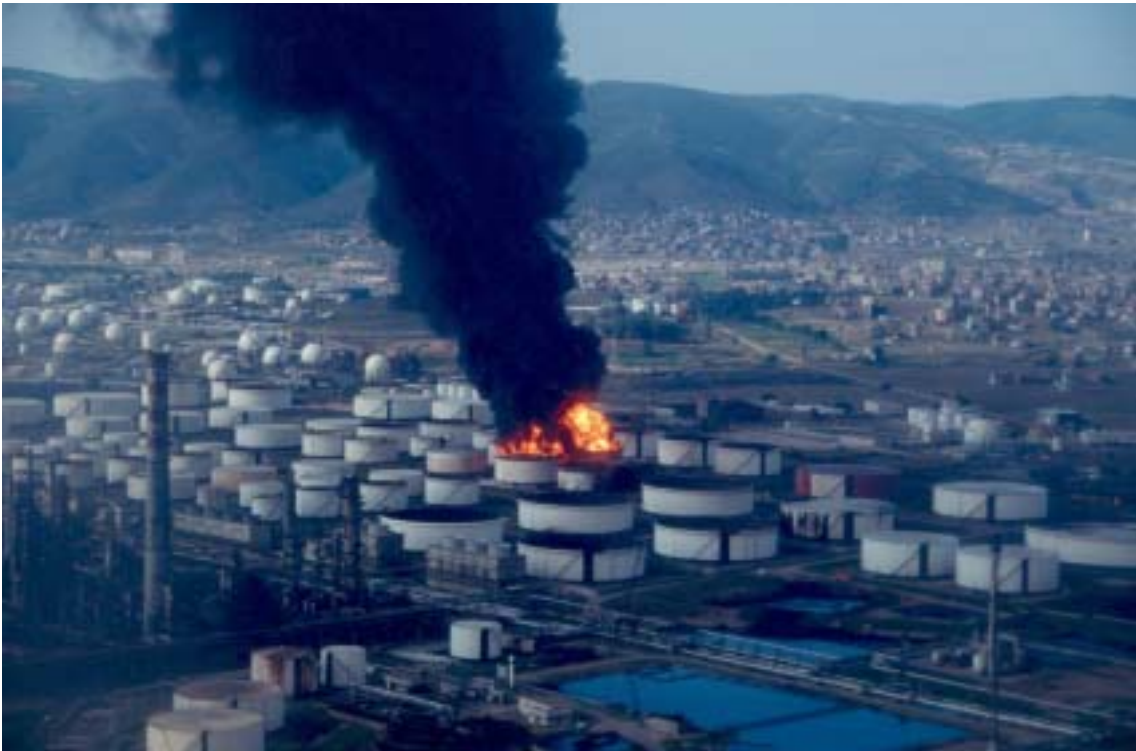
An extensive concentration of state-owned petrochemical complexes is located within 5 km of the causative fault of the Kocaeli earthquake, including Tupras, Petkim and Igsas. The heaviest damage occurred at the Tupras facility, the largest refinery in the region producing about twelve million tons per year. The refinery was working at about 90 percent of its design capacity and can be considered a modern and efficient plant. The earthquake caused significant structural damages to the refinery itself and associated tank farm with crude oil and product jetties (Figure 4.29). The consequent fire in the refinery and tank farm caused extensive damage. Fire started in one of the Naphtha tanks continued for three days endangering the safety of the whole region. Six tanks of varying sizes in the tank farm of 112 tanks were damaged due to ground shaking and fire. There were damage to cooling towers and the port area. Collapse of a 150m high heater stack on the boiler and crude oil processing unit caused significant damage and started a second fire. The total damage is estimated to be around US\$350 million.

Figure 4.29. Fire at TÜPRAŞ Refinery.

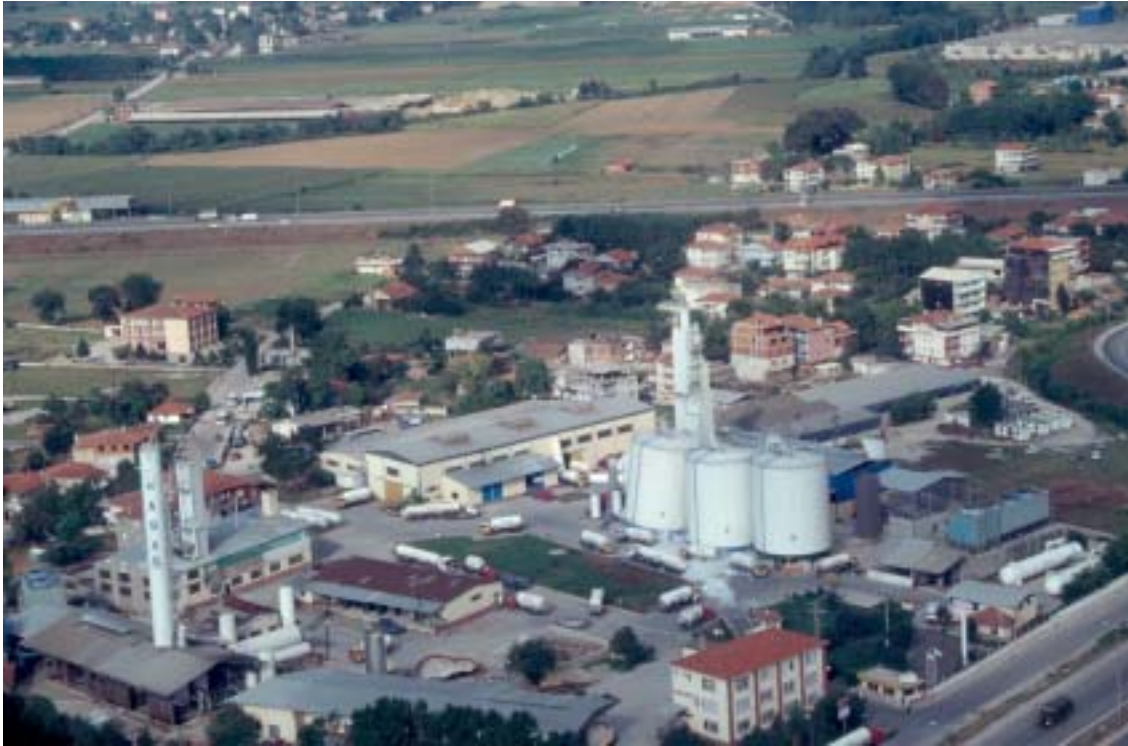
Figure 4.30. Damage at Habaş Facility.

food processing plant; storage rack collapse, toxic releases from mixing chemicals, and damaged piping at the Toprak pharmaceutical firm; and collapse of liquid oxygen tank support structures at the Habas medical gas facility (Figure 4.30). Lafarge-Aslan Cement Plant in Darica had no major structural and equipment damage except damage to its port. The rotary kiln and other sensitive equipment had to be stopped, cleaned up and realigned under supervision. Kudos textile factory in Adapazari, Cak textile factory in Akyazi (Duzce) and Ak-Al textile factory in Yalova had extensive damage due to the collapse of the pre-fabricated reinforced concrete factory buildings. Toprak Pharmaceutical Factory had damage due to collapse of stored material on racks and some equipment had to be stopped, cleaned up and realigned under supervision. Kudos textile factory in Adapazari, Cak textile factory in Akyazi (Duzce) and Ak-Al textile factory in Yalova had extensive damage due to the collapse of the pre-fabricated reinforced concrete factory buildings. Some tanks in Aksa chemical, installation in Yalova experienced damage, which was associated with leakage of chemicals. Food processing plants that have experienced heavily damage include Pepsi Co-Uzay Gida (Izmit) and Merko Gida (Yalova). In Duzce earthquake Superlit pipe factory in Kaynasli was heavily damaged. There was limited damage to the industry in Bolu (Filiz Macaroni Factory and Kelebek Furniture Factory).

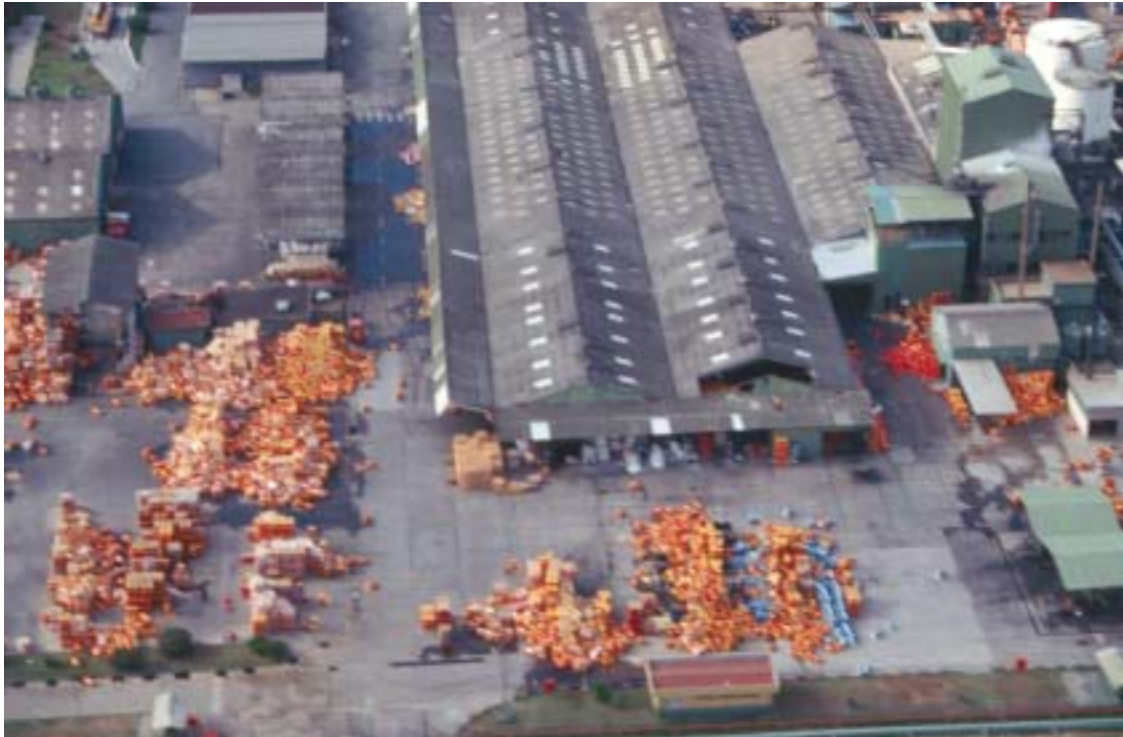
Figure 4.31. An example of industrial facilities experienced losses of open stored materials

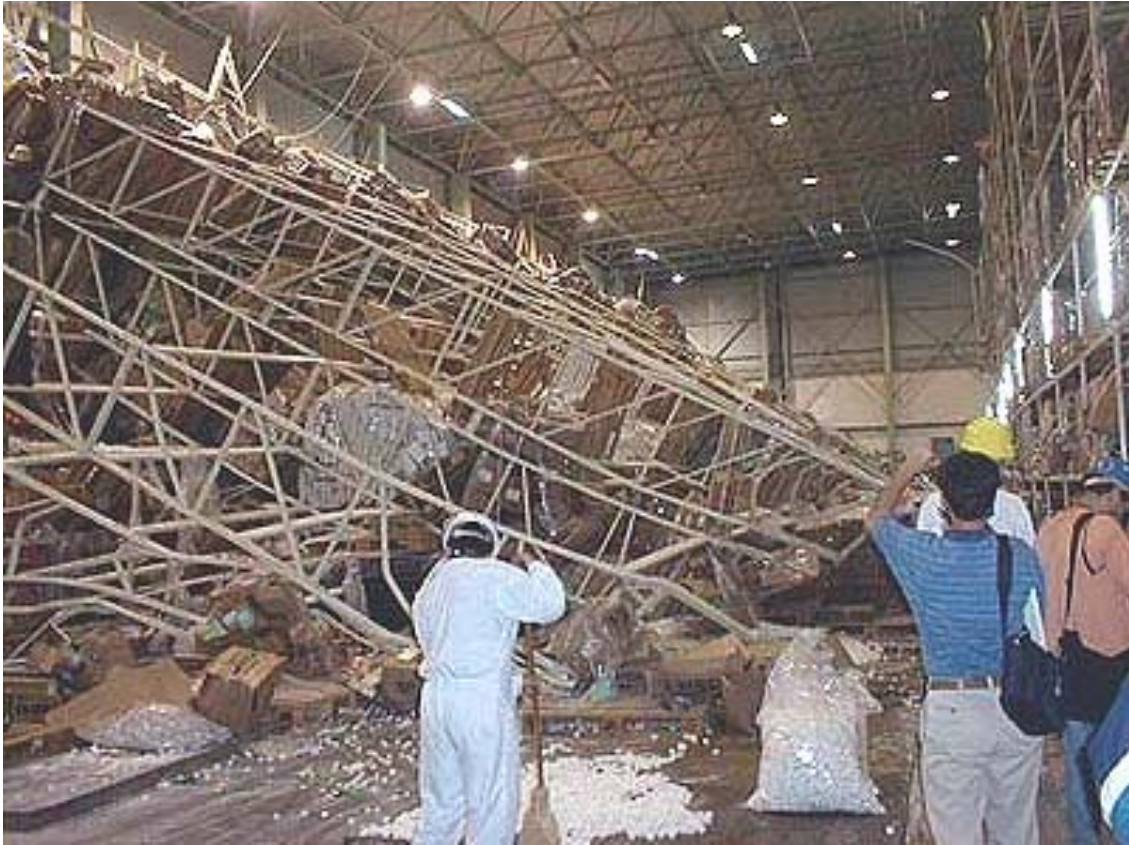
Figure 4.32. An example of industrial facilities experienced losses of rock-stored items in buildings.

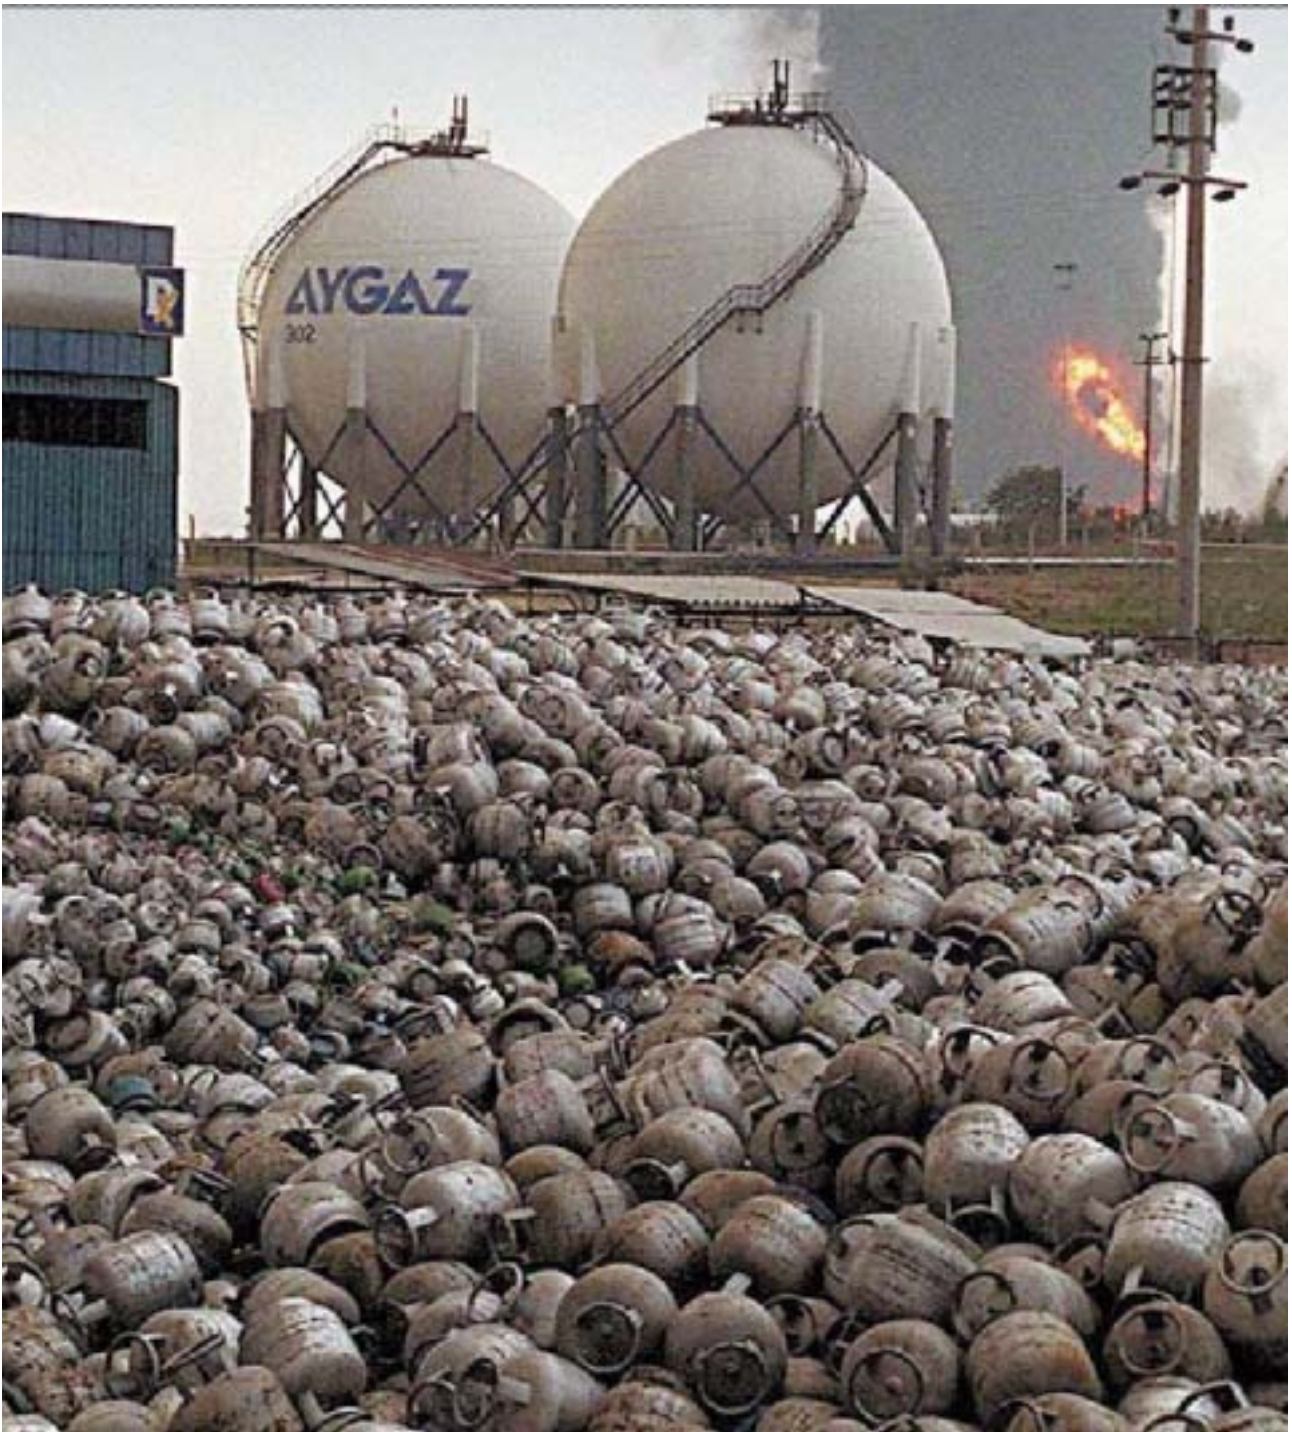
Figure 4.33. An example of industrial facilities experienced losses of rock-stored items in buildings

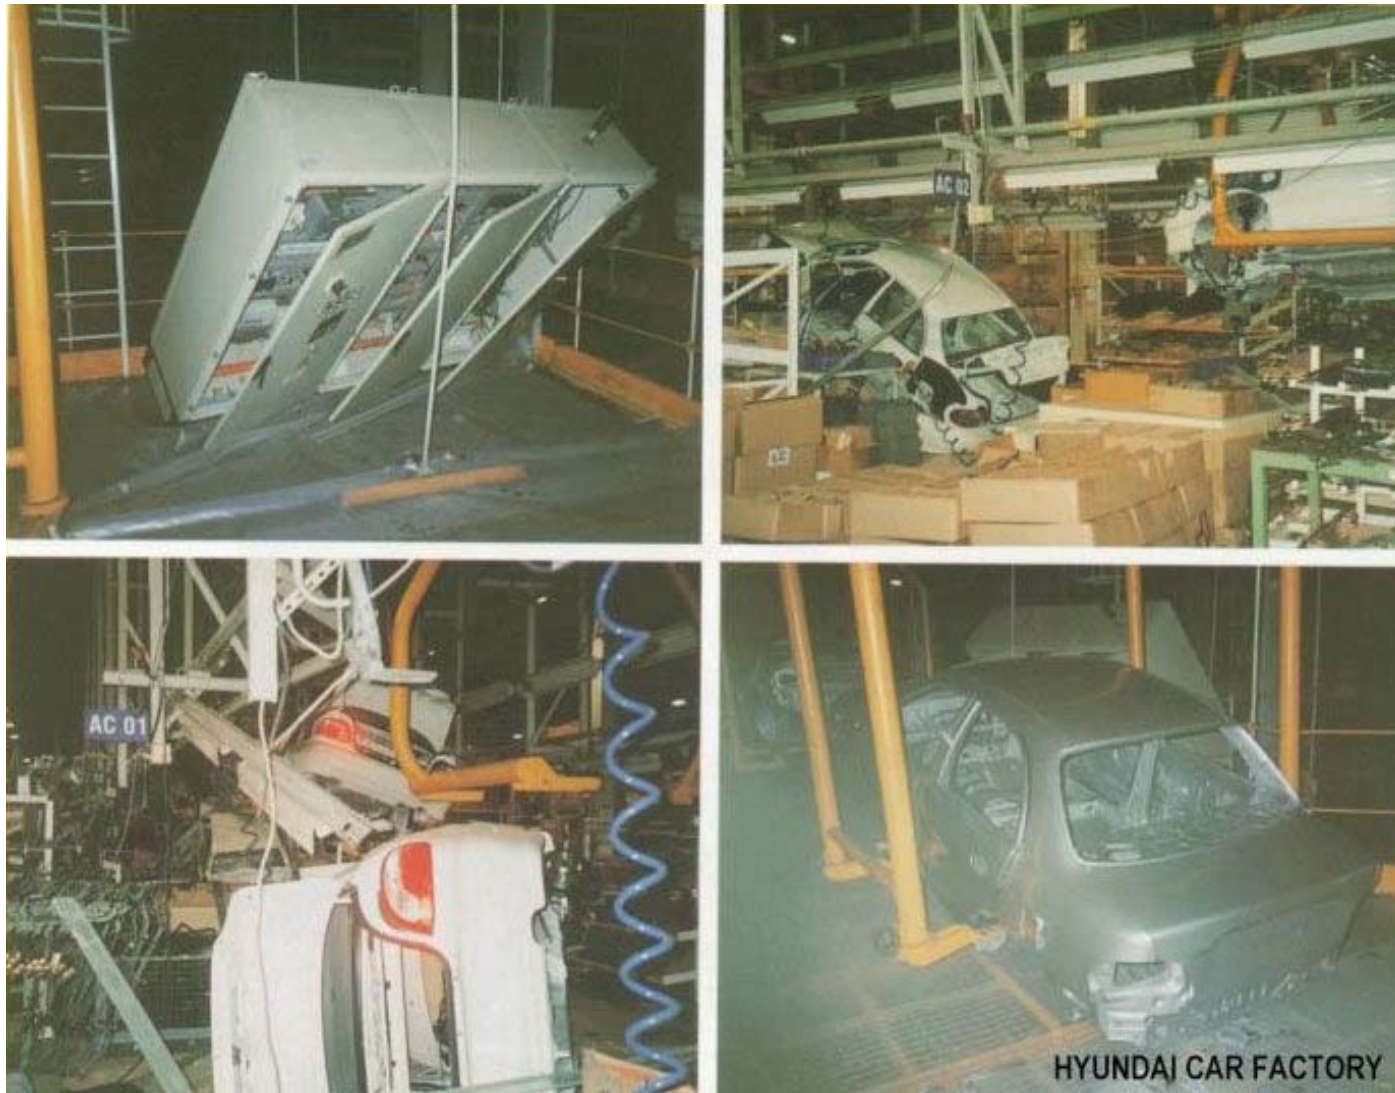
The Hyundai factory experienced significant nonstructural damage (Figure 4.34). It had damage to its airhandling systems, cable trays and shearing of bolted connections in the steel structure (EERI, 1999). The Toyota car factory had fault ruptures in its parking lot. There was very little structural damage to the steel framed buildings. Out of thirty buildings, two buildings experienced damage to their columns and there was a relative displacement of 10 cm between the foundation and roof levels (AIJ, 2001). Nonstructural damage included collapsed storage racks, transformers, cars on the assembly line, sliding of the cooling tower for about 1m breaking associated piping and tilting of some manufacturing machines (AIJ, 2001) (Figure 4.35). Piping for water, electricity and fire suppressing were broken and damaged and about 1000 cars in the car pool were slightly damaged as a result of bumper collisions (AIJ, 2001). Some automatic machinery in the production lines of these factories suffered from alignment problems. Ford Otosan car factory, under construction during the earthquake, has experienced significant terrain subsidence and some structural damage. Pirelli Tires, Bisa Tires and KordSa tire steel belt and Cord Company had extensive damage and business interruption. In Pirelli Tires one portion completely collapsed and the facility had difficulties in restarting since critical production equipment was in heavily damaged sections of the facility (EERI, 1999).

Figure 4.34. Equipment damage at Hyundai-Assan car factory (after Milli-Re).
