## **CHAPTER 4**

# **INDUSTRIAL DAMAGE AND LOSSES OBSERVED IN PAST EARTHQUAKES IN TURKEY**

## **4. INDUSTRIAL DAMAGE OBSERVED IN PAST EARTHQUAKES**

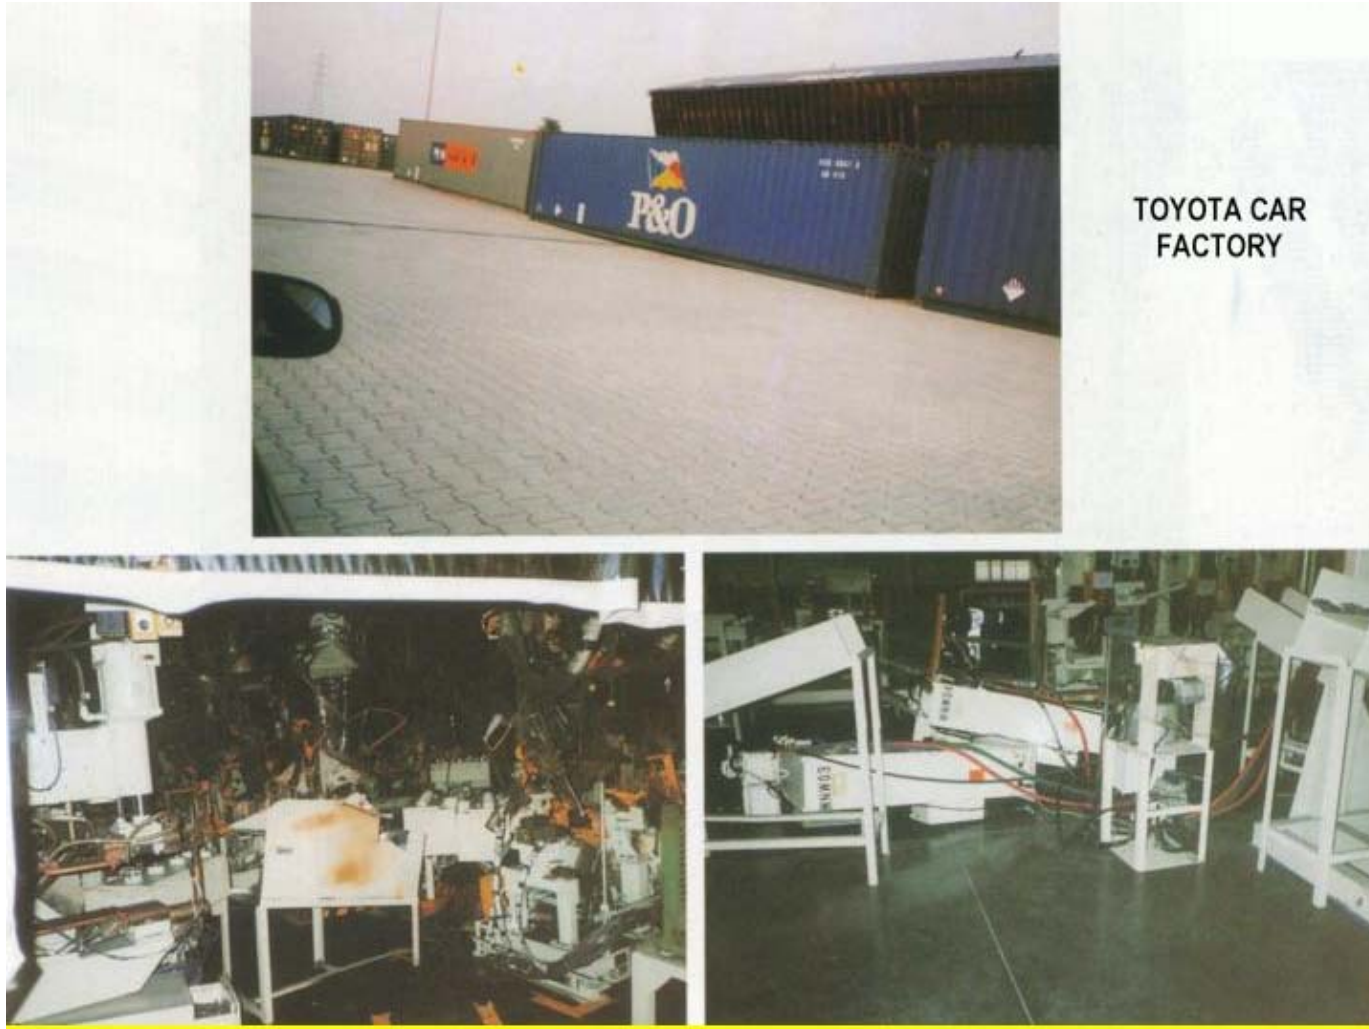
Figure 4.35. Equipment and storage damage at Toyota Car Factory (Afte Milli-Re).

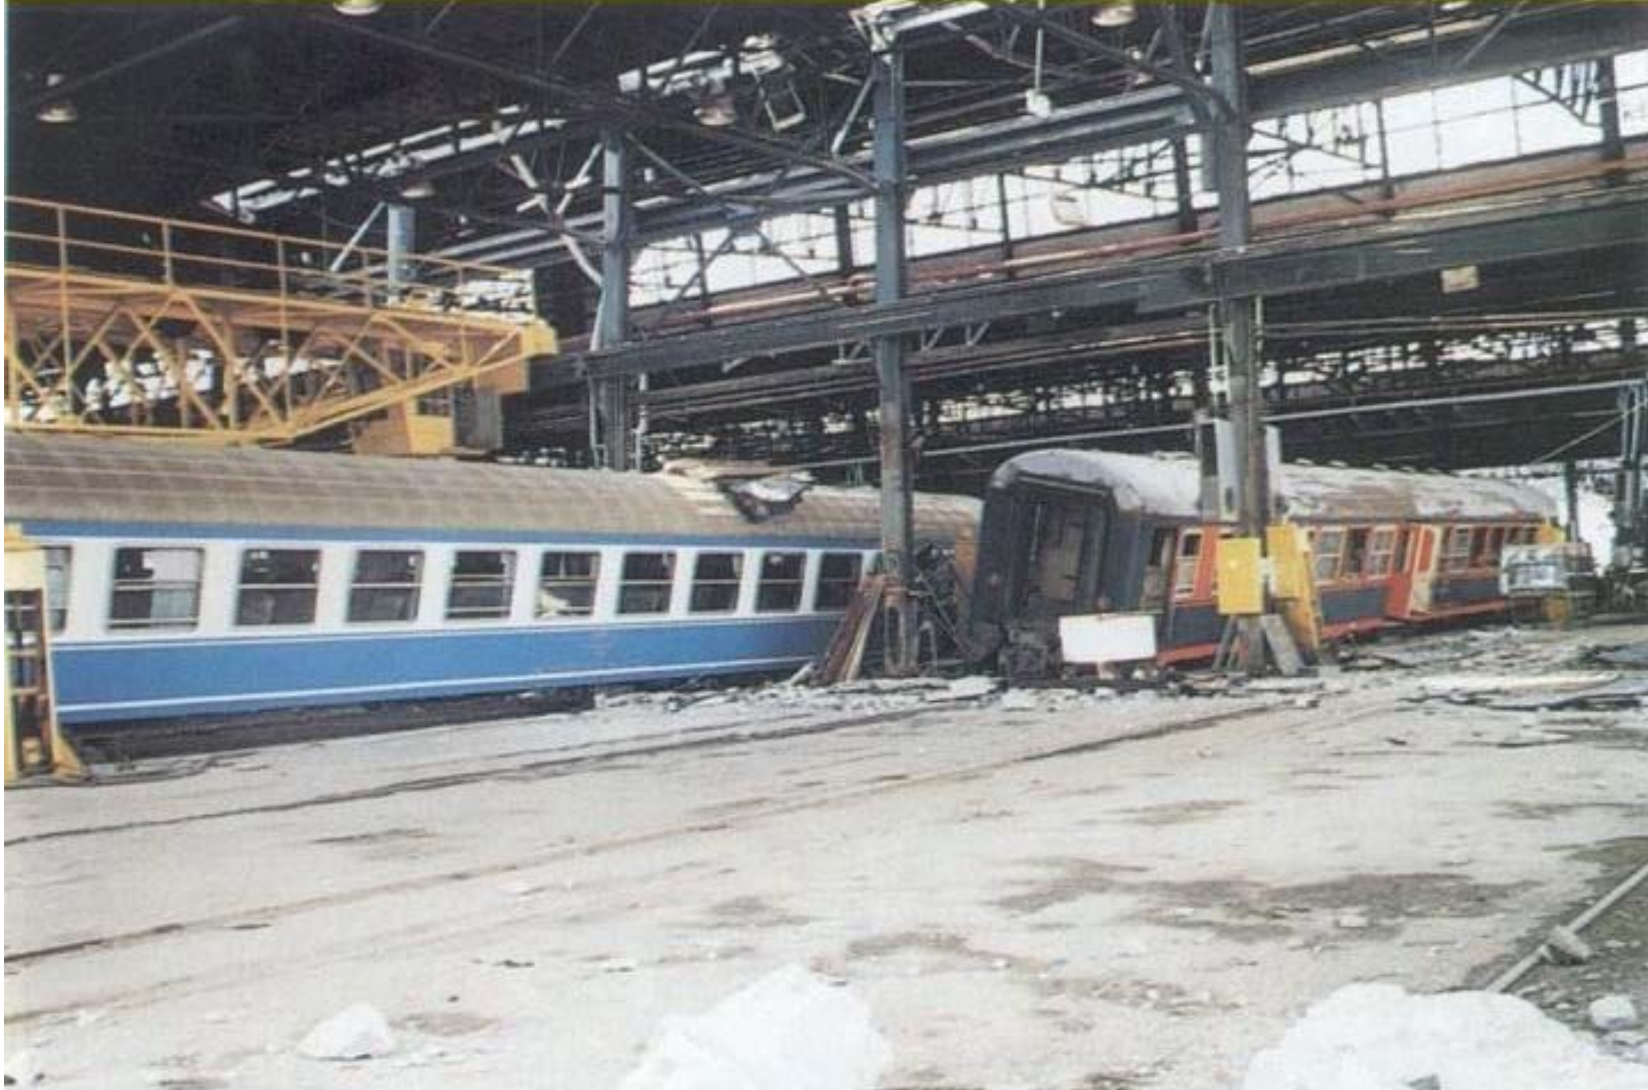
Figure 4.36. Damage at TUVASAŞ Rail Car Factory (after Milli-Re).

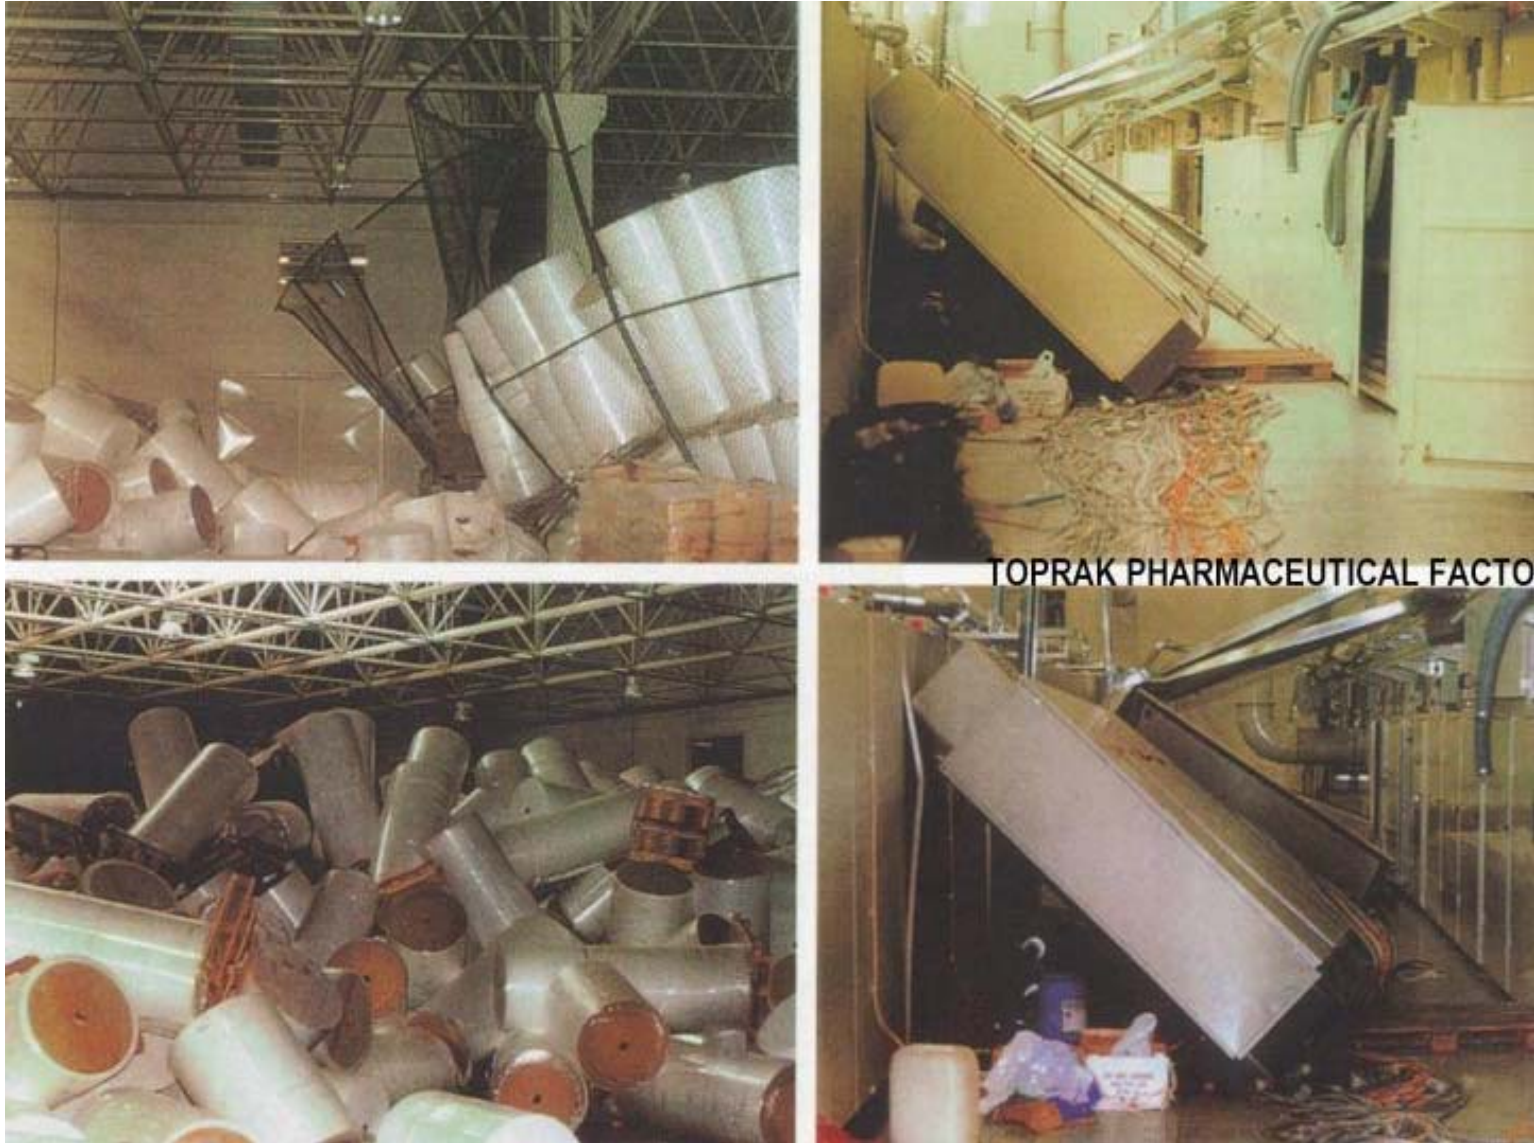
Figure 4.37. Damage at Toprak Pharmaceutical Company (after Milli-Re)
