Learning from Earthquakes

The Izmit (Kocaeli), Turkey Earthquake of August 17, 1999

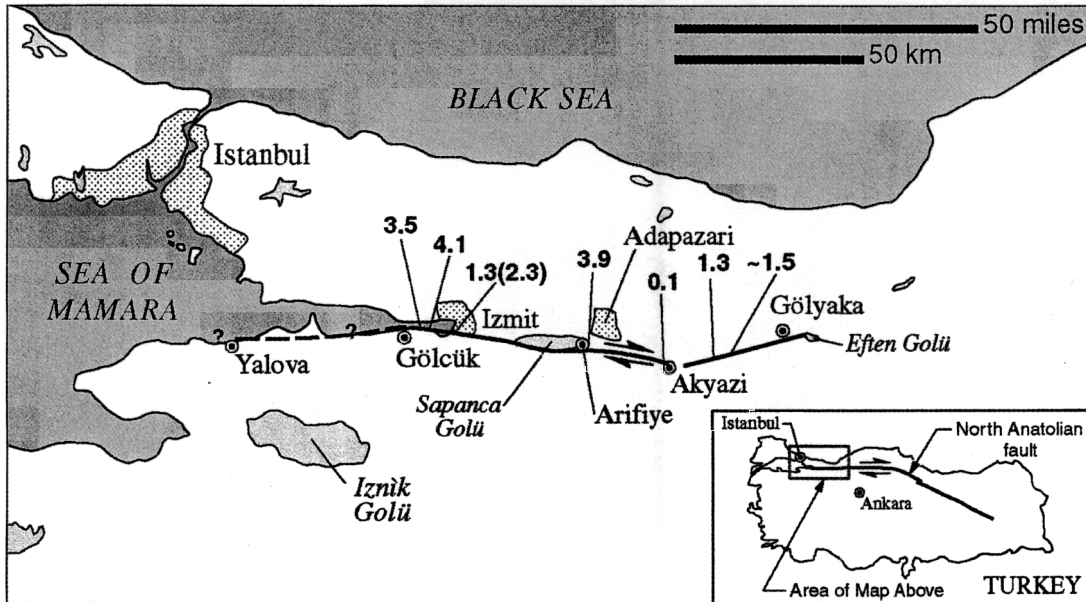
Figure 1 - Location of the North Anatolian fault (inset) and the fault rupture that generated the August 17, 1999 earthquake. Numbers without parentheses indicate the amount of right-lateral offset in meters; values in parentheses indicate vertical displacement.

The earthquake was generated by rupture along a branch of the North Anatolian fault (Figure 1). The 1300 km-long North Anatolian fault system is one of the most seismically active right-lateral strike-slip faults in the world. Since 1939, there have been

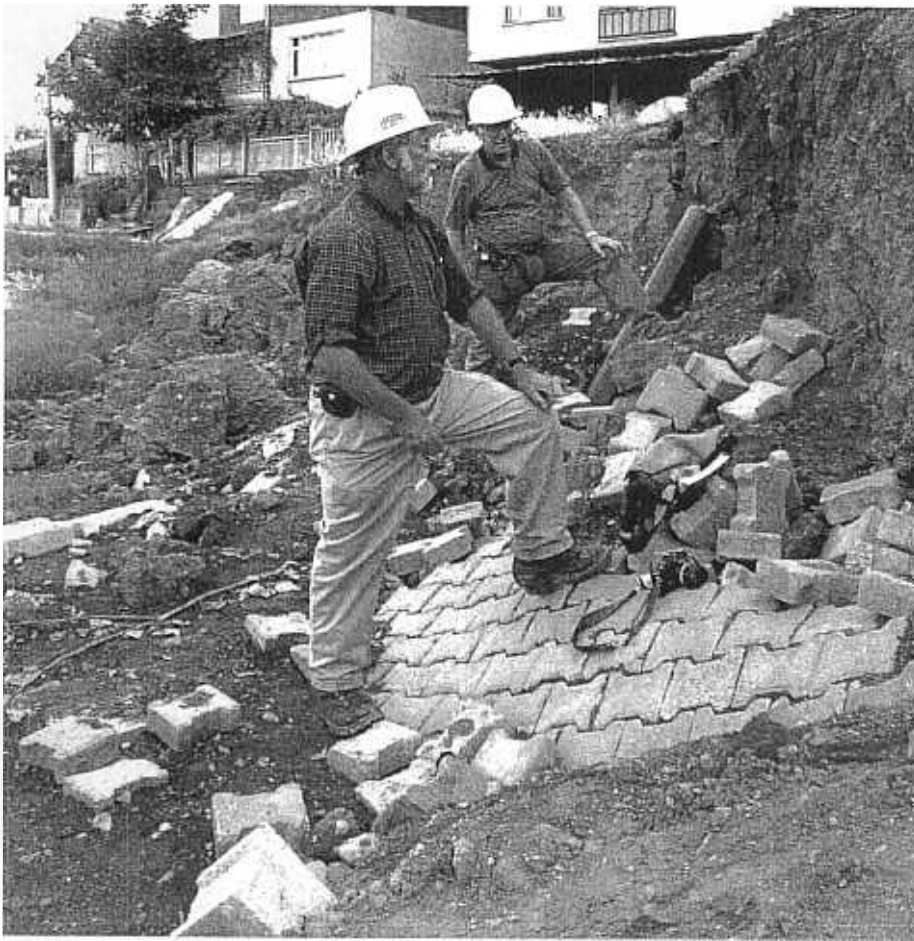
Figure 2 - Fault scarp east of Golcuk. The vertical displacement is 2.3 m down-to-the north, with 1.3 m of right slip. (Photo: Mark Milstein, Atlantic News Service)

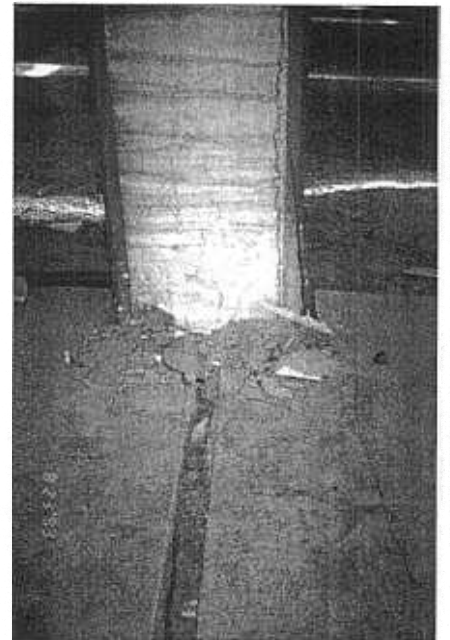
the Ford automobile assembly plant, which is nearly complete but not yet occupied, was deformed by about 0.5 m of right-lateral fault displacement distributed over a 100-m-wide zone. Floor slabs in this code-compliant building were fractured and split apart, and columns were tilted as footings moved with the earth. The tops of columns were pinned to the roof and remained in place. The columns cracked and underwent ductile deformation, but retained ample strength to support the roof structure without danger of collapse (Figure 3). Although substantial repairs will be required, the building deformed without threat to the life safety of occupants. In general, for buildings not directly astride the fault, ground shaking had greater influence on performance than did proximity to the fault.

Figure 3 - Column pushed through the floor slab and tilted due to 0.5 right-lateral fault displacement. Column underwent ductile deformation without losing significant axial load capacity. (Photo: Youd)

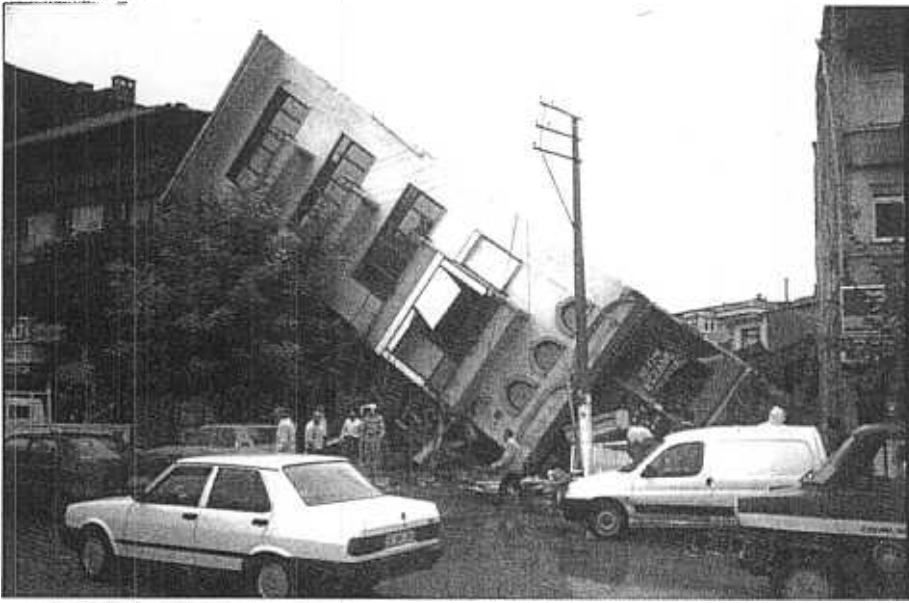
Figure 4 - Building that toppled due to liquefaction-induced loss of bearing strength beneath shallow mat foundation. (Photo: Youd)

settled, tipped or toppled as liquefaction weakened soils beneath reinforced mat foundations (Figure 4). More than 60 percent of multistory buildings in the severe liquefaction areas suffered partial or total collapse due to structural failure. Follow-up investigations are in progress to determine layer thicknesses, soil properties, and foundation loads. These investigations, which were initiated in response to the EERI investigation, should add a considerable body of case history data to better define loading and soil conditions associated with liquefaction-induced foundation failures.

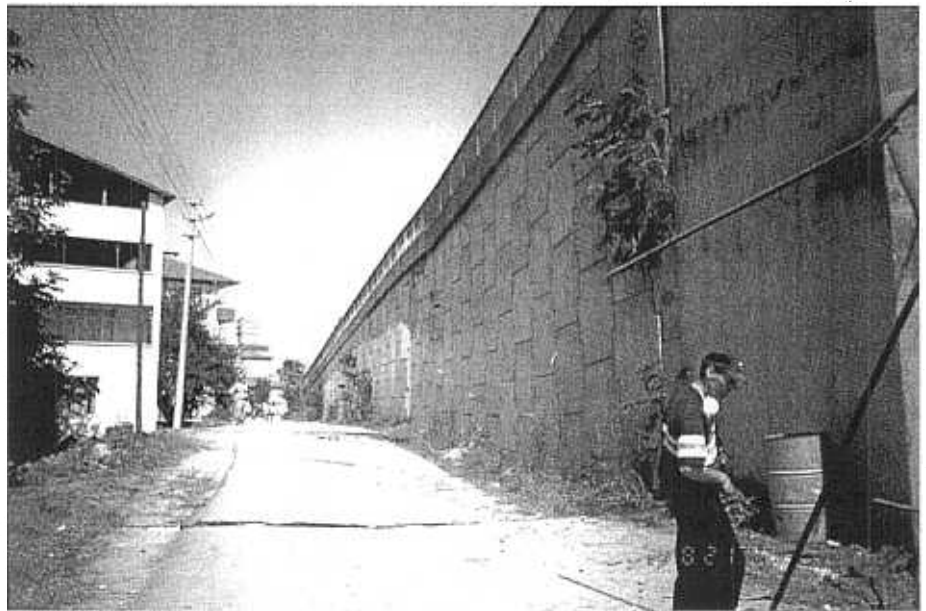
A pair of MSE walls retaining a bridge approach fill were severely tested by the earthquake (Figure 5). The primary fault rupture was only a few meters from the walls and passed beneath the bridge structure, which collapsed. Differential settlement also occurred beneath the walls due to a rigid reinforced concrete box culvert beneath the walls. Shear deformations from the differential settlement propagated upward through the paneled faces, with some panels separating as much as 75 mm, allowing a small amount of fill material to seep through the face.

However, damage to the wall was relatively minor: no straps broke, no facing panels fractured, and there was no immediate threat of wall collapse.

Figure 5 - Mechanically stabilized earth wall within a few meters of the primary fault rupture. Although subjected to differential settlement, it suffered only minor damage. (Photo: Youd)

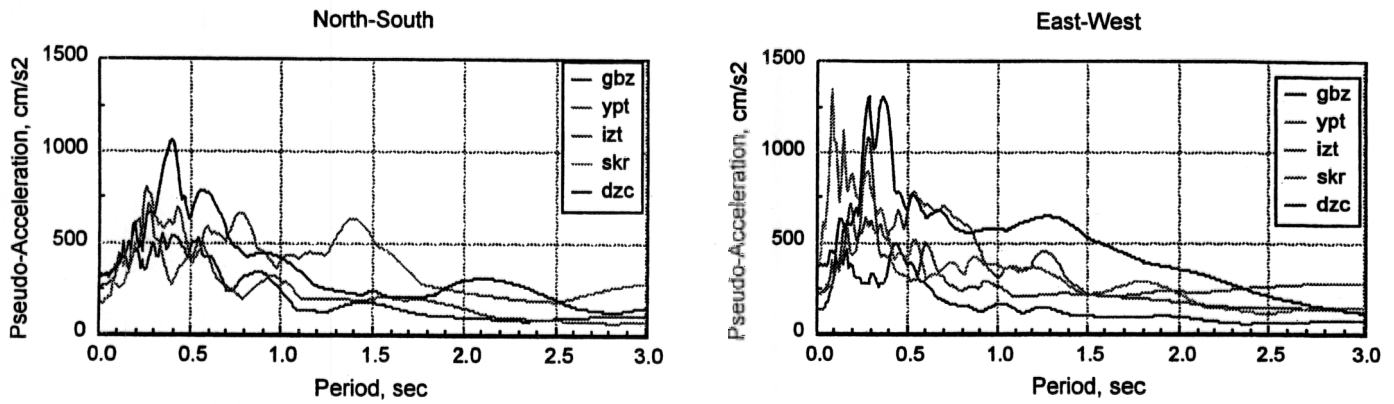
Figure 6 - Response spectra (5% damped): a) north-south components, and b) east-west components. The north-south component in Sakarya was not available. (Records provided courtesy of the Earthquake Research Department of the General Directorate of Disaster Affairs and Bogazici University.)

Response spectra are computed for the north-south and east-west components of ground motion for five stations located approximately along the fault: Gebze (GBZ), Yarimca Petrochemical (YPT), Izmit (IZT), Sakarya (SKR) and Duzce (DZC) (Figure 6). Of these, the largest peak ground acceleration was about 0.4g at Sakarya.

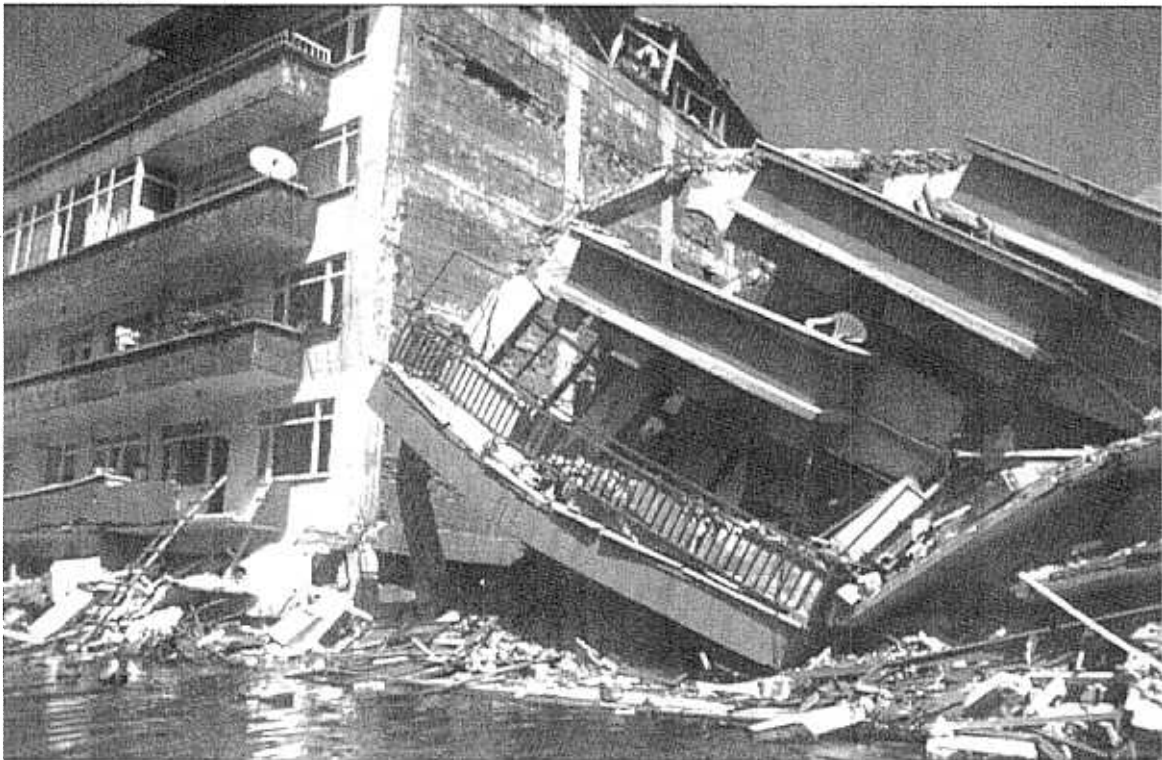
and ground shaking, and in some regions were subjected to ground settlement, liquefaction, or subsidence and sea water inundation (Figure 7). Numerous buildings were located on top of the fault trace, where there were lateral offsets of up to 4 m or vertical offsets of up to 2 m. Some buildings reportedly were "washed" into the Marmara Sea by waves resulting

Figure 7 - Inundated buildings in Golcuk. Tectonic displacement along the fault and liquefaction-induced subsidence resulted in extensive areas of flooding along the south shore of Izmit Bay. Note also out-of-plane roof infill, and collapsed building in foreground. (Photo: Aschheim)

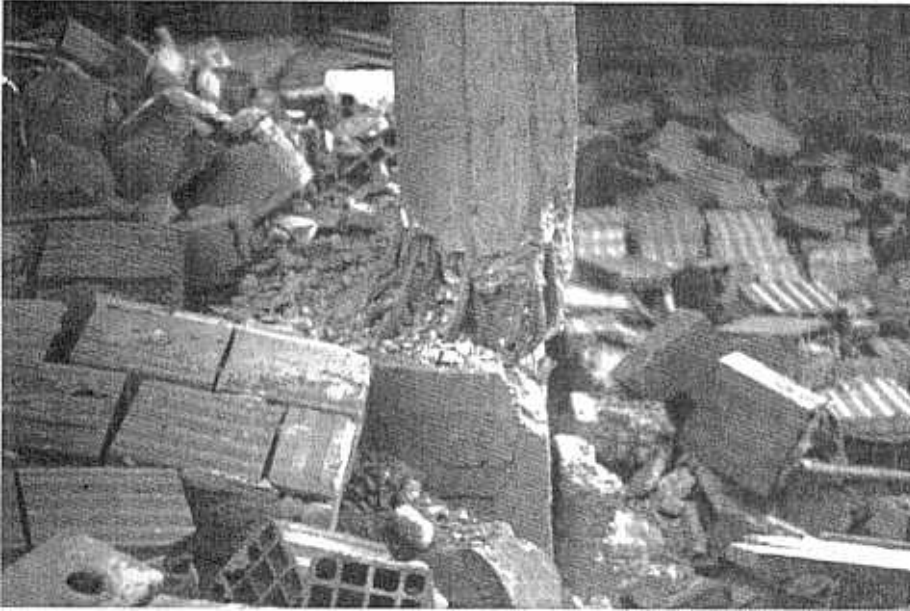
Figure 8 - Typical weak-axis column hinging.

Flexural hinging at the ends of the columns often led to buckling of longitudinal reinforcement, sometimes resulting in shear failures at the hinges under weak axis bending (Figure 8). Strong-axis demands typically caused flexural hinging at

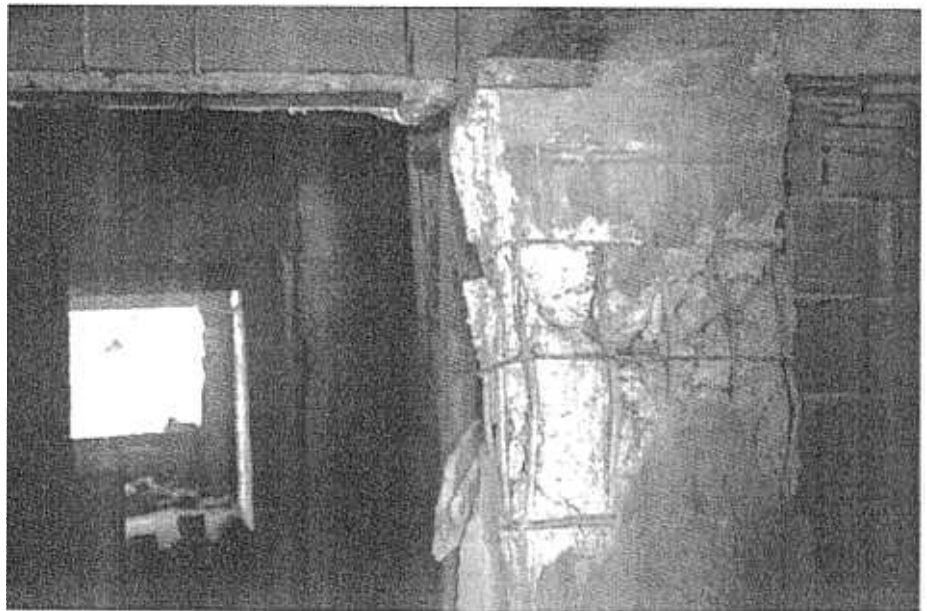
the ends of the columns and buckling of longitudinal reinforcement, or they caused shear failures at the mid-heights of the columns (Figure 9). Columns usually showed indications of large demands in only one principal direction. Soft (or weak) story mechanisms were common. In some cases, column axial forces resulting from overturning moments appeared to contribute to column failures. Loss of joint integrity was infrequent but ap-

Figure 9 - Typical strong-axis column shear failure.

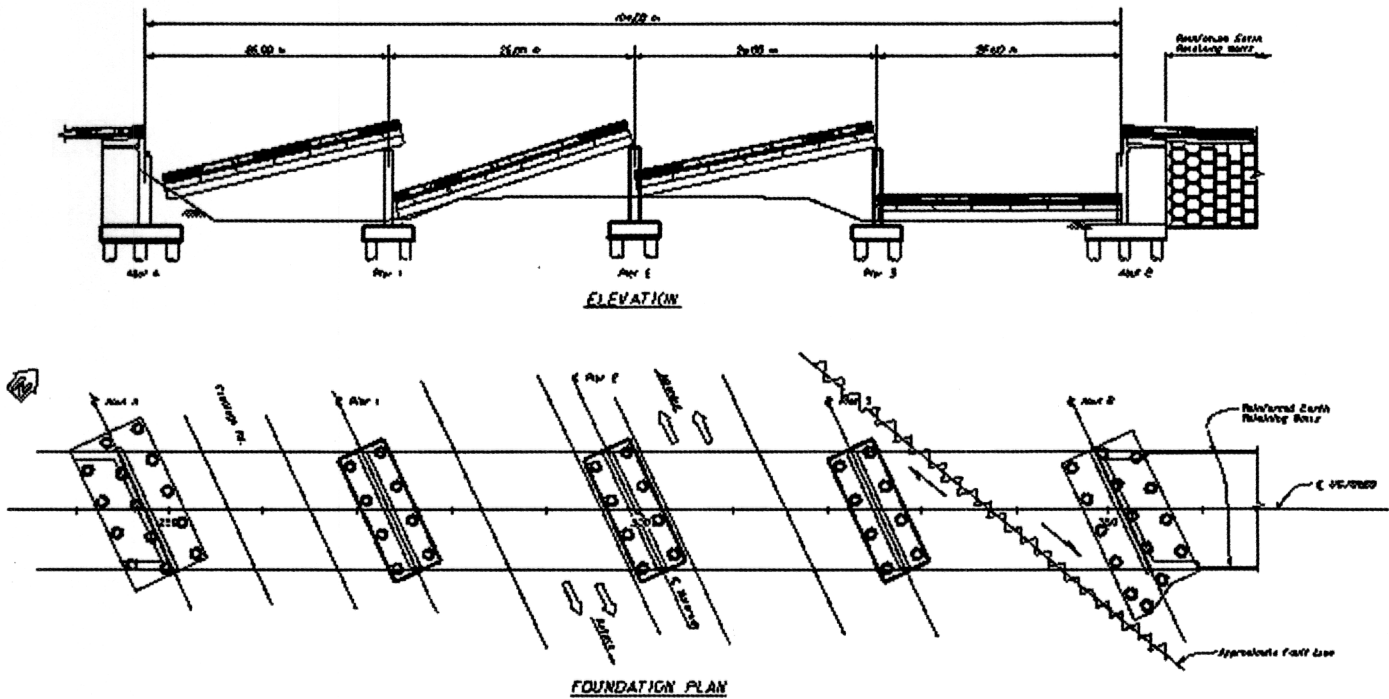
Figure 10 - Plan and elevation of collapsed overpass

The fact that one overpass crossing the E80 at Artifye did collapse was not surprising, as the fault rupture passed directly beneath the bridge (see Figure 10). The fault movement exceeded the

available seat width, causing the span to collapse. In so doing, it dragged the remaining three spans off their seats. One of the spans crushed a passing bus, killing ten people.

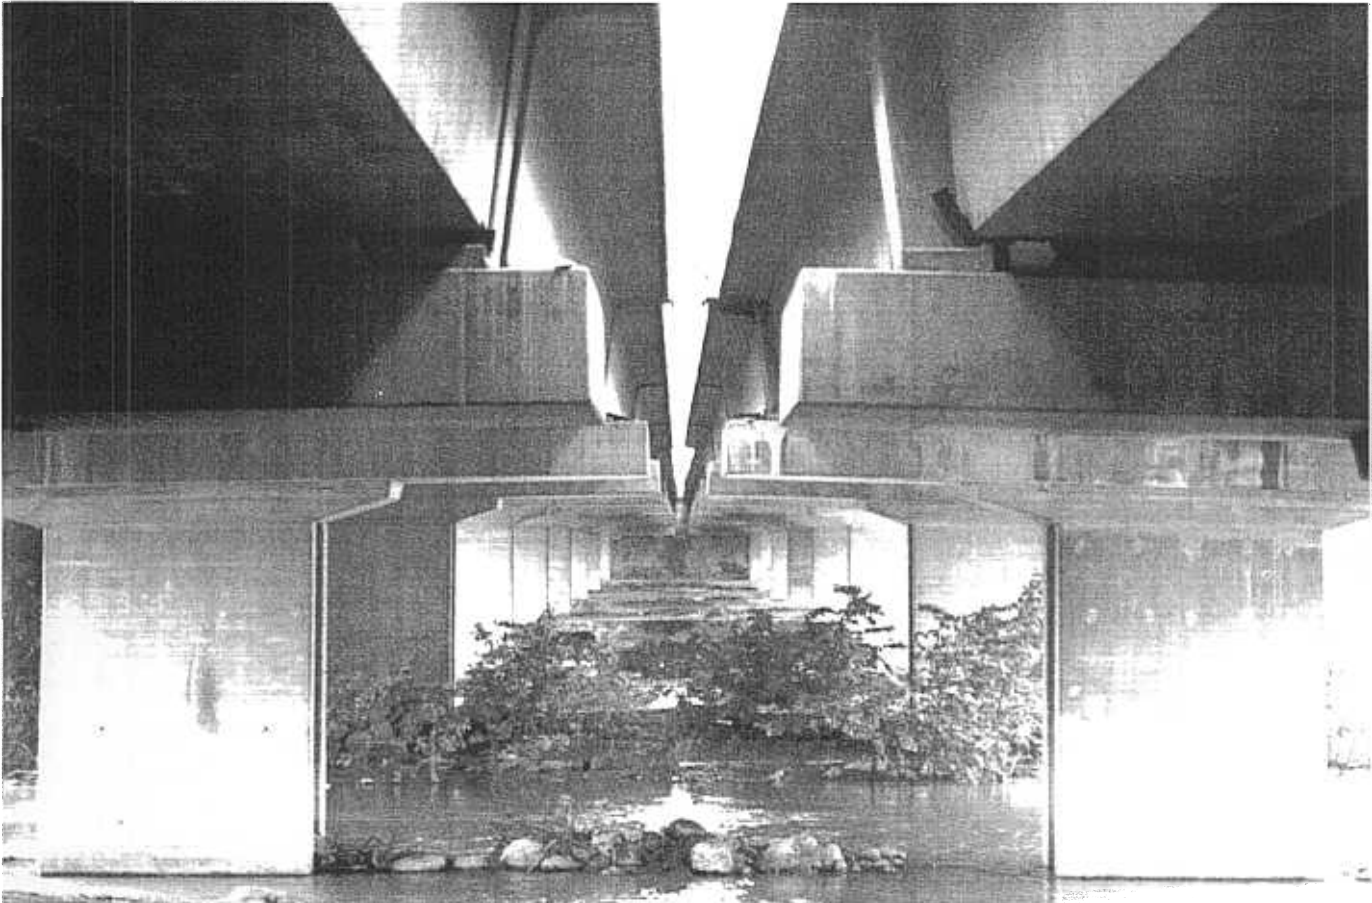
Problems were also encountered with four highway bridges crossing the Sakarya River (Figure 11). Most notable was the bridge carrying the westbound lanes of the E80 motorway. It consists of ten 40-m simply-supported prestressed-concrete trough-shaped girders seated on laminated elastomeric bearing pads. Shear keys are provided at the end of each box to inhibit transverse and longitudinal seismic movements; the elastomeric bearings accommodate thermal movements. The apparent large impulsive fault-normal ground shaking, coupled with vertical accelerations, caused the shear keys to fail in several spans and unseat their bearings. This damage is consistent with what has been observed in pre-

vious earthquakes. The westbound bridge had to be closed for repairs. The eastbound sister bridge sustained less damage to the shear keys and only partial walk-out of the bearing pads; in the absence of complete unseating, the bridge has remained fully operational.

Figure 11 - The east (left) and westbound bridges over the Sakarya River. Note shifting of the spans and the unseating of the bearings in the westbound bridge. The bearings on the eastbound bridge have partially "walked out," but not unseated. (Photo: Mander)

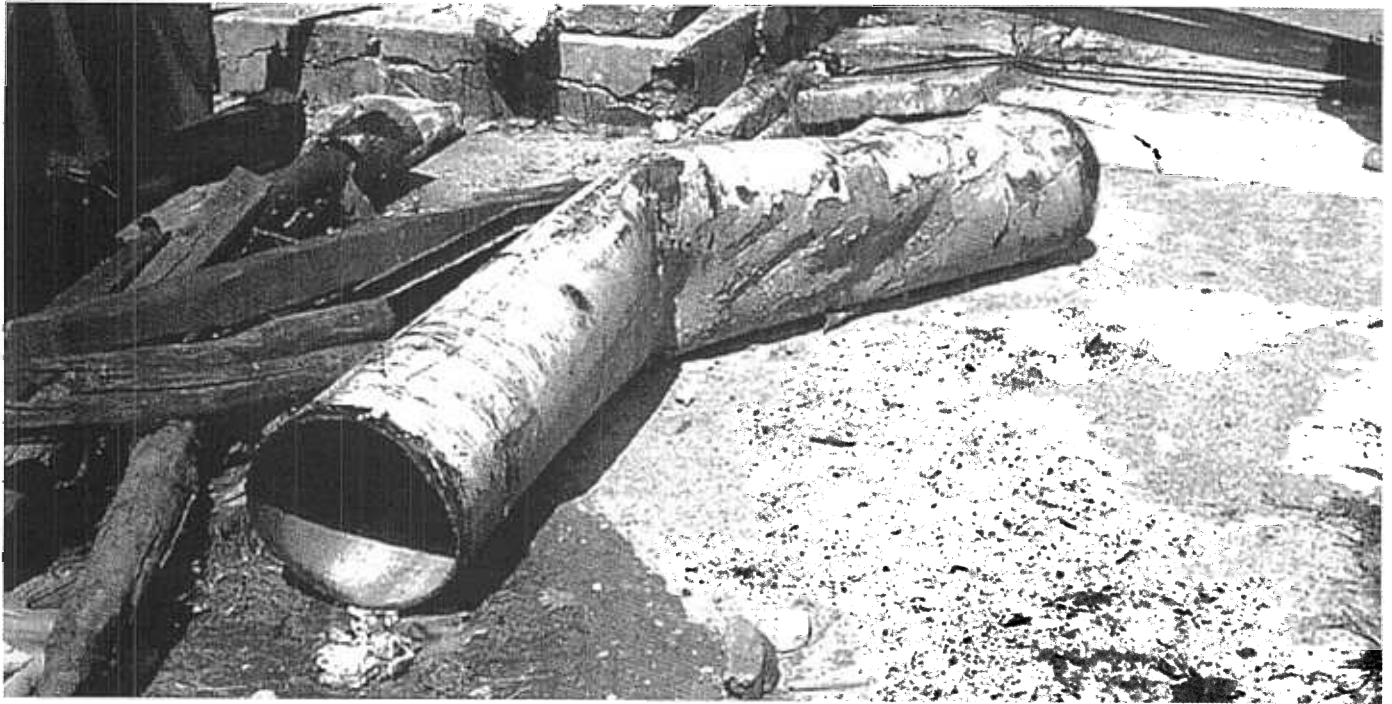
Figure 12 - Buckled steel pipe at crossing near Arifiye.

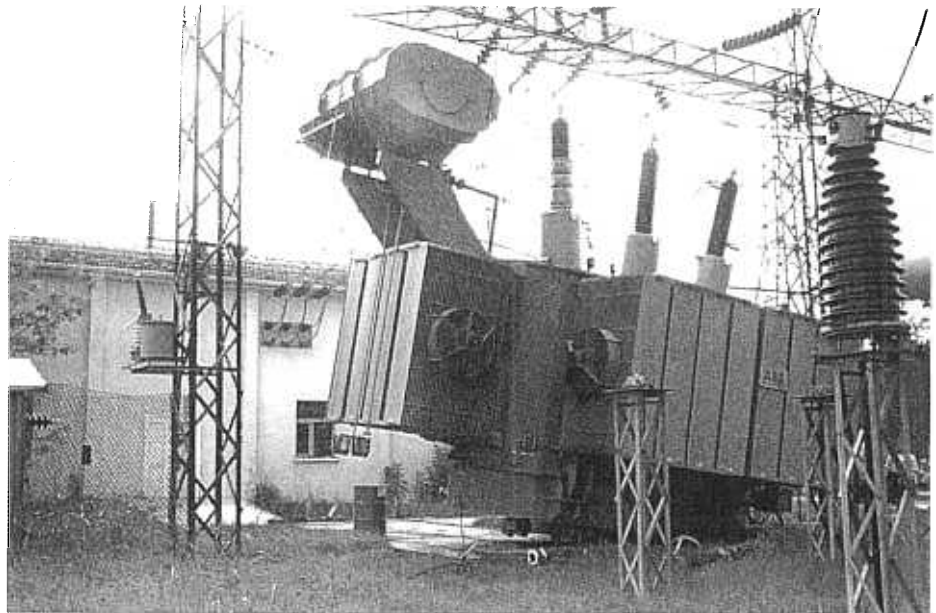
Figure 13- Damage to transformer in Izmit-2 substation. Tilting due to movement of support.

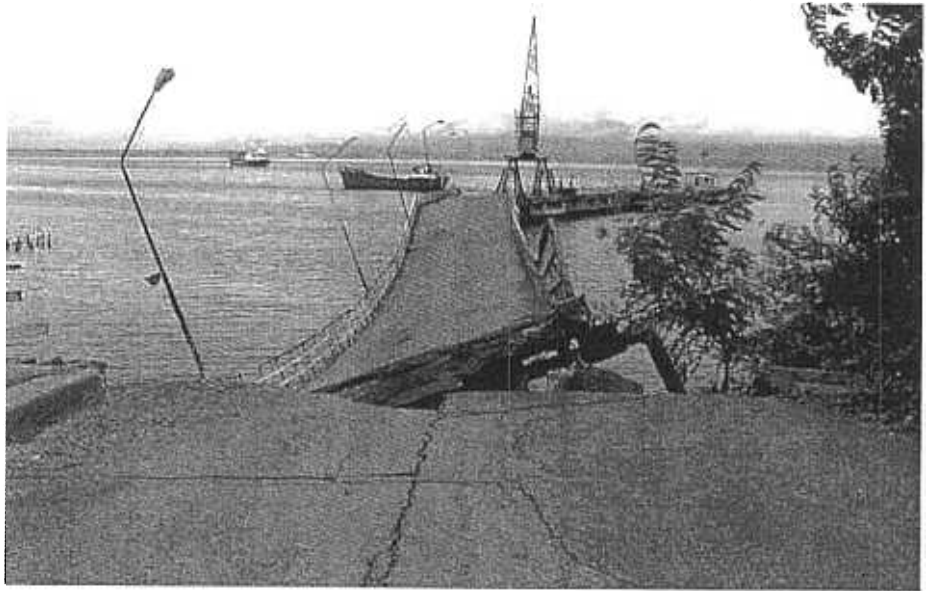
Ports: Most of the ports and jetties of industrial facilities along the northern shores of the Izmit Bay sustained damage ranging from minor to extensive (Figure 14). Extensive damage was observed at fault crossings, for example, at the navy base. It included failure of steel piers and piping systems and the collapse of cranes. At the port of Derince, the largest port facility, two of the three main cranes were nonfunctional due to horizontal and vertical movement of the caisson of up to 40 cm. The port continued its operation using mobile cranes. A few jetties at the industrial facilities were functional by the end of the third week. The total estimated loss for port facilities in the region is on the order of \$200 million.

Figure 14 - Private port facility for SEKA paper mill in Izmit. (Photo: Johnson)

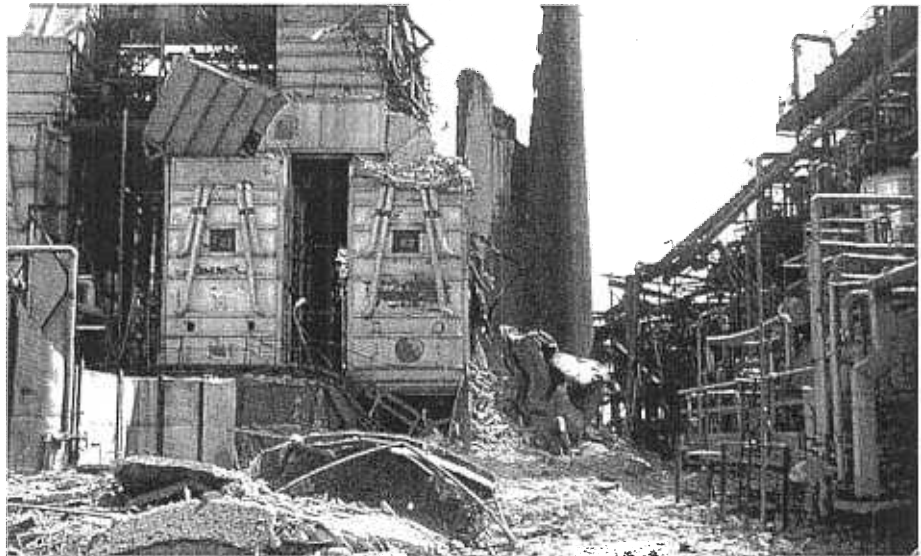
Figure 15 - Collapsed 90-meter reinforced concrete stack at the Tüpras refinery caused extensive damage and fires. (Photo: Johnson)

crude unit, when a 90-meter high reinforced concrete heater stack catastrophically collapsed, knocking down equipment and pipeways (Figure 15). Tupras also had a wood cooling tower that completely collapsed, and there was an oil spill at the port.

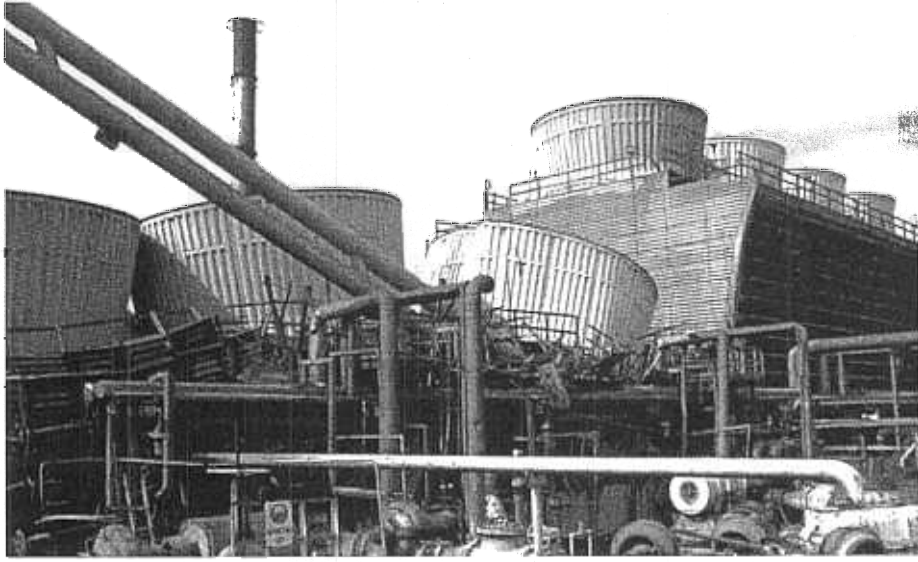
Figure 16 - Collapsed wooden cooling towers at the Petkim petrochemical plant. Instrument at the site measured peak horizontal acceleration at 0.32g. (Photo: Johnson)

Petkim had extensive damage to the port, complete collapse of the wood cooling towers (Figure 16), and severe damage to concrete cooling towers. Peak horizontal accelerations of 0.32g were recorded on a soil-founded instrument located at this site.

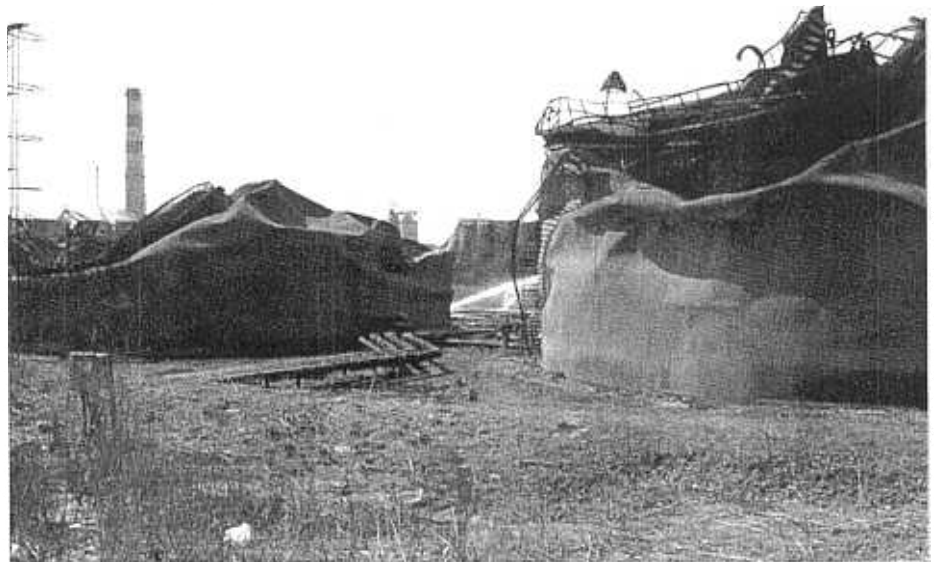
Petrochemical Industry: The most widely publicized and spectacular damage occurred at the massive Tupras refinery in Korfez (Figure 17). Several tanks and a cooling tower burned out of control for three days when naphtha spilled from a floating roof tank and ignited; all water was lost to the refinery. A second fire started in a

Figure 17- Tanks destroyed by out-of-control fire in the Tupras refinery tank farm. (Photo: G. Johnson)
