Fire of Petroleum Tank, etc. by Niigata Earthquake

June 16th, 1964, Niigata, Niigata pref.

AKATSUKA, Hirotaka (High Pressure Gas Safety Institute of Japan)

KOBAYASHI, Hideo (Tokyo Institute of Technology)

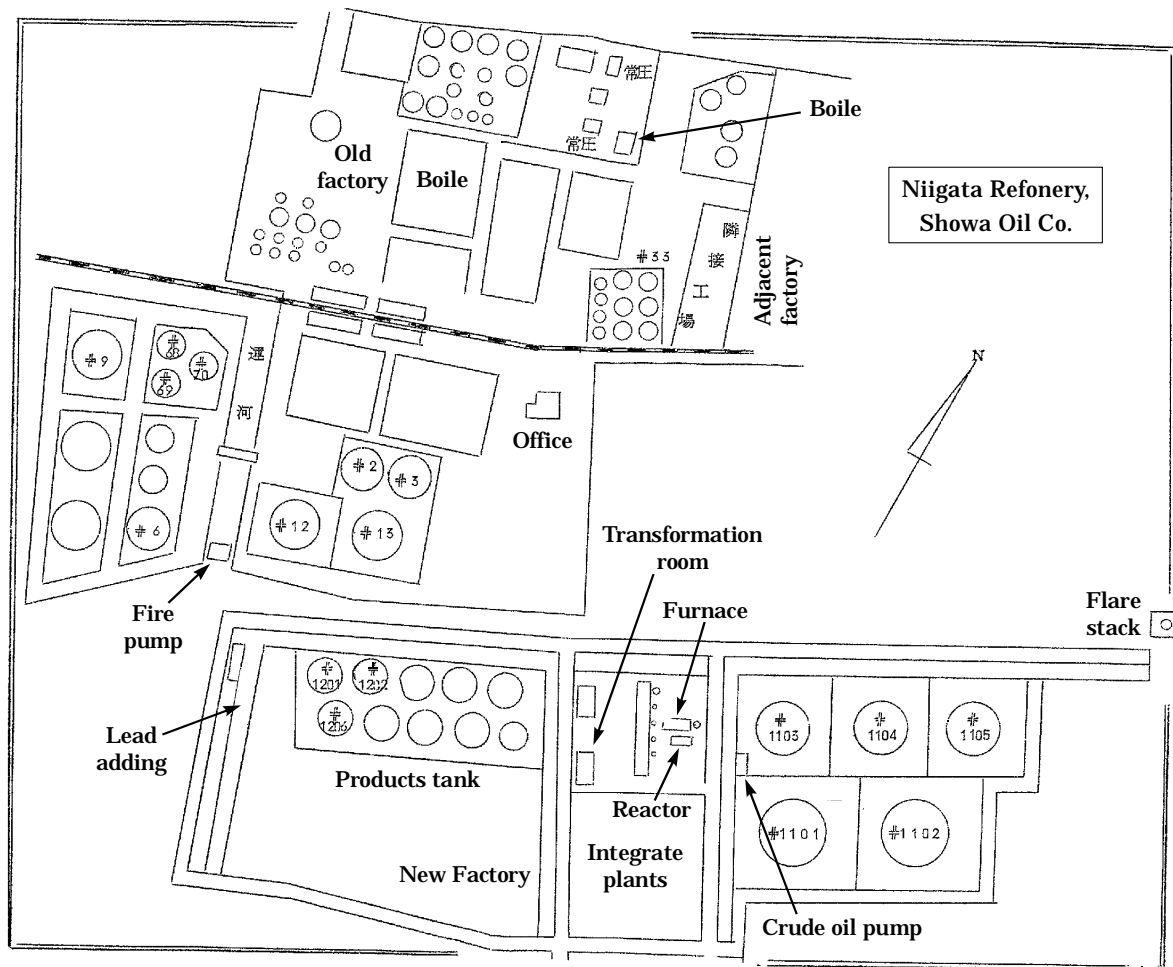
Each tank in the refinery was shaken by the earthquake in the north and south direction, coinciding with the direction to the seismic center (Figures 1 and 2). The floating roofs of five crude oil storage tanks shocked, and shaking motion of one of them was complicated by its inclination to the west, which was caused by subsidence of the ground that was associated with the soil liquefaction phenomenon. "Sloshing" is defined as the phenomenon of vibration induced on the free surface of a liquid contained in a vessel by the shaking of the vessel itself (Figure 3). In the sloshing of large vessels such as petroleum tanks, the force of impact to the top and the negative pressure to the side wall are serious problems. As a result of the shaking of the floating roof, the crude oil flowed out of the top of the tank, fell down along the side wall, and was ignited by the sparks generated by the collision between the floating roof and the side wall. The crude oil storage tank yard was located adjacent to the main plant area. That is, the tank was within 40m of the plant area, and 48m away from the nearest equipment. A part of the crude oil flowed into the main plant

Fig. 2 Damaged part of refinery.

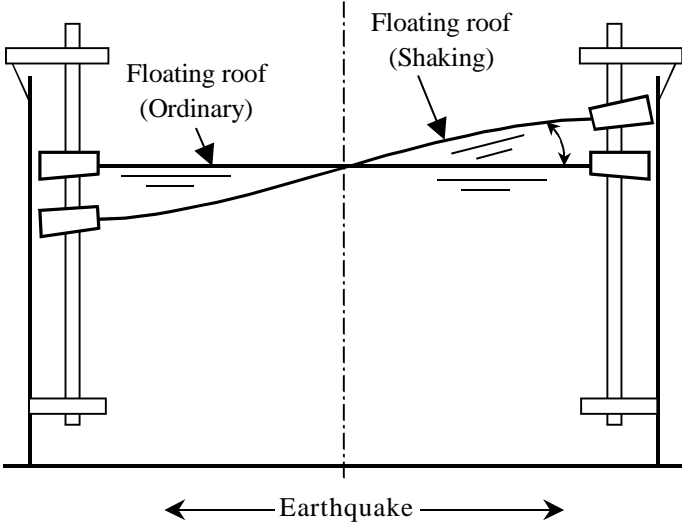
associated with the sloshing phenomenon is greater for the floating roof than for the cone roof. This disaster happened as a result of the following process; the floating roof was shaken vigorously by the earthquake together with the uneven settlement of the tank caused by the ground liquefaction, which resulted in ignition of the oil by sparks generated by the collision between the floating roof and the side wall. The sparks were generated by the metal touch sealing between the floating roof and the side wall. Recently, soft touch sealing composed of synthetic rubbers or urethane foams has been used instead of the metal touch sealing.

Fig. 3 Sloshing phenomenon.

The metallic seal mechanism was eliminated entirely and the side wall was heightened to prevent the outflow of oil.

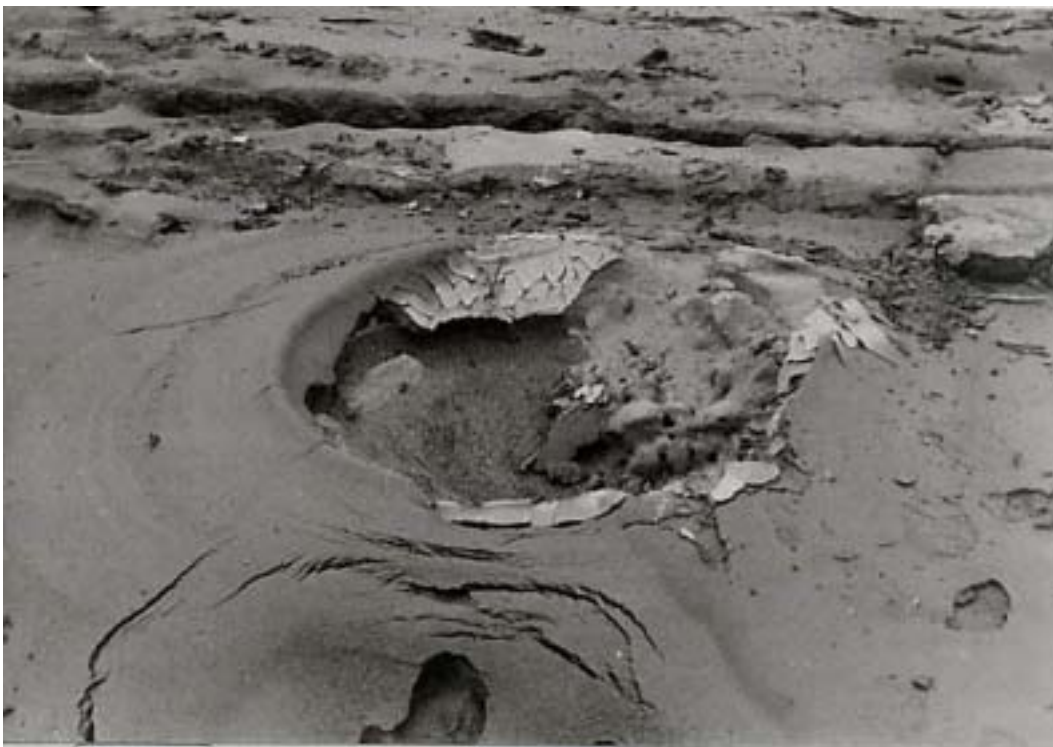
Various damages occurred as a result of the liquefaction of the ground. The "liquefaction of the ground" occurs when seismic vibration causes sandy ground saturated with underground water to become a liquid. Buildings that had been supported by the ground lose their support and become tilted or sink into the ground. On the other hand, structures that had been buried underground are lifted out of the ground (Figures 4 and 5). The ground liquefaction phenomenon caused uneven settlement to the tanks, which resulted in the deformation and failure of the pipes (Figure 6). The oil fence cracked to expose the reinforced steel bars, which in turn suffered from thermal expansion by the fire, causing the fence to lose its strength and collapse. Underground water rose up to the surface by the ground liquefaction, filling the campus together with the sea water that had come in with the earthquake induced tidal wave (Tsunami). Oil flowed out through cracks in the tanks and pipes and was spread by the flood water, causing the fire to spread at an accelerated rate.

Fig. 4 Liquefaction of ground (Kawagishi-cho).

The vibroflotation is a method for consolidating and tightening loose and soft ground as follows; the vibroflot (vibrator with water jet) is slowly lowered while vibrating to the bottom of soil layer, and then it gradually withdrawn while feeding sand into the area.

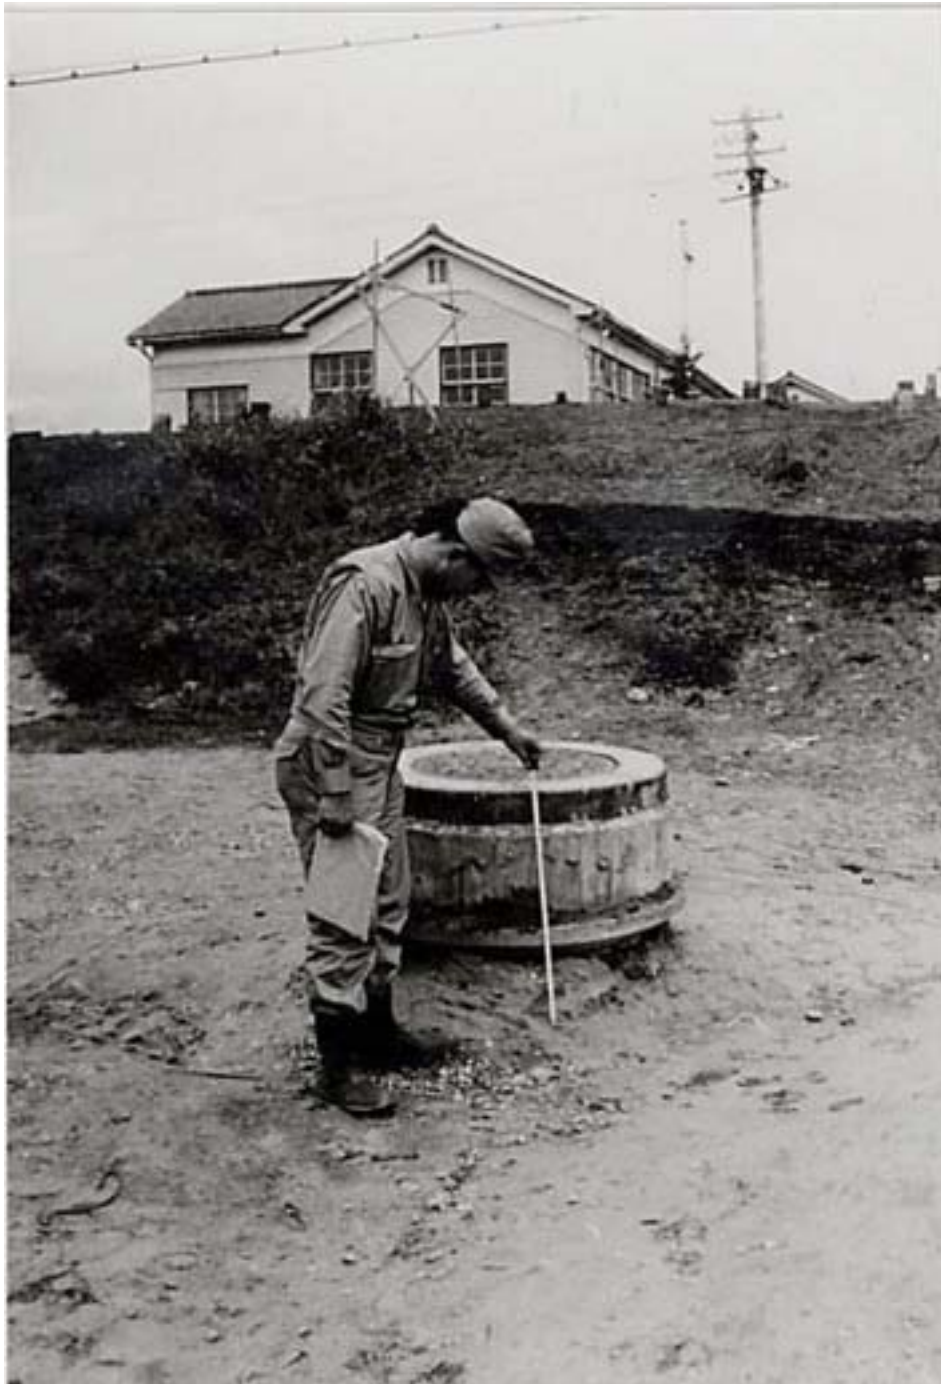
Fig. 5 Uplifted manhole by liquefaction (Near girder bridge of Echigo-line).

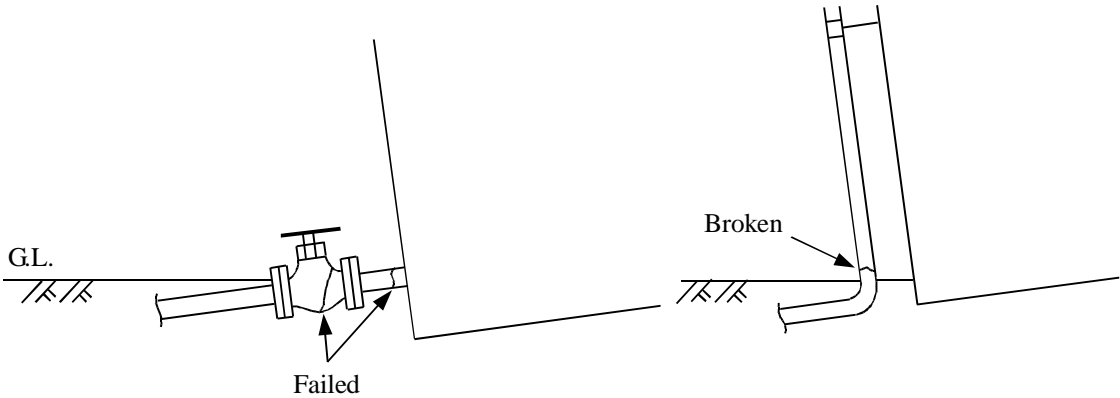
Insufficient improvement of the basic foundation for heavy structures as tanks and insufficient flexibility of the pipe line against the subsidence of the ground resulted in the amplification of the damages, especially in the areas of ground liquefaction and of zero ground level ground into which sea water could easily flow. In fact, some of tanks that were located on the improved basic foundation suffered little damages from the uneven settlement. At the initial stage, the oil fence helped to prevent expansion of the fire, however, later it collapsed because of insufficient earthquake-proof design.

Fig. 6 Damage of tank attachment piping.

Design such as the spring support and the flexible joint have been adopted depending on the kind of piping. Moving underground piping above ground has made it easier to find defective parts during ordinary operation and to take necessary actions quickly in the case of an emergency.
