TURKEY—OIL SPILL RESPONSE FOLLOWING AN EARTHQUAKE

*Tony Harmer
Oil Spill Response Limited
Lower William Street
Southampton, Hampshire SO14 5QE United Kingdom*

ABSTRACT: *This paper provides an overview of the incident at the Tupras Oil Refinery in Izmit, Turkey following the August 1999 earthquake, including the scenarios encountered and lessons learned. Oil spill operations are not simply confined to “at-sea incidents” and can be situated within areas of complete devastation, where priority for the cleanup of leaking oil is simply an afterthought. A good example of this would be Kuwait during the Gulf War and the strategic destruction of the oil fields.*

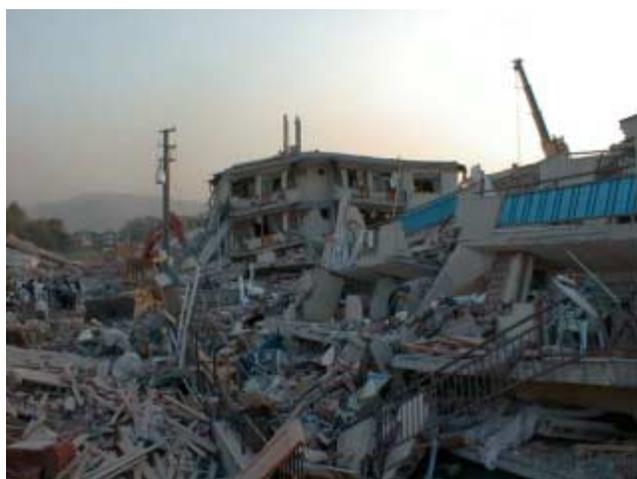
Figure 1. Earthquake damage adjacent to Tupras Refinery, Izmit.

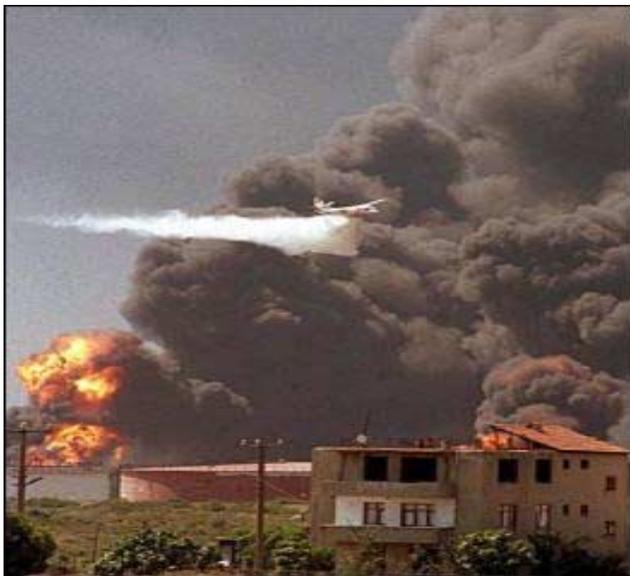
Storage tanks at the tank farm are surrounded by a “bund” (in this case an earth made wall), which contains any leakage or spillage of product. As the firefighting effort continued with combating the blaze and boundary cooling adjacent tanks (Figure 2), the high volumes of oily water liquid began to spill into the oily water drainage system; this then flowed to the oil water separators. These were a series of holding ponds and API separators designed to deal with the small quantities of oil normally found in surface runoff water. In this case, the volumes of water and oil were too much for the separator system to handle. The runoff overwhelmed the separators, and the oil was released into the bay leading to a spill. The spill may have been controlled easily if personnel were available to manage the flows in the interceptors, but all available personnel were engaged in either firefighting operations or rescue missions. The disruption of the power supplies within the refinery also prevented the use of the refinery pumps to control the carryover into the outfall.

Figure 2. Boundary cooling of Tupras Tank Farm.

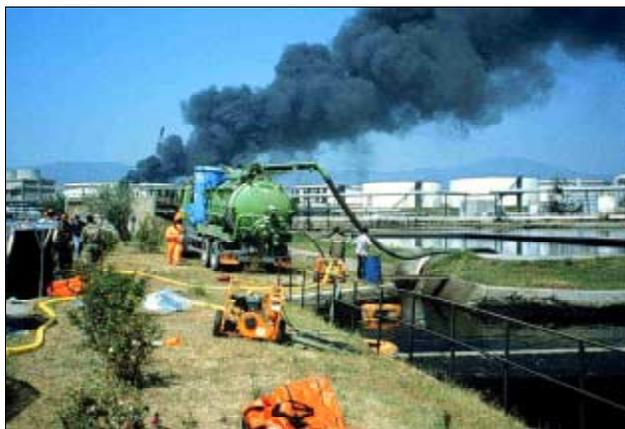
The OSRL team promptly deployed further containment booms and recovery devices into the separator ponds in an attempt to limit the flow of oil through the outfall (Figure 3). The upset in the interceptor system may have been a result of ruptured pipelines in conjunction with the large amounts of firefighting water coming from the tank farm area. The emphasis was placed on controlling the oil flow within the separator system. The on-scene team quickly operated the weir gates in the separators to lower the water level and to retain the oil. Utilizing temporary storage tanks, oleophilic skimmers, and spate pumps, the situation was quickly stabilized.

Figure 3. Separator recovery operation, Tupras Refinery.
