**The Mudurnu Valley
(West Anatolia)
Earthquake**

of 22 July 1967

by N. N. Ambraseys
A. Zátpek
M. Taşdemiroğlu
A. Aytun

Serial No. 622/BMS.RD/AVS
Paris, June 1968

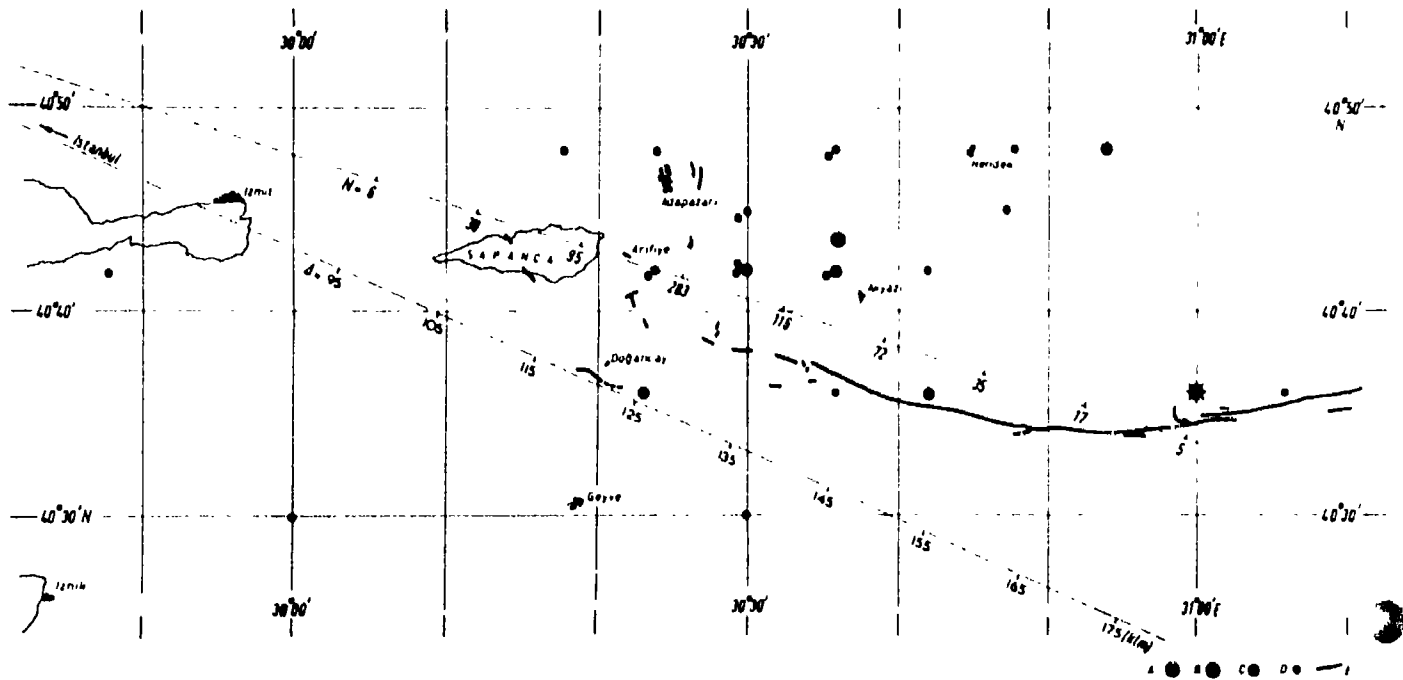
10

10. Aftershock distribution of the Mudurnu earthquake for the period 22 July 1967 - 18 September 1967. A : $M \geq 5\frac{1}{2}$; B : $5\frac{1}{2} > M \geq 5$; C : $5 > M \geq 4\frac{1}{2}$; D : $4\frac{1}{2} > M$; E : fracture zone; N = number of aftershocks within a zone of ± 5 kilometres from D.

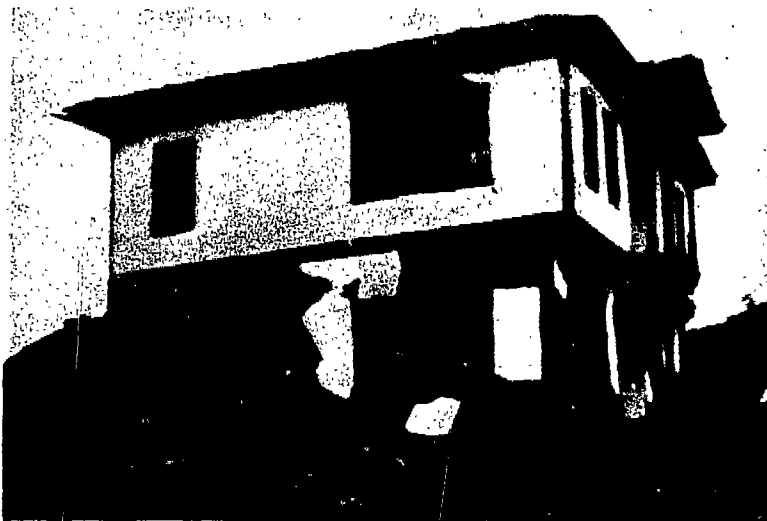
19

19. Continuation of the trace shown in Figure 18 at Bickidere; en echelon fractures pass under house.

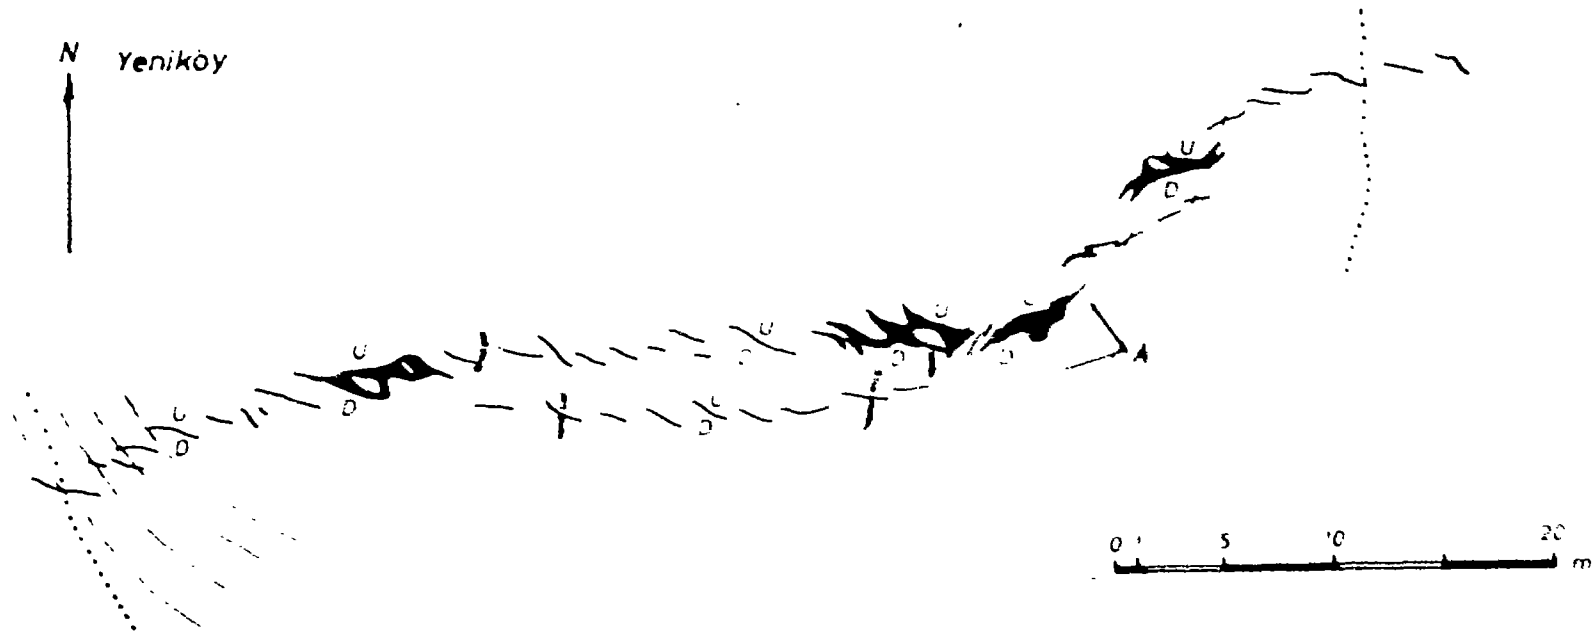
55. Sketch of fracture at Kenikoy cemetery (scale approximate).

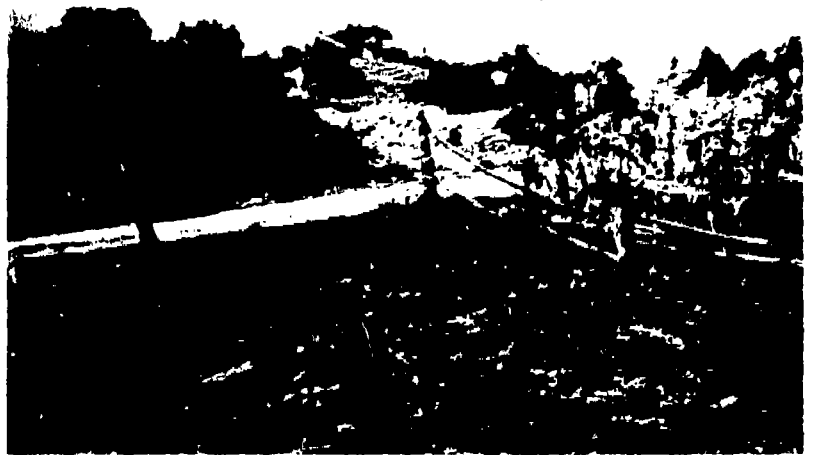
58

58. Offset fence at point A of figure 57.

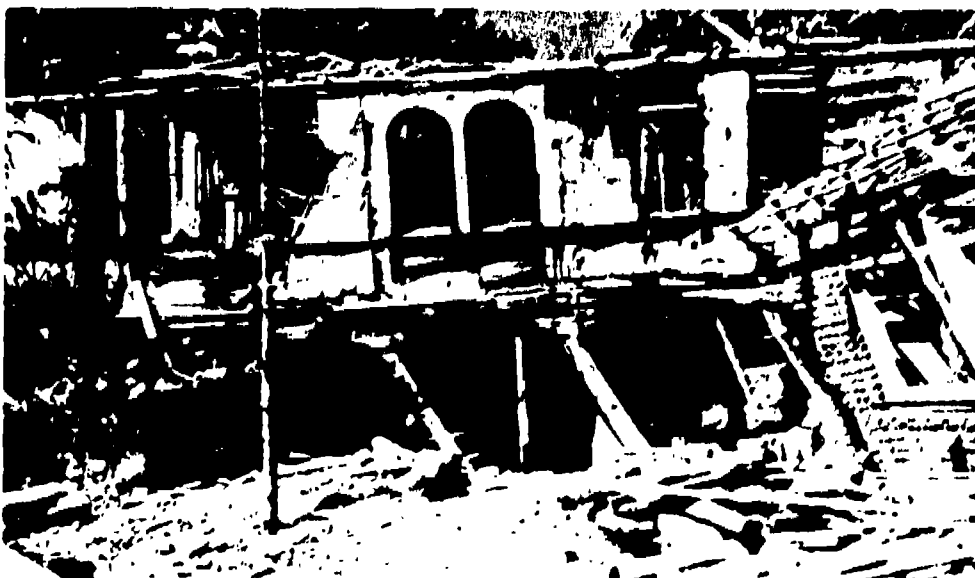
61

61. Damage to local construction at Sigirlikoy.

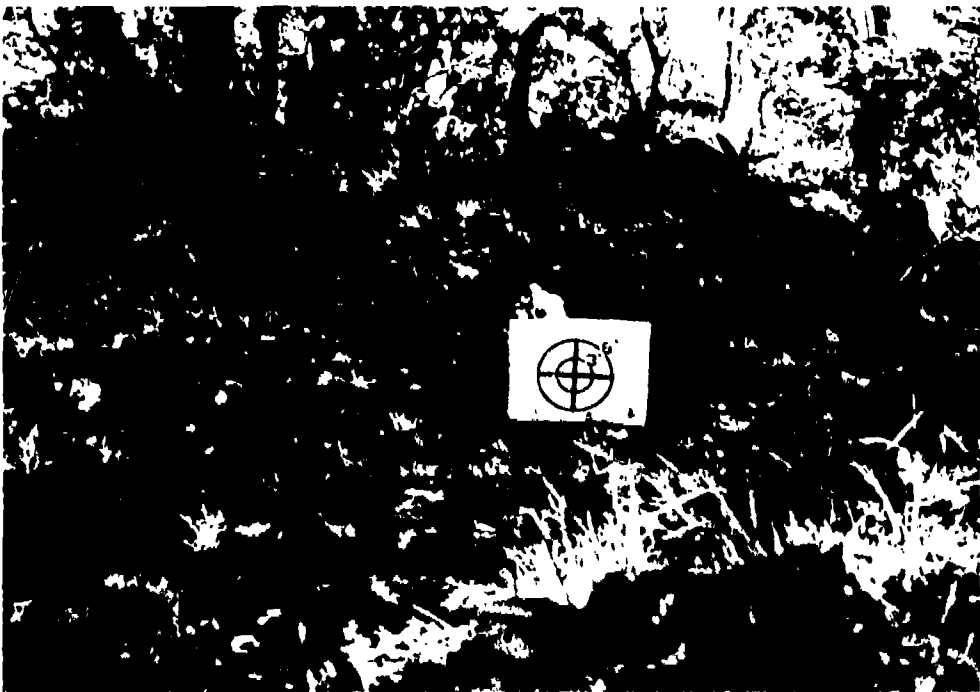
66

66. Normal faulting near locality 49.

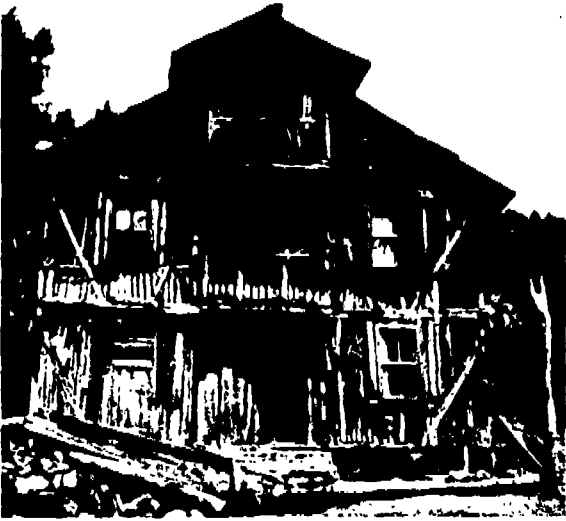
93

93. Undamaged timber construction at Hamitler.

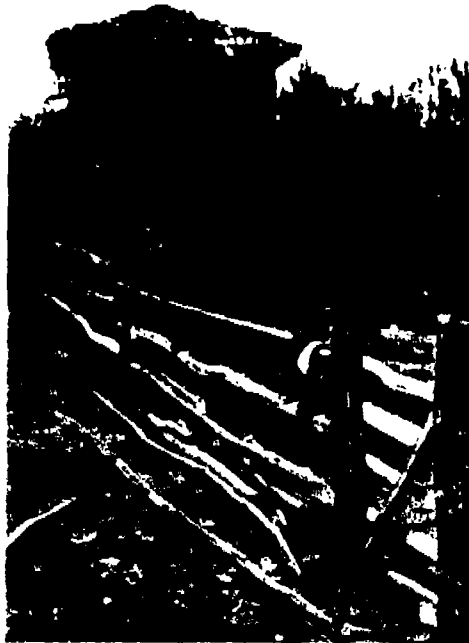
110

110. Elevated timber barn situated 20 metres west of adobe house shown in Figure 108; no damage.

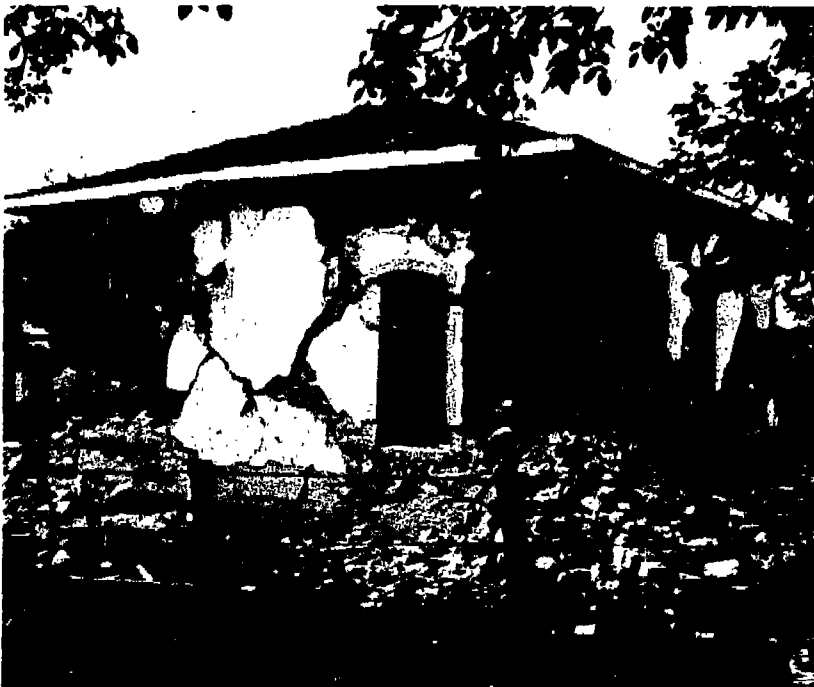
111

111. Destroyed adobe mosque at Dogan-cay. In the background timber braced house suffered small damage.

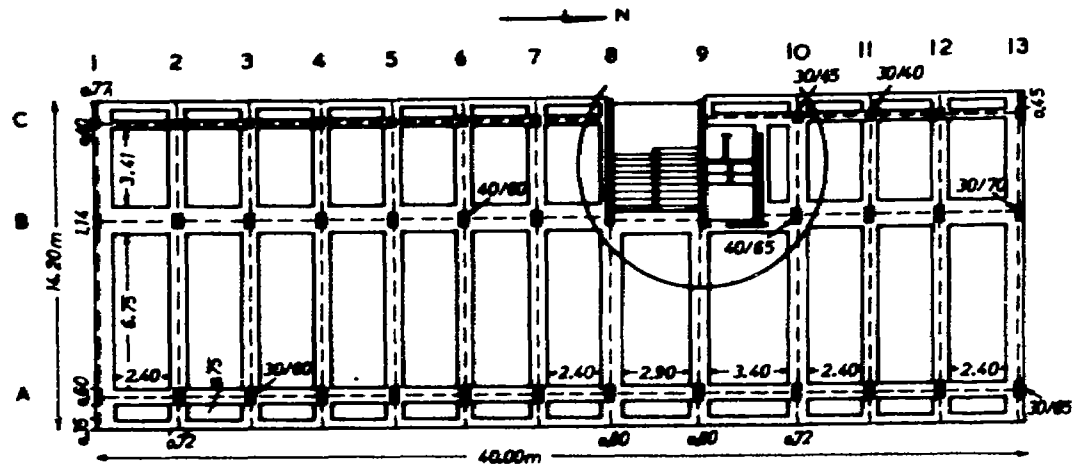
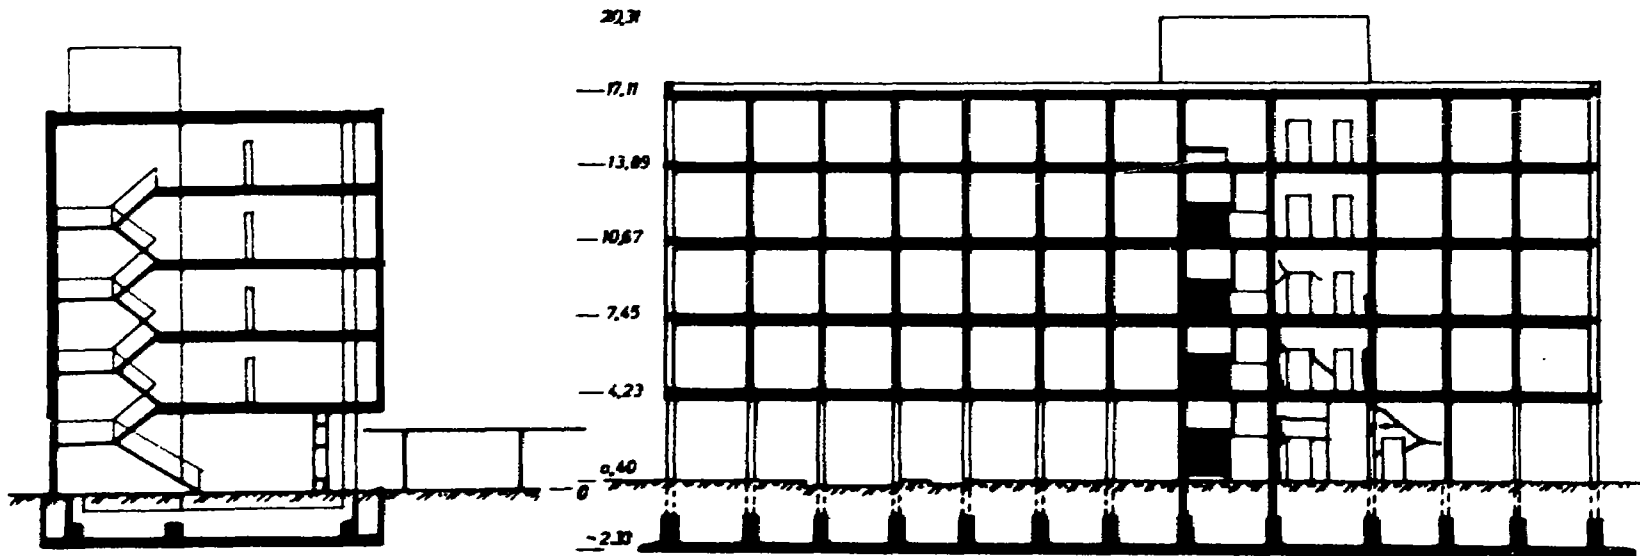
120. Sakarya Vilayet, Adapazari. Circle indicates area of damage at ground-floor and first-floor levels.

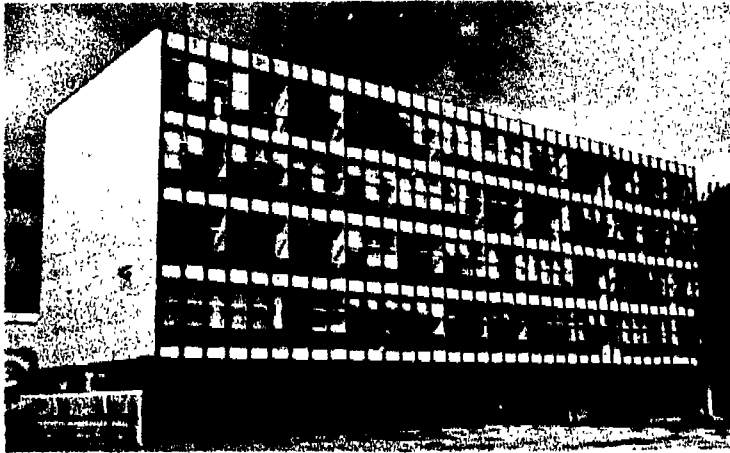
122. Damage to lift-shaft and column B10- Sakarya Vilayet, Adapazari.

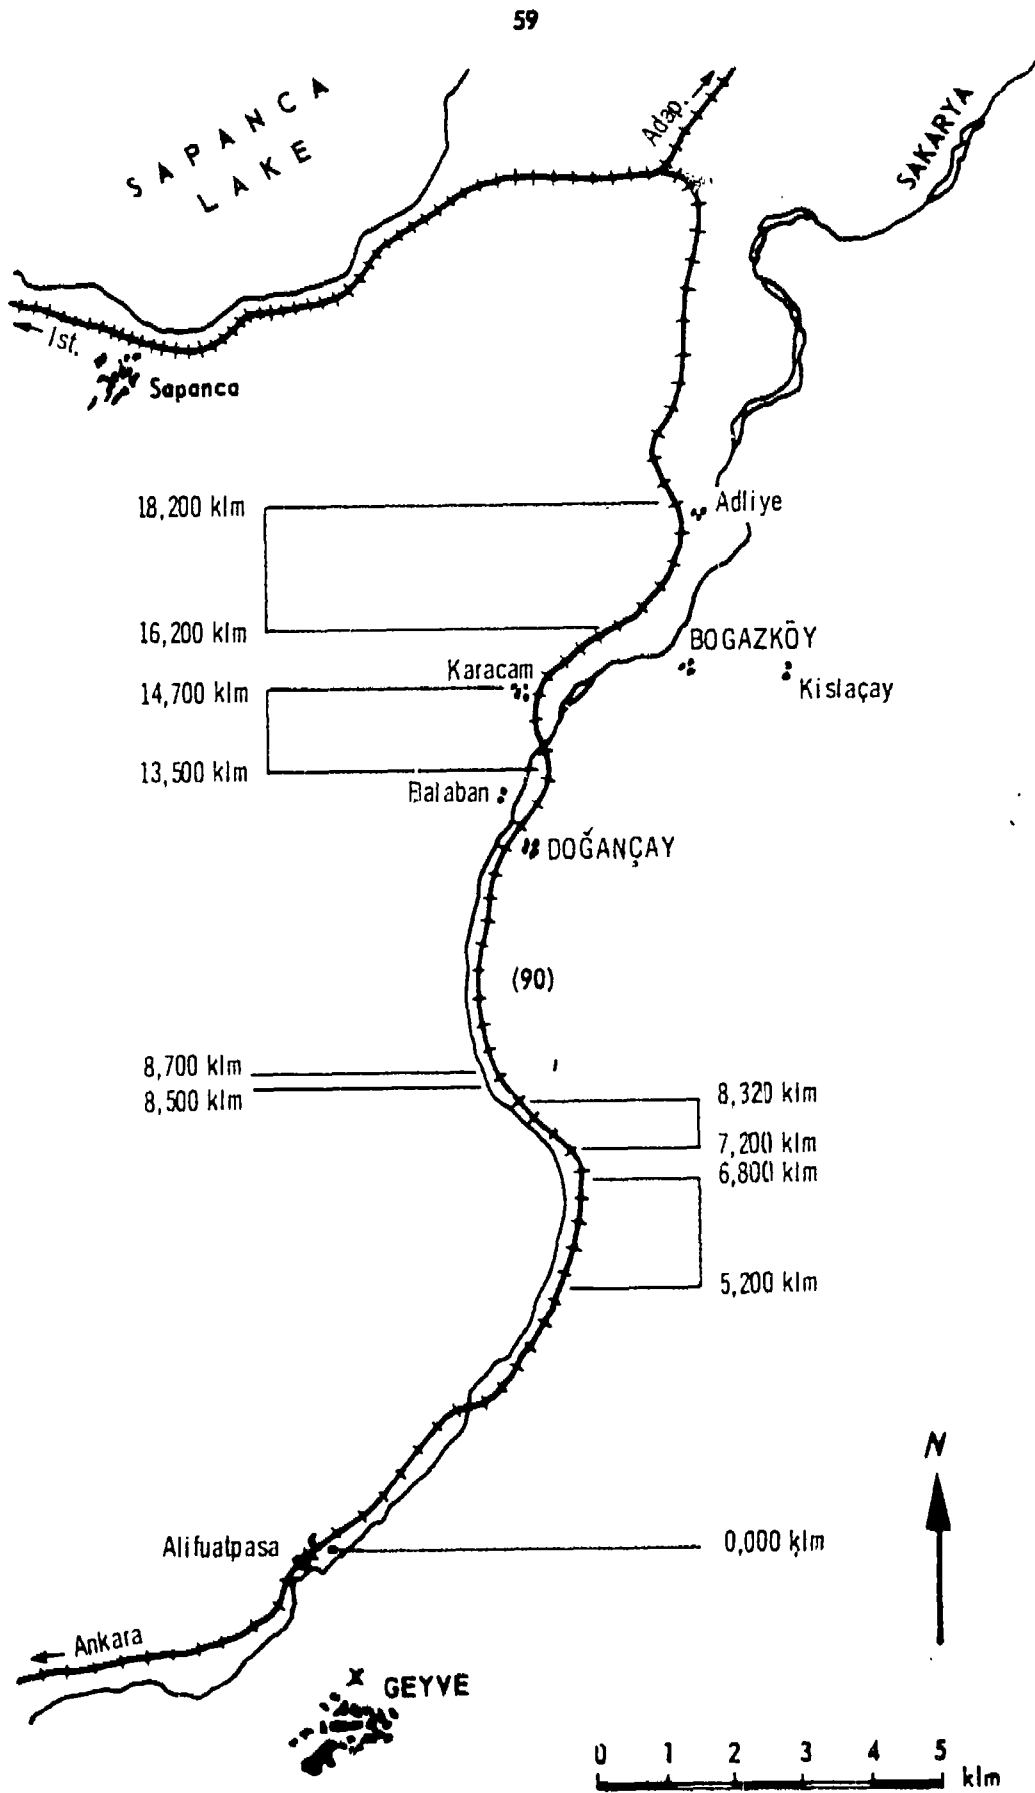
132. Damage to İstanbul and Ankara railway line in the Balaban defile.
