Structural Engineering Reconnaissance of the August 17, 1999 Earthquake: Kocaeli (Izmit), Turkey

PEER Report 2000/09
Pacific Earthquake Engineering Research Center
College of Engineering
University of California, Berkeley
December 2000

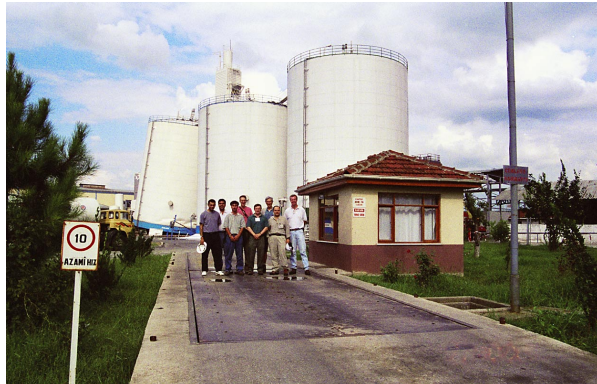
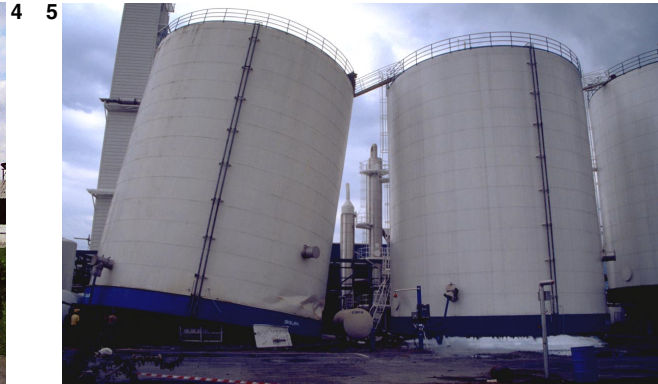
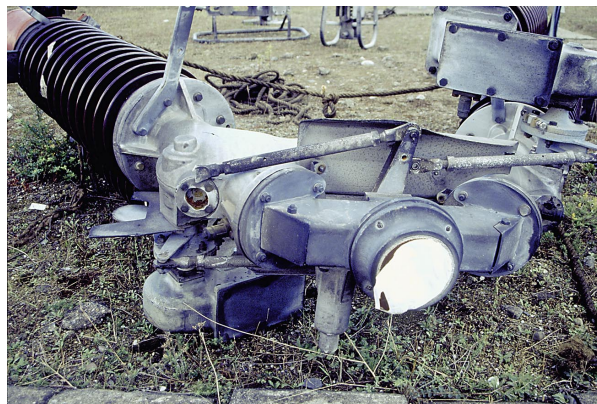
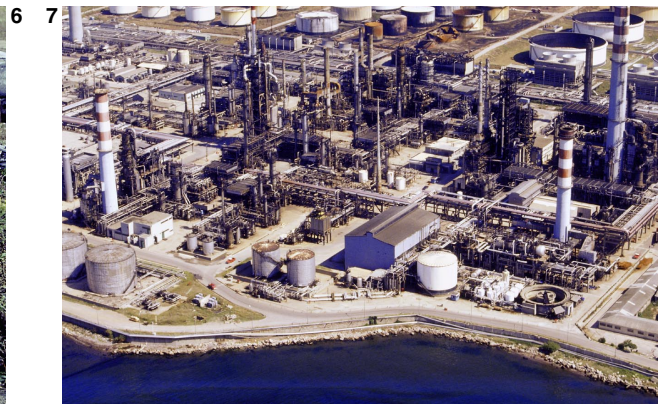
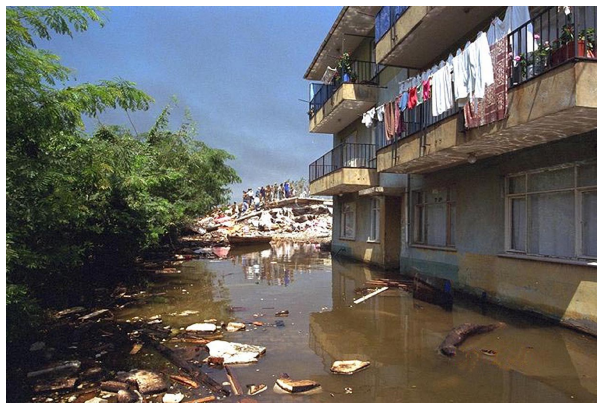
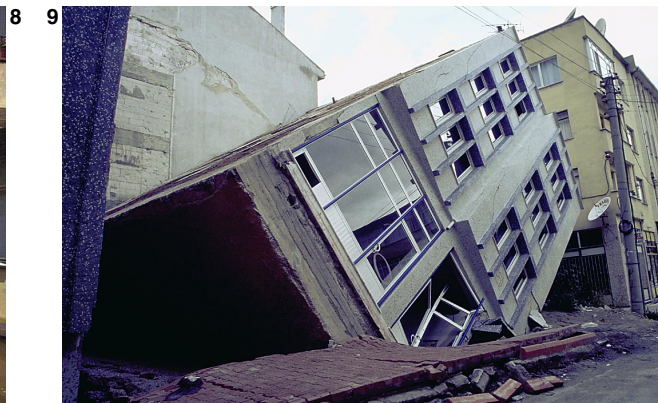
- 1 Large permanent drift in weak first story of reinforced concrete building
- 2 Collapsed and damaged reinforced concrete apartment buildings in Degirmendere
- 3 Fault trace through naval station building
- 4 PEER reconnaissance team in front of damaged fertilizer plant tanks
- 5 Damaged fertilizer plant storage tanks
- 6 Damaged electrical substation equipment
- 7 Aerial view of Tüpras refinery
- 8 Flooding and damage resulting from sinking coastline near Gölcük
- 9 Soil-bearing capacity failure
