# 1 Introduction

## 1.1 1999 Izmit Earthquake

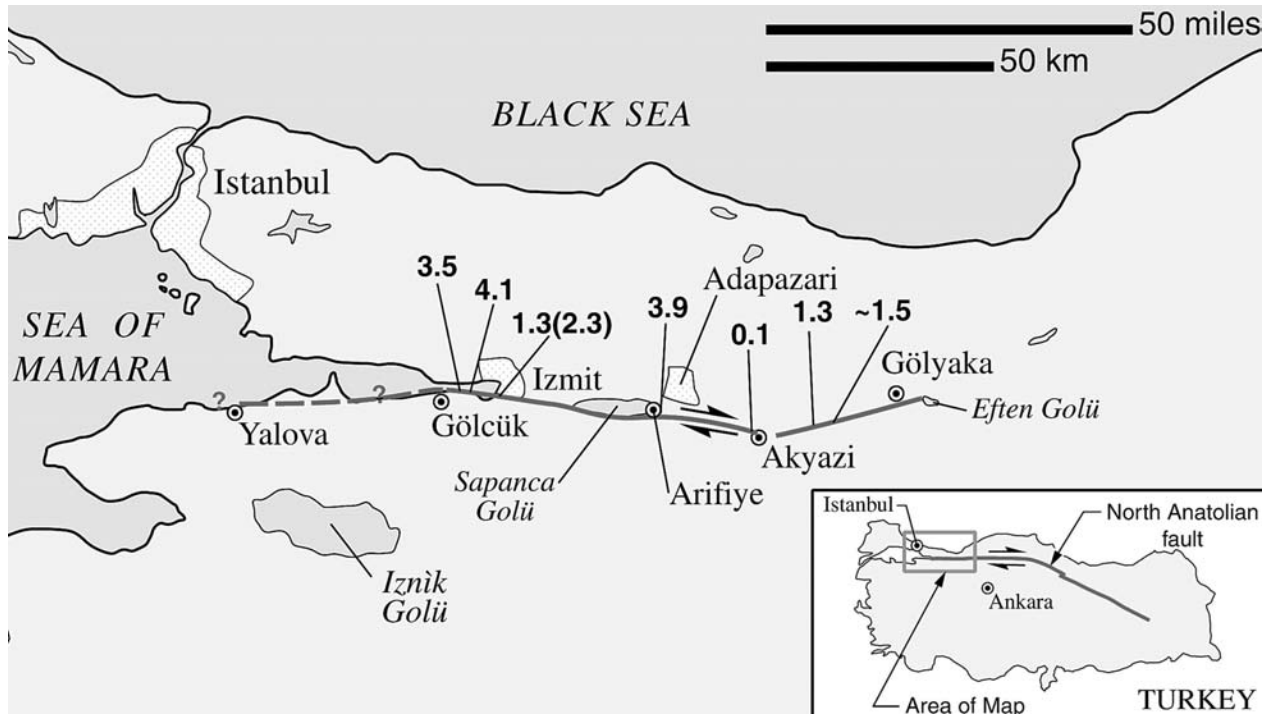
**Figure 1-1 Map of affected region showing locations and size (meters) of horizontal offsets and a vertical offset (in parentheses)**

The 1500-km-long North Anatolian fault, which has many characteristics similar to the San Andreas fault in California, is one of the most extensively studied right-lateral strike-slip faults in the world. During the August 17 earthquake, approximately 110 km of the North Anatolian fault ruptured, with a maximum horizontal offset of 5.5 m (west of Golcuk) and a maximum vertical offset of more than 2.3 m (east of Golcuk). Figure 1-1 shows the measured horizontal and vertical offsets at selected locations. Figure 1-2 is a photograph of the vertical offset near the Ford plant in Golcuk; team member Atila Zeikoglu is standing in front of the ledge formed by the faulting.

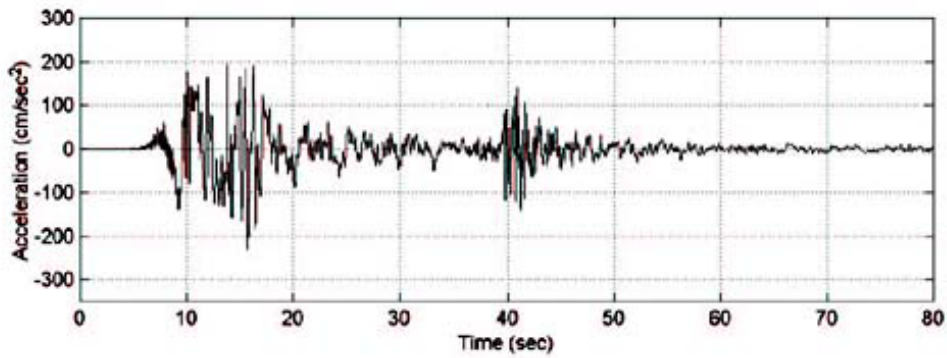
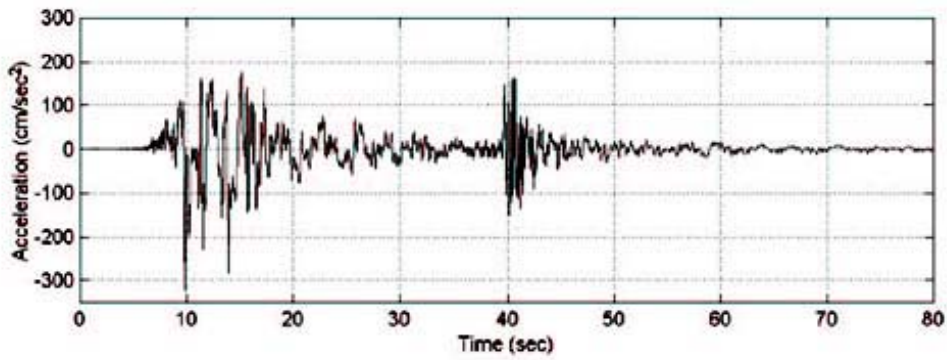
Figure 1-3 Acceleration time histories from the Yarimca (YPT) Station

An acceleration time history recorded at the Yarimca (YPT) station across the Izmit Bay from Golcuk is shown in Figure 1-3. The secondary shaking evident at 40 sec appears in most acceleration time histories from the Izmit earthquake. However, when these accelerations histories are integrated, this high-frequency shaking has very little effect on the ground velocity and ground displacement. Response spectra for selected acceleration histories for 5% damping are shown in Figure 1-4. (The instrument at Sakarya failed to record the ground motion in the north-south direction.) The spectra have been divided into north-south (Figure 1-4a) and east-west components (Figure 1-4b). Since the fault line runs approximately east-west, these components can be interpreted as approximately fault-normal and fault-parallel, respectively.
