3 Reinforced Concrete Frame and Wall Buildings

3.1 Introduction

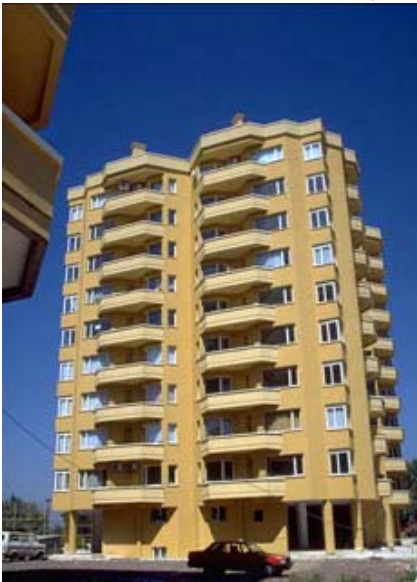
The reconnaissance team found evidence of both extremely good and extremely poor commercial construction. One example of excellent quality construction is the building of Figure 3-1 that was located in central Yalova. Residential construction quality also ranged from excellent to poor. Although construction work by registered contractors was generally of better quality than that by individuals and homeowners, the quality of contractor-completed construction was often poor by U.S.

Figure 3-1 High quality apartment construction, Yalova

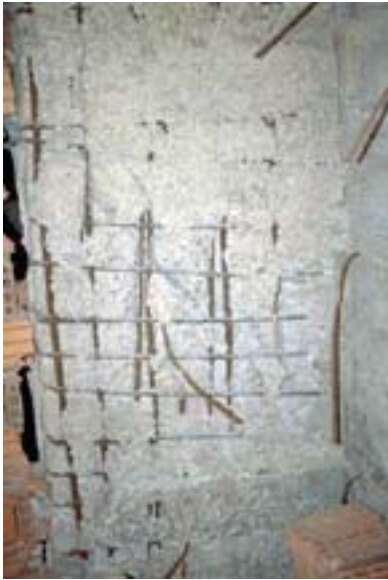
standards. Figure 3-2 shows a completed shear wall in a multistory apartment building in Yalova. The vertical and horizontal rebar in the shear wall can be seen on the exterior face of the wall. Although buildings in Yalova suffered damage in the earthquake, the apartment building was not damaged despite the poor quality of the concrete evident in the photograph.

Figure 3-2 Poor quality construction of a shear wall in an apartment building in Yalova

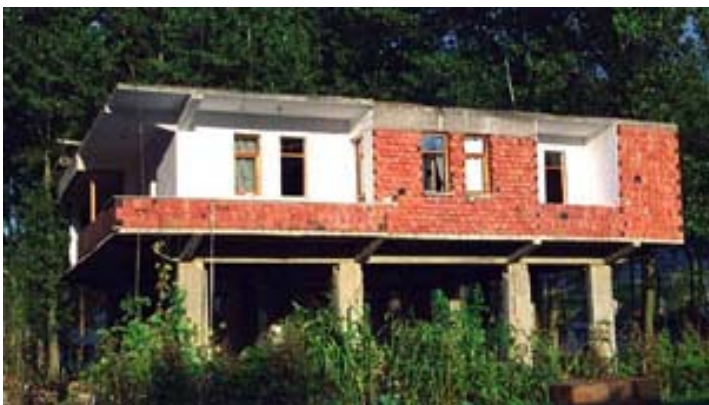
a. Two-story building

Residential buildings in the epicentral region typically range in height between two and seven stories. Sample two- and four-story buildings are shown in Figures 3-5a and 3-5b, respectively. Because federal agencies limit the building first-story footprint-to-plot ratio, cantilever construction in the form of beams or as masonry floor framing (see Section 3.3.2) is often employed at the second-floor level to maximize the gross floor area of the building. Cantilever construction can be seen in both buildings of Figure 3-5.

Figure 3-5 Typical framing systems in epicenter region

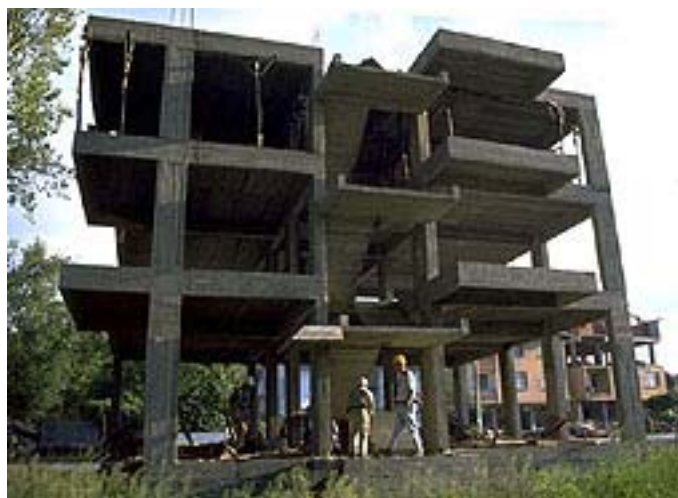
a. north-south elevation

Figure 3-6 Three-story moment-resisting frame east of Gölcük

Not all moment-frame buildings that straddled the line of rupture collapsed. The fault ran directly beneath the building shown in Figure 3-6, but this building suffered only modest damage despite approximately 1 m of horizontal offset beneath the foundation. The lack of damage can be attributed to the stiffness of the building's 1-m-deep raft foundation. Three hundred meters from the building of Figure 3-6, a moment-frame school building that straddled the fault collapsed completely (Figure 3-14). Figure 3-15 shows collapsed and damaged moment-frame buildings on the Gölcük naval base. The horizontal offset of the fault beneath these buildings was on the order of 4 m. Fault rupture beneath a five-story building (Figure 3-16) located approximately 200 m east of the naval base caused a partial collapse.

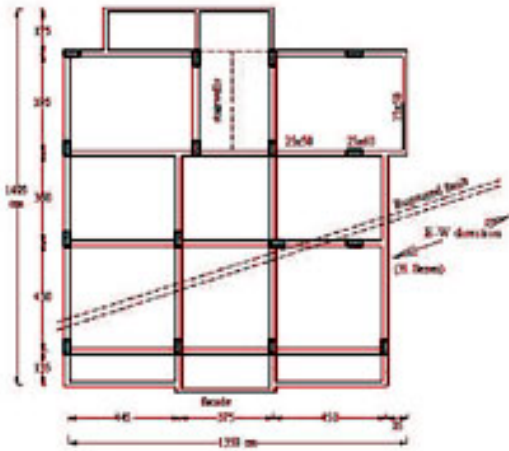
Figure 3-6 presents photographs of a three-story building that was under construction at the time of the earthquake. A plan of the second-floor framing is shown in Figure 3-7. The column and beam orientation shown in Figure 3-7 suggests that the framing system is much stiffer and stronger in the direction perpendicular to the street (parallel to the y -axis of Figure 3-7), assuming that similar rebar are used in all beams and columns in this building. The ratio of total column area to plan footprint in this building is 1.3%.

Figure 3-7 Floor plan for the three-story building shown in Figure 3-6

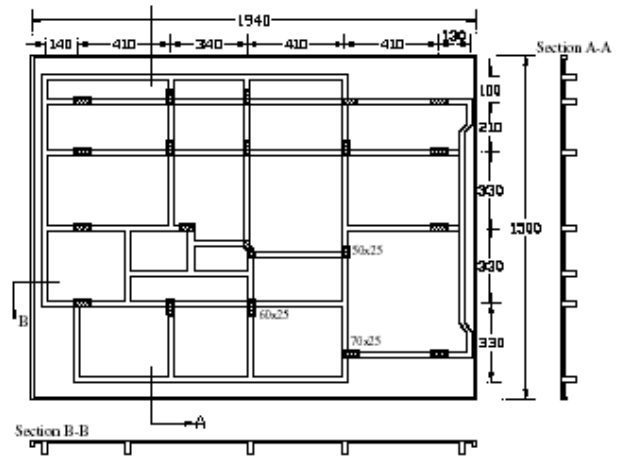
A plan of the roof framing of a five-story moment-resisting frame building is shown in Figure 3-8. The column orientations and locations are such that there are no moment-resisting frames of more than one bay in either direction of the building in the fifth story. Such framing likely possesses limited strength and stiffness that, if coupled with nonductile reinforcement details, results in a vulnerable building in the event of earthquake shaking.

Figure 3-8 Plan of roof framing for a five story apartment

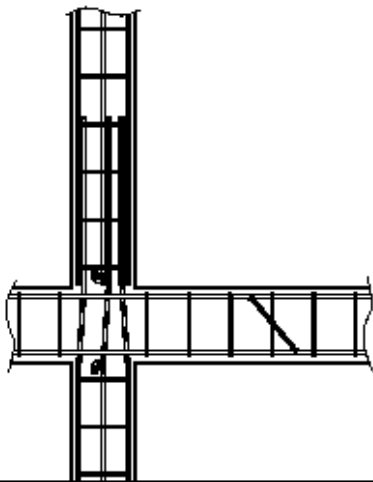
Figure 3-9 Typical modern beam and column rebar details

Information on column and beam rebar details is provided in Figure 3-9. Corner column rebar are spliced above the floor slab with lap lengths of 40 to 70 bar diameters. Side-face column rebar are either spliced per corner rebar or terminated above and below the joint with 180° hooks. No transverse reinforcement for the purpose of confinement is provided in the hinge, joint, or splice regions. Bent-up beam rebar is shown in the typical section.

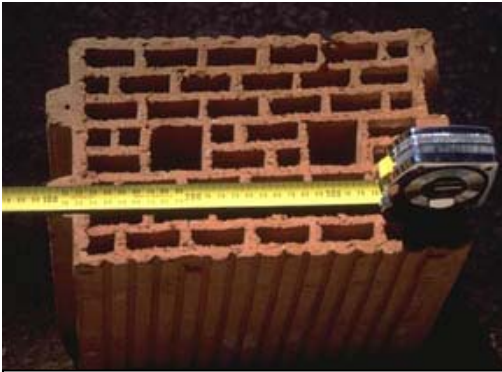
Figure 3-10 Hollow clay tile block used for infills

Interior and exterior infill walls are constructed of either *hollow clay tile* or lightweight gas-concrete blocks. The hollow clay tile block is more widely used than the gas-concrete block and is extremely brittle. The block infill is not reinforced nor is it anchored to the structural framing with masonry ties. Block infill walls are built in contact with the structural framing and add significant stiffness and strength to the framing system. Photographs of hollow clay tile block are shown in Figure 3-10.

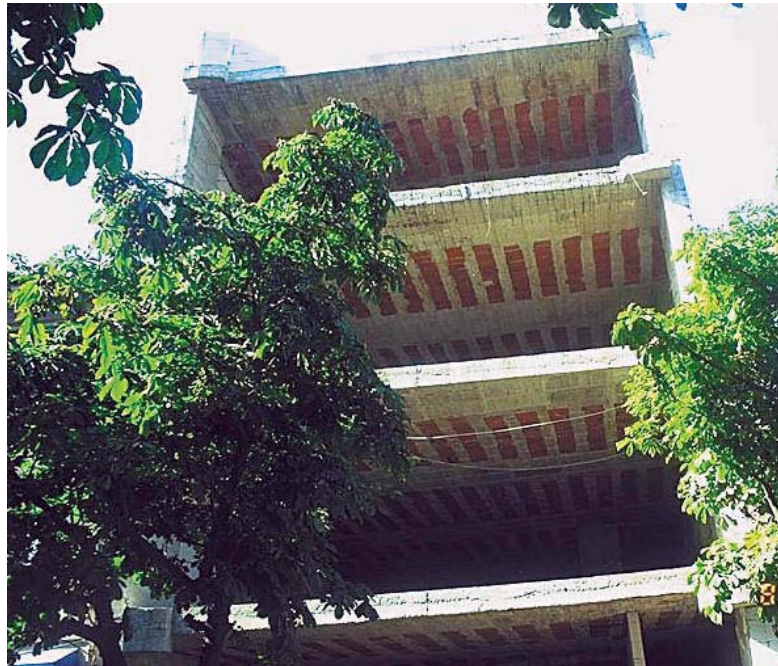
Figure 3-11 Asmolen floor system in a four-story building

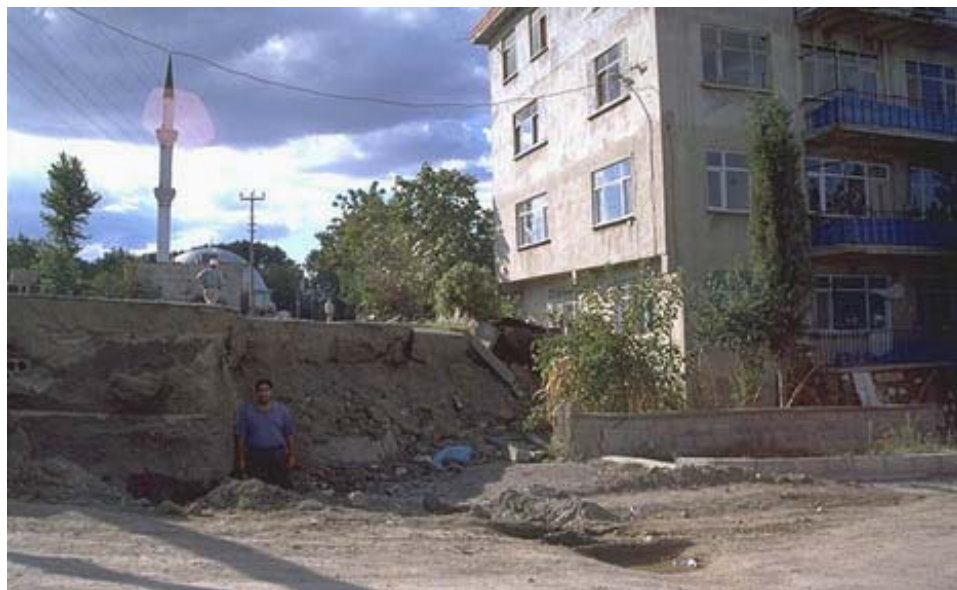
“Near-field” is the common term used to define the zone within 5 to 10 km of a major fault. Earthquake shaking in the near field is often severe, as illustrated by recorded ground motions obtained from the Northridge (1994) and Kobe (1995) earthquakes. Widespread collapse of older construction is to be expected in the near field due to the intensity of the earthquake shaking. Although many moment-frame buildings in the near field of the Izmit earthquake suffered gross damage or collapsed, some fared surprisingly well. Shown in Figure 3-17, the four-story moment-frame building is sited within 2 m of the line of rupture and yet suffered no visible damage despite 1.2 m of horizontal offset and 2.35 m of vertical offset on the fault. Figure 1-2 shows another view of the same building. The reasons for such good performance of this 10- to 30-year-old frame building with masonry infill are unknown.

Figure 3-17 Undamaged building located within 2 m of the line of rupture

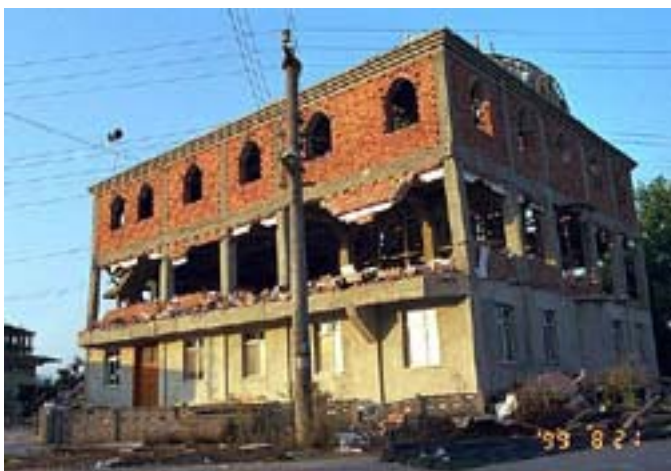
Column-infill masonry wall interaction resulted in severe damage to and failure of many moment-frame columns. Consider the building east of Gölcük that is shown in part in Figure 3-30. The infill hollow clay tile masonry on each side of the central column in this figure failed completely and the column hinged at each end. The column to the left of the central column was captured approximately 1 m above the floor by the residual hollow clay tile. The shear cracks that were observed in this captive column formed in the column at the top face of the remaining infill masonry.

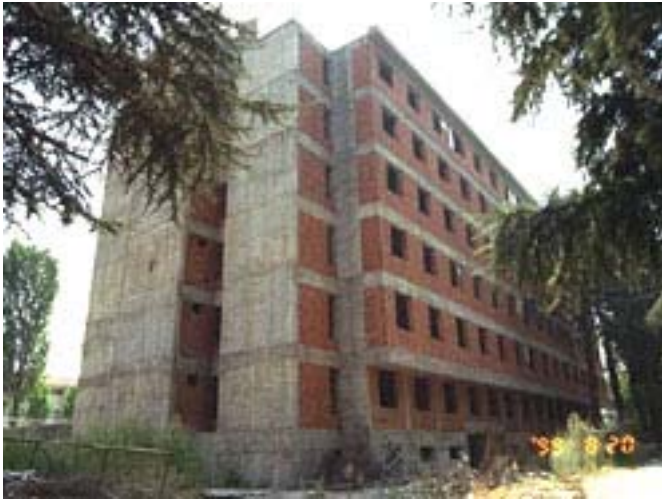
Outside Istanbul, few buildings in western Turkey are constructed with shear walls as the primary lateral load-resisting system. However, those wall buildings in the epicentral region, such as the building under construction in Figure 3-38 and the apartment buildings of Figure 3-39, performed well. Shear walls were used as the lateral load-resisting system in both the transverse and longitudinal directions of the building in Figure 3-38. This building suffered minor damage to the infill walls. The lateral force-resisting systems in the two apartment buildings shown in Figure 3-39 included moment-frames along the major axis of the buildings and shear walls along the minor axis. These buildings

Figure 3-38 Shear wall building under construction at the time of the earthquake

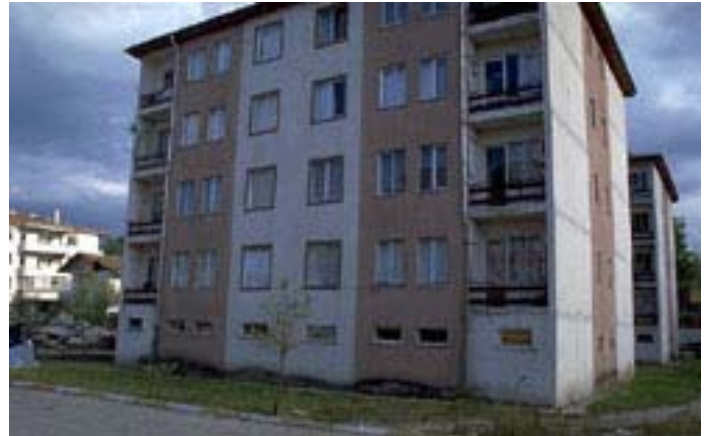
Figure 3-39 Undamaged apartment building in Gölcük

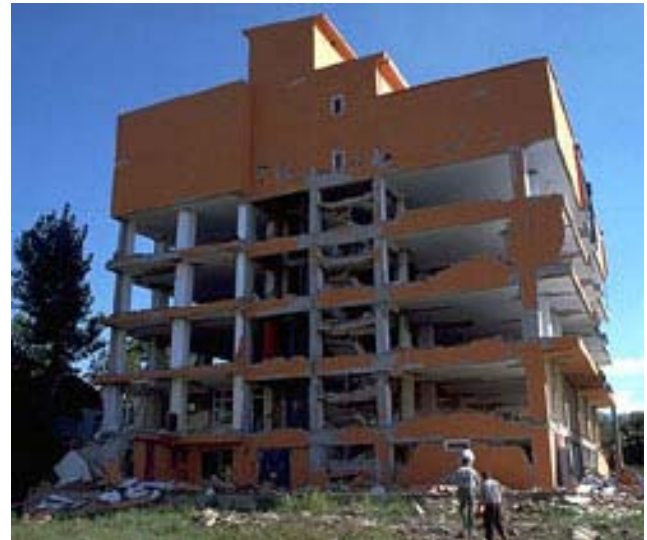
Figure 3-45 Rear elevation of Building A showing intact infill masonry walls

Building A, shown in Figures 3-44 and 3-45, was located at the eastern outskirts of Gölcük. Much of the first story of this moment-frame building (not seen in Figure 3-44) was located below grade. The grade level sloped down from the front to the back of the building. A sketch of the first-floor plan of the building is shown in Figure 3-46. Most of the hollow clay tile infill masonry failed during the earthquake but some remained intact at the rear of the building in the sixth story (see Figure 3-45).

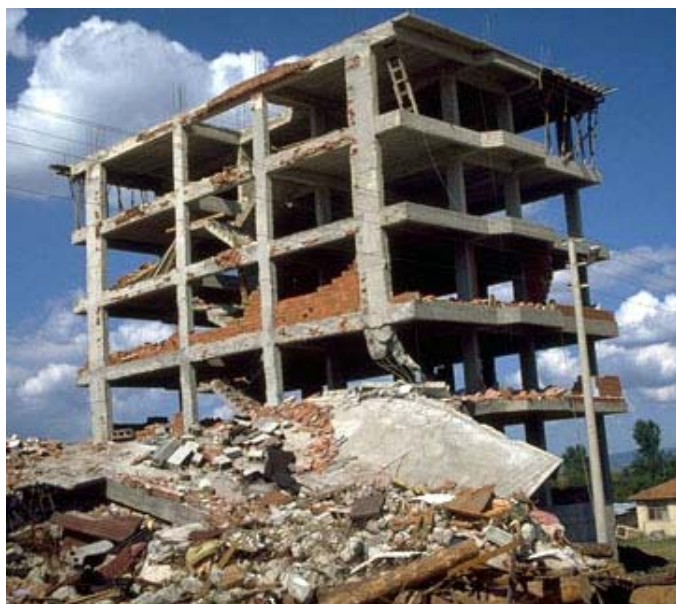
Building B (Figure 3-52) was located 5 km east of Gölcük. The six-story reinforced concrete frame building was unoccupied at the time of the earthquake. The footprint of the building was approximately 12 m by 16 m.

Figure 3-52 Elevation of Building B

A corner column in the third story of Building B failed during the earthquake, as seen in Figure 3-52. Part of the roof framing of the adjacent building can be seen immediately below the failed column, indicating that the third-story column failed due to the impact of the adjacent building. Figure 3-53 shows more details of the failed column and the roof slab of the adjacent building.

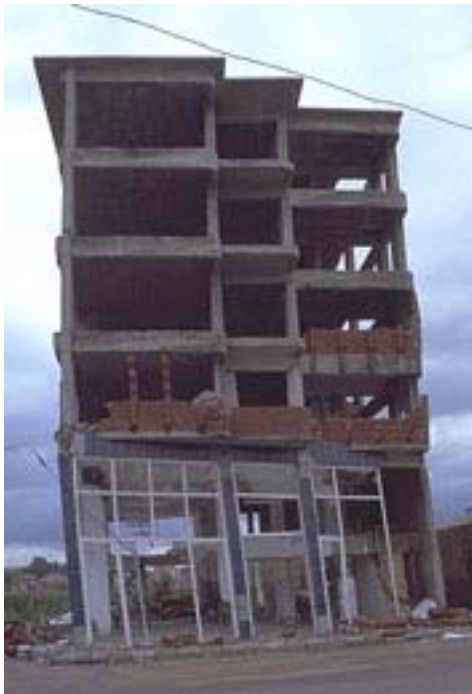
Building C, shown in Figure 3-54, was located near the Adapazari city center. The five-story reinforced concrete frame building included a high retail space in the first story. The retail space shown in Figure 3-55 included a mezzanine level on the west side of the building. The building was not occupied at the time of the earthquake.

Figure 3-54 Elevation of Building C

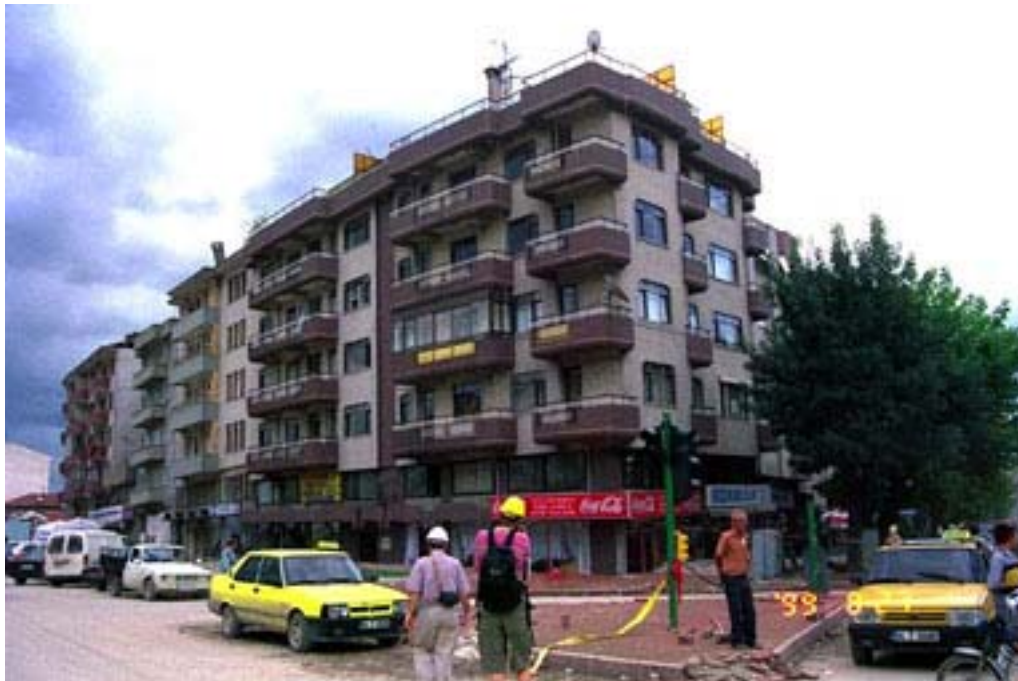
Building D was a six-story moment-frame building located in the center of Adapazari. An elevation of the building is shown in Figure 3-59. Based on similar construction of the same age in Adapazari, the foundation for Building D was probably a mat or raft with a thickness of approximately 1 m.

Figure 3-59 Elevation of Building D
