4 Industrial Facilities

4.1 Overview of Construction and Damage

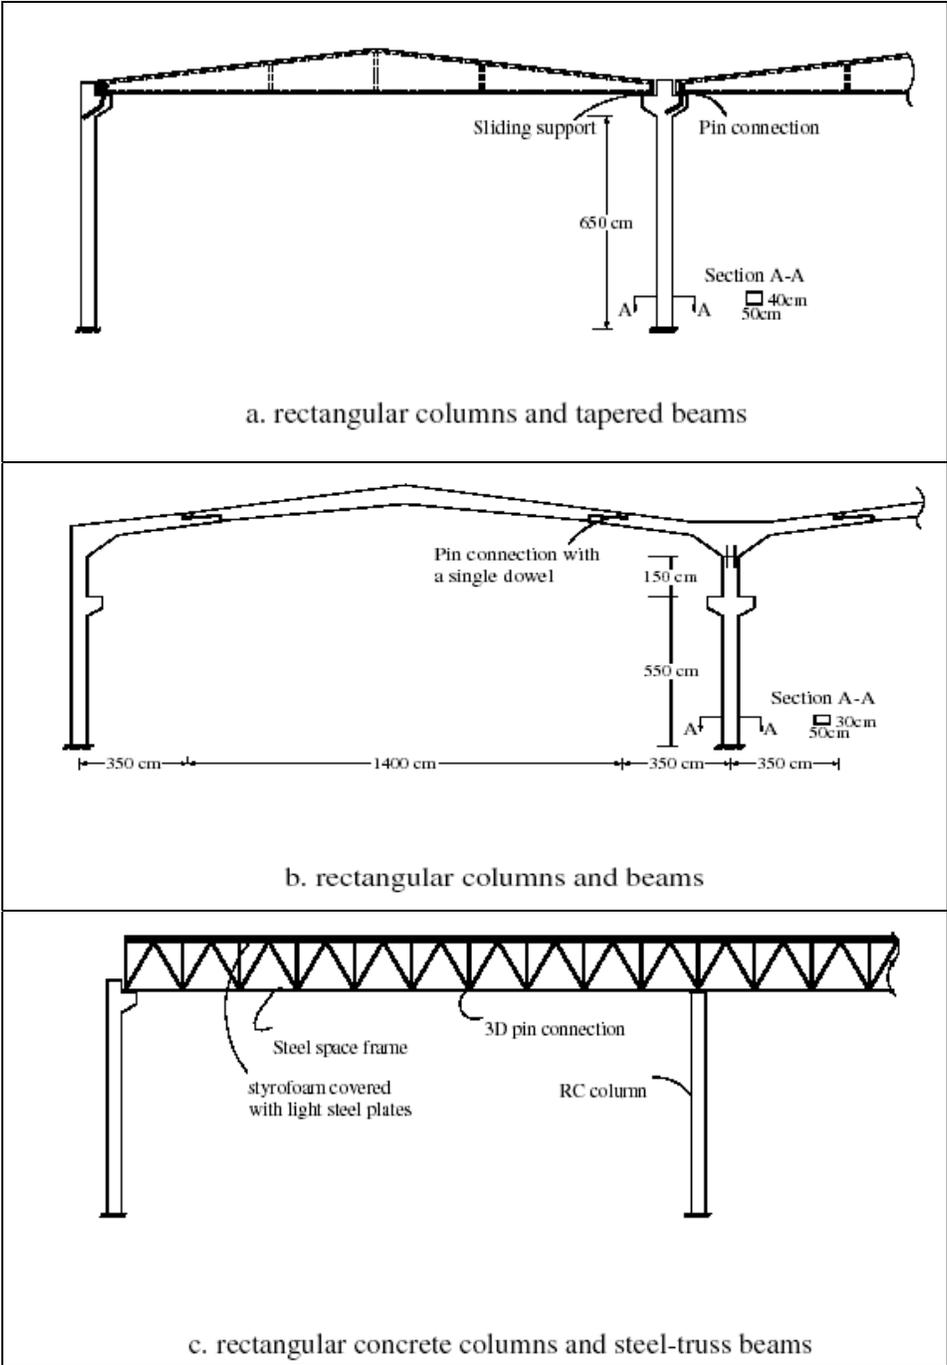
Figure 4-3 Prefabricated reinforced concrete construction

Three of the popular precast structural systems in Turkey are shown in Figure 4-3. The frame of Figure 4-3a is composed of individual columns and long-span rectangular or tapered beams, each

Another common prefabricated structural system in this part of Turkey is shown in Figure 4-3b. This system includes a precast T-shaped member at the top of the central column that serves to connect the column to simply supported roof beams. The connection of the T-shaped unit to the column is detailed to transfer moment and shear, but likely for gravity-load effects only. The lengths of the T-shaped unit and the simply supported roof beams are selected on the basis of gravity-load actions in a two-span continuous beam; namely, the doveled connections between the units are located at the points of contraflexure. Such an approach would minimize the volume of material in the roof beams for gravity-load effects only. Figure 4-6 shows damage to a steel pipe production facility, which was under construction at the time of the earthquake. The roof panels had not been installed, and as such there was no diaphragm at the roof level. The seismic load paths in this building, both parallel and perpendicular to the frames of Figure 4-3b, would have been questionable even if the roof panels had been installed. As is evident in the figure,

many of the columns acted as cantilevers and hinged at their bases during the earthquake. The precast T-units of Figure 4-3b rotated off the top of the two central columns in the middle of the photograph Figure 4-6 and are upside down. There was minimal reinforcement joining the T-shaped units to the columns below.

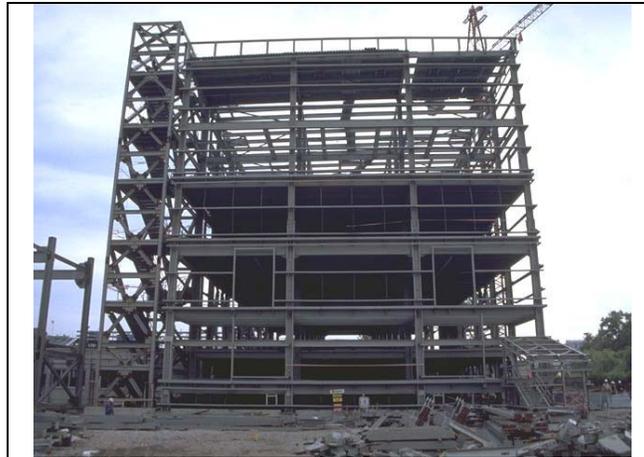
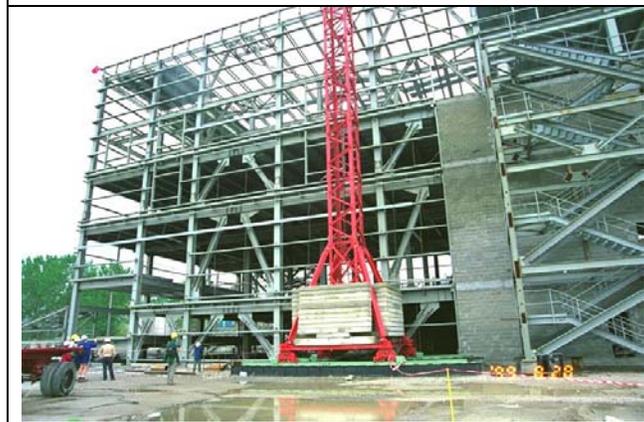
Figure 4-7 Five-story steel-framed industrial facility under construction

Braced and moment-resisting steel frames are used for some single-story and many multistory industrial facilities. One such facility, under construction at the time of the earthquake for DuSA, is shown in Figure 4-7. The framing system in this five-story building suffered no damage but much of the reactive weight in the form of the concrete-on-metal deck floors and masonry perimeter walls was not present at the time of the earthquake. The building was designed and detailed in the United States using U.S. standards for such facilities. The seismic moment-resisting frame in the elevation of (Figure 4-7a) used bolted end-plate connections. On the perpendicular elevation (Figure 4-7b), eccentrically braced steel frames were used to resist seismic loads. On this elevation, part of a three-story masonry wall peeled off the exterior steel framing and collapsed; the remaining part of the wall can be seen to the right of the crane base.

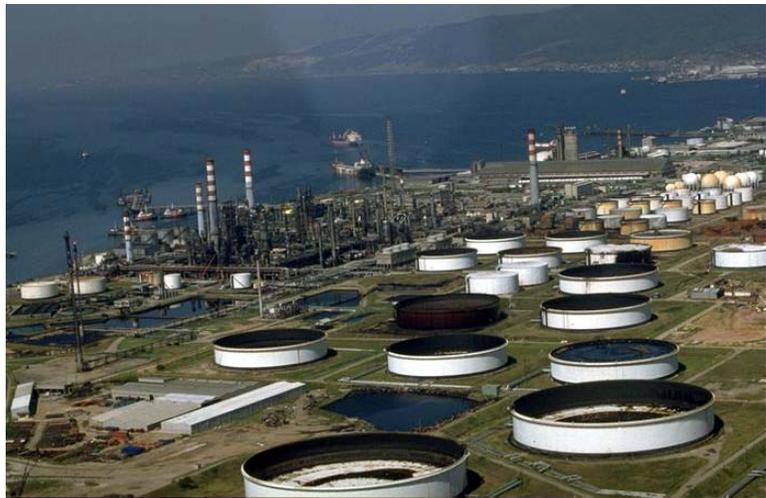
Figure 4-9. Tüpras refinery showing part of the tank farm

Figures 4-9, 4-10, and 4-11 are aerial photographs of the refinery taken by members of the reconnaissance team two weeks after the earthquake. Figure 4-9 shows the main processing facility and part of the tank farm (in the foreground). The jetty that serviced the refinery is not shown but is located at the left-hand edge of the figure. Another view of the main processing facility shows the failed heater stack (see the circled section in Figure 4-10). Some of the burned fuel-oil tanks can be seen in the upper right middle of the figure. The remains of the timber cooling tower that burned following the earthquake can be seen in the middle right of the photograph between the burned tanks and the northern perimeter of the main processing facility. Substantial pollution can be seen (Figures 4-9 and 4-10), which resulted from the failure and breaching of fuel-oil tanks, much of which was successfully contained by the earthen berms that surrounded the tanks. According to refinery staff, some oil spilled into Izmit Bay due to fractured pipes and from an oil tanker that pulled away from the loading jetty immediately following the earthquake.

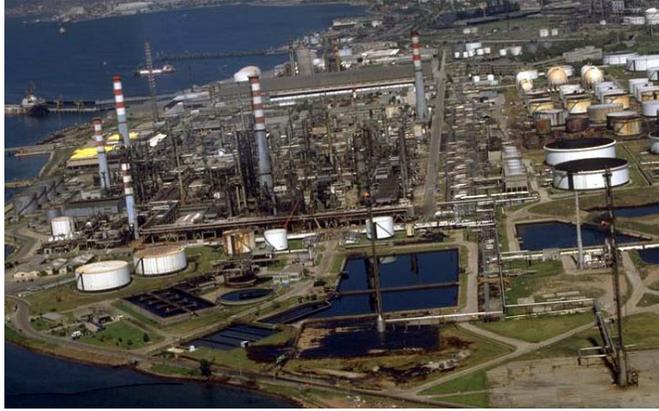
Figure 4-10. Tupras refinery

The damage to the Tüpras refinery was widespread and included port facilities, storage tanks, cooling towers, stacks, and crude-oil processing units. Much of the damage was fire related: an indirect consequence of the earthquake shaking. The fire-fighting capability of the refinery was lost immediately following the earthquake because of multiple ruptures of the water pipeline from Lake Sapanca, 45 km east of the refinery. (The refinery received all of its water from this lake.) In the days immediately following the earthquake, the resulting fires were contained by aerial bombardment with foam (Danis 1999). At the height of the conflagration, a 3-km region around the refinery was evacuated (Danis 1999). The fires were extinguished by water drawn from Izmit Bay by using portable diesel pumps and flexible hose that didn't arrive at the refinery until three days after the earthquake. Had this fire-fighting equipment been stockpiled at the refinery in advance of the earthquake, the fires that took five days to extinguish would have been put out much sooner. For information, the reconnaissance team visited the Tüpras refinery on September 1, 1999, two weeks after the earthquake and approximately ten days after the fires had been extinguished. (Valuable lessons for refineries on the West Coast of the U.S. can be learned from the problems encountered by the fire-fighting and emergency-response staff at the Tüpras refinery.)

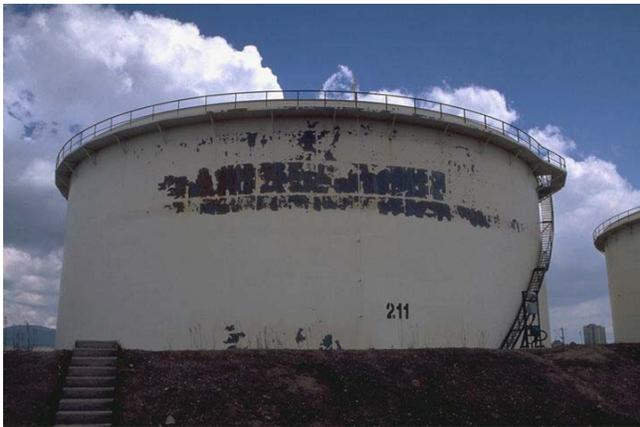
Figure 4-15. Tank 211 in the Tüpras refinery tank farm

Many of the 100+ tanks in the Tüpras refinery farm were constructed with floating roofs. Figures 4-15, and 4-17 are photographs of Tank 211, which is located immediately adjacent to many of the burned tanks (see Figure 4-18). Figure 4-17 is a photograph of the detail at the junction of the edge of the floating roof and perimeter wall, showing the perimeter seal. Sloshing of the fluid in the tank likely damaged the perimeter seal, which permitted the fluid to escape from the containment. Such observations have been made in other earthquakes (ASCE 1997). Oil evident on the top of the floating roof (Figure 4-17) spread over much of the roof. Danis (1999) reported substantial damage to a large number of tanks (30+) in the farm; the inability of perimeter seals to retain the sloshing fluid in the tanks resulted in failure or sinking of these floating roofs. Each of these damaged floating roofs required repair or replacement before the tanks could be returned to service. Repair of the damaged or sunken roofs would have involved draining the tanks, decontamination of the roof, and replacement of the perimeter seals.

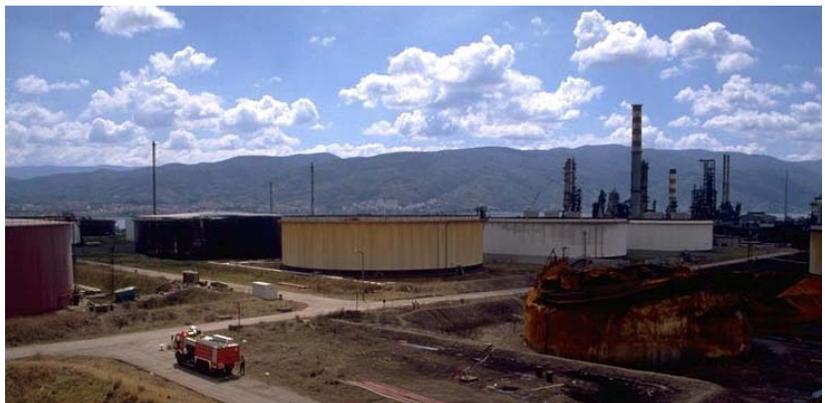
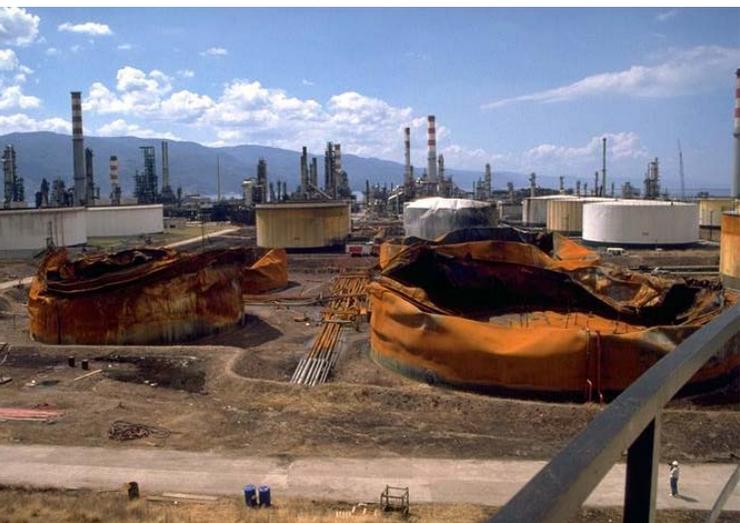
Figure 4-21. Photograph from top of Tank 211 facing south

Figure 4-22. Photograph from top of Tank 211 looking approximately south

Considered write-offs by the management (Danis 1999), approximately 20 tanks in the Tüpras refinery farm were damaged or destroyed by fire. Figures 4-21 and 4-22 are overlapping left-to-right photographs of burned tanks taken from the top of Tank 211 looking south toward the main processing facility. For reference, the mountains in the background of these photographs are located on the other side of Izmit Bay, to the south of the cities of Gölcük and Degirmendere. An overtopped tank can be seen to the left of the middle of Figure 4-21. Figures 4-23 and 4-24 are photographs of two tanks destroyed by fire. The tank in Figure 4-23 is located in tank burn zone 1 of Figure 4-18. The tank of Figure 4-24 is located in tank burn zone 2 of Figure 4-18. Twisted wreckage of the walls, walkways, and floating roof of the tank in Figure 4-24 can be seen in Figure 4-25. Figure 4-26 is a photograph of one tank, located immediately adjacent the burned tank of Figure 4-25 and linked to this tank by hard piping. Gross expansion of this fixed roof tank due to intense heating from the burning tank is evident. This tank can be seen to the right of the middle of Figure 4-22.

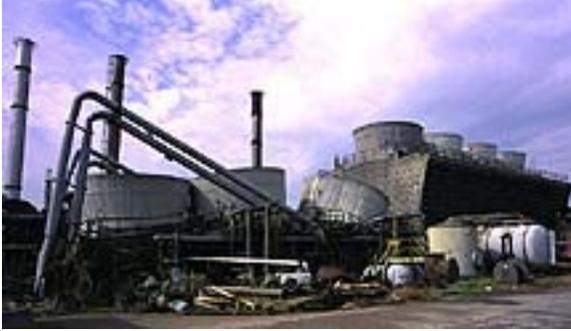
Figure 4-31. Collapsed wooden cooling tower at the Petkim petrochemical facility

Parts of the Petkim facility were severely damaged. Maximum accelerations of approximately 0.32g were recorded at the YPT station (see Chapter 1), which was located within 200 m of the collapsed three-cell tower. Figure 4-31 shows the complete collapse of an older three-cell wooden cooling tower; but a four-cell tower adjacent to the collapsed tower suffered no damage. A reinforced concrete cooling tower approximately 400 m from the YPT station was badly damaged. Nonductile reinforced concrete columns at the perimeter of the cooling tower and atop a continuous reinforced concrete perimeter were severely damaged at the bases (Figure 4-32). Figure 4-33 shows typical damage and rebar details at the base of one column. The column in this figure was constructed with round longitudinal rebar. The transverse ties were widely spaced and 90° hooks were employed. It is evident in the figure that the transverse ties failed leading to dilation and failure of the core concrete in the *hinge* zone.

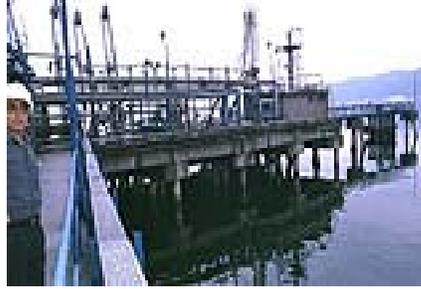
Figure 4-34. Loading and unloading facility, Petkim petrochemical plant

The Petkim petrochemical plant, similar to the Tüpras refinery, had a dedicated port facility through which much of the plant's raw material and processed product passed. Ground failure was observed near the jetty entrance. This port, like the port that serviced the Tüpras refinery, was badly damaged by the earthquake and was not operational afterward. Many of the battered piles beneath the jetty (Figure 4-34) were badly damaged. Typical damage to these battered piles is shown in Figure 4-35.

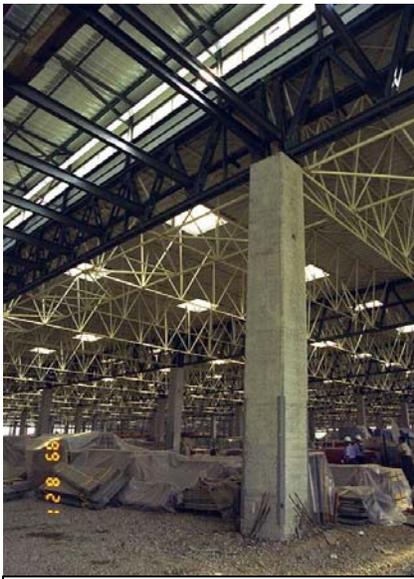
The body-shop building of a new Ford plant near Gölcük was under construction at the time of the earthquake. The single-story building was composed of 6-m-tall square reinforced concrete columns supporting one-way steel trusses and a lightweight space frame spanning between the trusses. The roof and walls were constructed of lightweight steel panels. Figure 4-36 is a photograph of the interior of the new body shop.

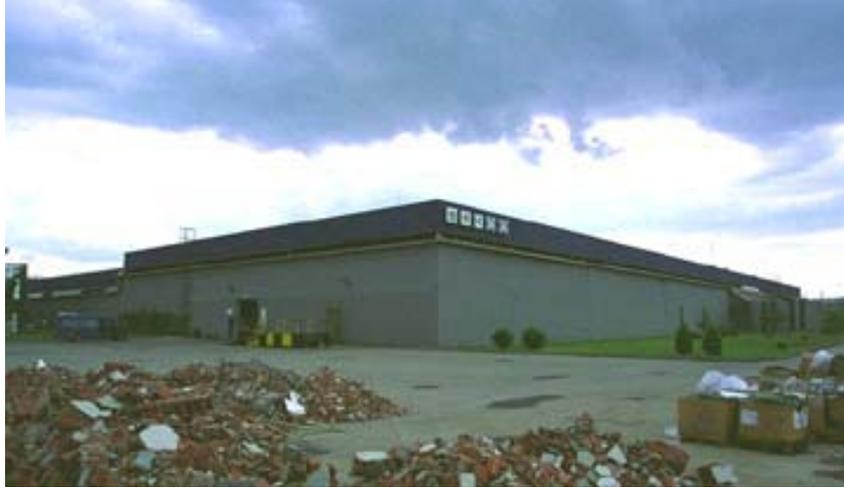
Figure 4-39. BekSA plant

BekSA was established in 1987 and is apparently the largest independent steel wire manufacturer in the world. (The steel wire or cord is a key component in tires, bead wire, hose wire and spring wire.) The 57,000 m² BekSA plant (Figure 4-39) was partially operational ten days after the earthquake. The plant and the office buildings (to the left of the plant building in the photograph) were constructed of reinforced concrete. The main plant building suffered no apparent structural damage, but some nonstructural damage occurred including breakage of the windows at the top of the perimeter infill walls and cracking of infill masonry walls. One of the reinforced concrete framed office buildings collapsed completely. Many of the nonductile reinforced concrete columns in the main office building failed in shear but did not lose their ability to carry modest gravity loads.

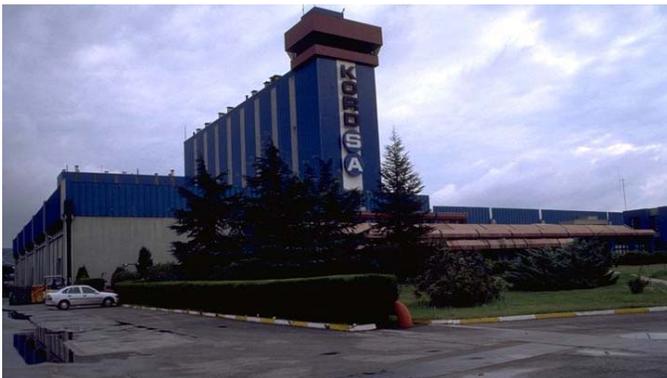
KordSA is a large producer of tire-cord fabric and industrial fabric. KordSA representatives reported that the plant was 50% operational one week after the earthquake. The main plant building (Figure 4-41) was constructed in 1973 with braced steel framing in the tower and precast reinforced concrete framed construction elsewhere. Only minor structural damage was observed in the tower, with buckled steel braces and damaged bolted connections. (No photographs were permitted by KordSA inside the main plant building.) The precast reinforced concrete framing in the main plant building suffered little-to-no structural damage (Figure 4-42). Some of the parapets atop the precast framing collapsed, as can be seen in the photograph. Only modest nonstructural damage was observed in the interior areas visited by the reconnaissance team.

Figure 4-41. KordSA main building showing steel braced-framed tower

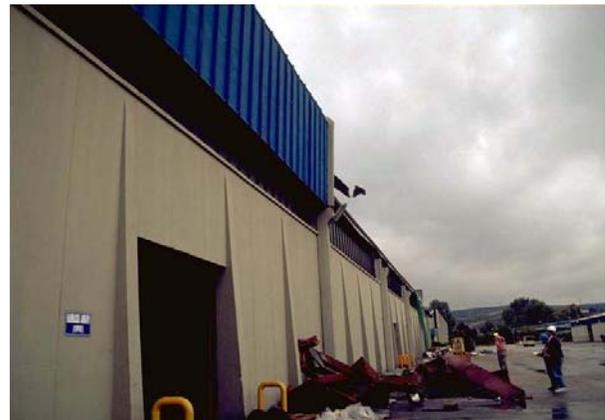
Figure 4-42. Perimeter of precast reinforced concrete framed KordSA main plant building

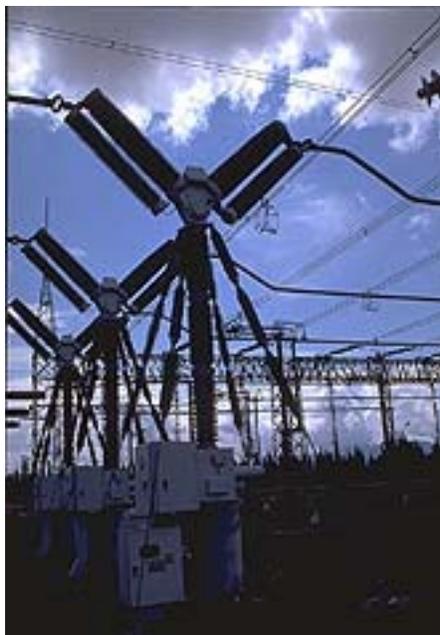
V-headed gas circuit breakers from a number of manufacturers were in service at the time of the earthquake. Many of the cantilever ABB circuit breakers failed during the earthquake. None of the braced Hitachi circuit breakers of Figure 4-52 were damaged.

Figure 4-52. Braced Hitachi gas circuit breaker, Adapazari substation

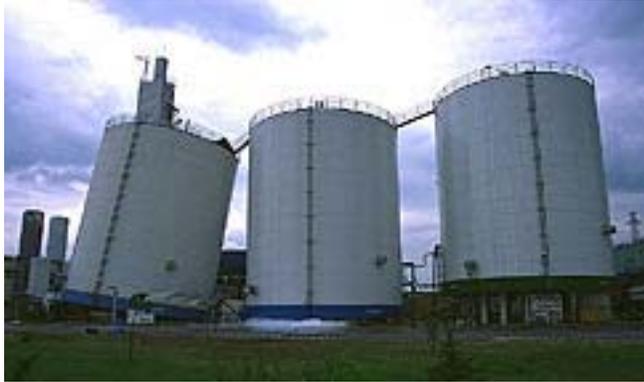
Figure 4-55. Liquid gas plants at the Habas plant

The Habas plant in Izmit provides liquefied gases to commercial plants and medical facilities in the Izmit and surrounding regions. The major damage at Habas was the collapse of two of the three liquid gas storage tanks shown in Figure 4-55.

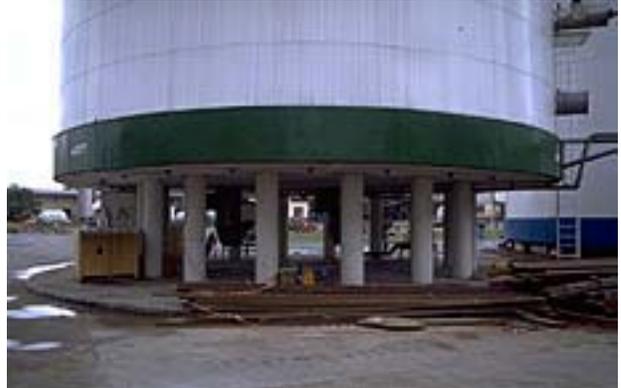
Three identical 14.63-m-diameter tanks were built in 1995. Each tank consisted of two concentric stainless steel shells, one with an outside diameter of 14.63 m and the other with an outside diameter of 12.80 m. Figure 4-56 is a photograph of the undamaged tank. The gap between the shells is filled with insulation. Both shells were supported on a 14.63-m-diameter, 1.07-m-thick reinforced concrete slab that was in turn supported by sixteen 200-mm-diameter reinforced concrete columns. Each column was 2.54 m in height and reinforced with 16 No. 16-mm-diameter longitudinal bars and 8-mm-diameter ties at 100 mm on center.

Figure 4-56. View of Reinforced concrete framing at base of undamaged tank, Habas plant

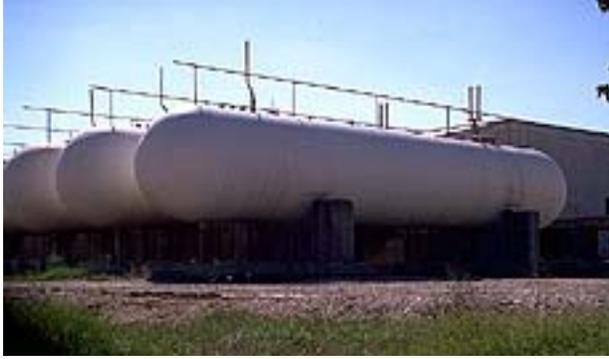
Cylindrical (bullet) liquid gas tanks of the type shown in Figure 4-63 were common in the Körfez industrial parks. Most of the tanks of this type were not anchored and had hard pipe connections of the type seen in Figure 4-63b. These connections are most susceptible to damage due to movement and rotation of the tank with respect to the supporting saddle. Movement and rotation of the tank with respect to the pedestal are clearly evident in Figure 4-63b.

Figure 4-63a. Typical support arrangement for cylindrical liquid gas tanks
