## **CHAPTER 4**

# **INDUSTRIAL DAMAGE AND LOSSES OBSERVED IN PAST EARTHQUAKES IN TURKEY**

## **4. INDUSTRIAL DAMAGE OBSERVED IN PAST EARTHQUAKES**

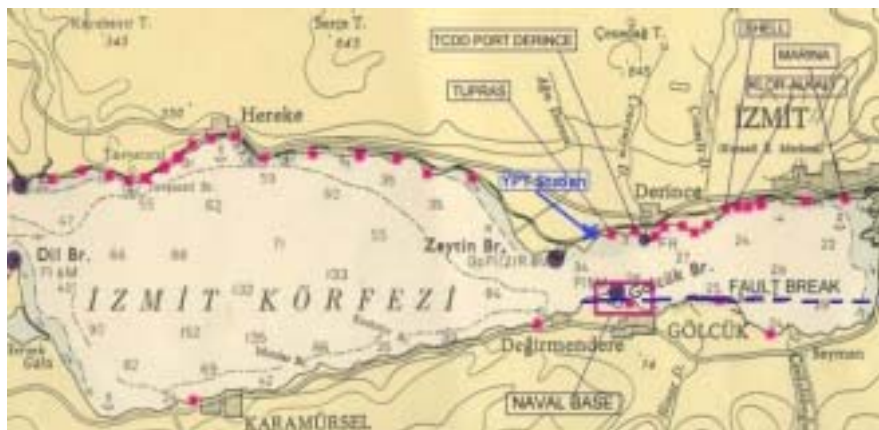
Figure 4.19. Location of affected ports and jetties in Izmit Gulf in the the Kocaeli Earthquake

Most of the ports and jetties of industrial facilities along the northern shores of the Izmit Bay sustained damage ranging from minor to extensive. Damage included failure of piers, mechanical equipment, piping and the collapse of cranes. Location of damaged ports and jetties are indicated in Figure 4.19.

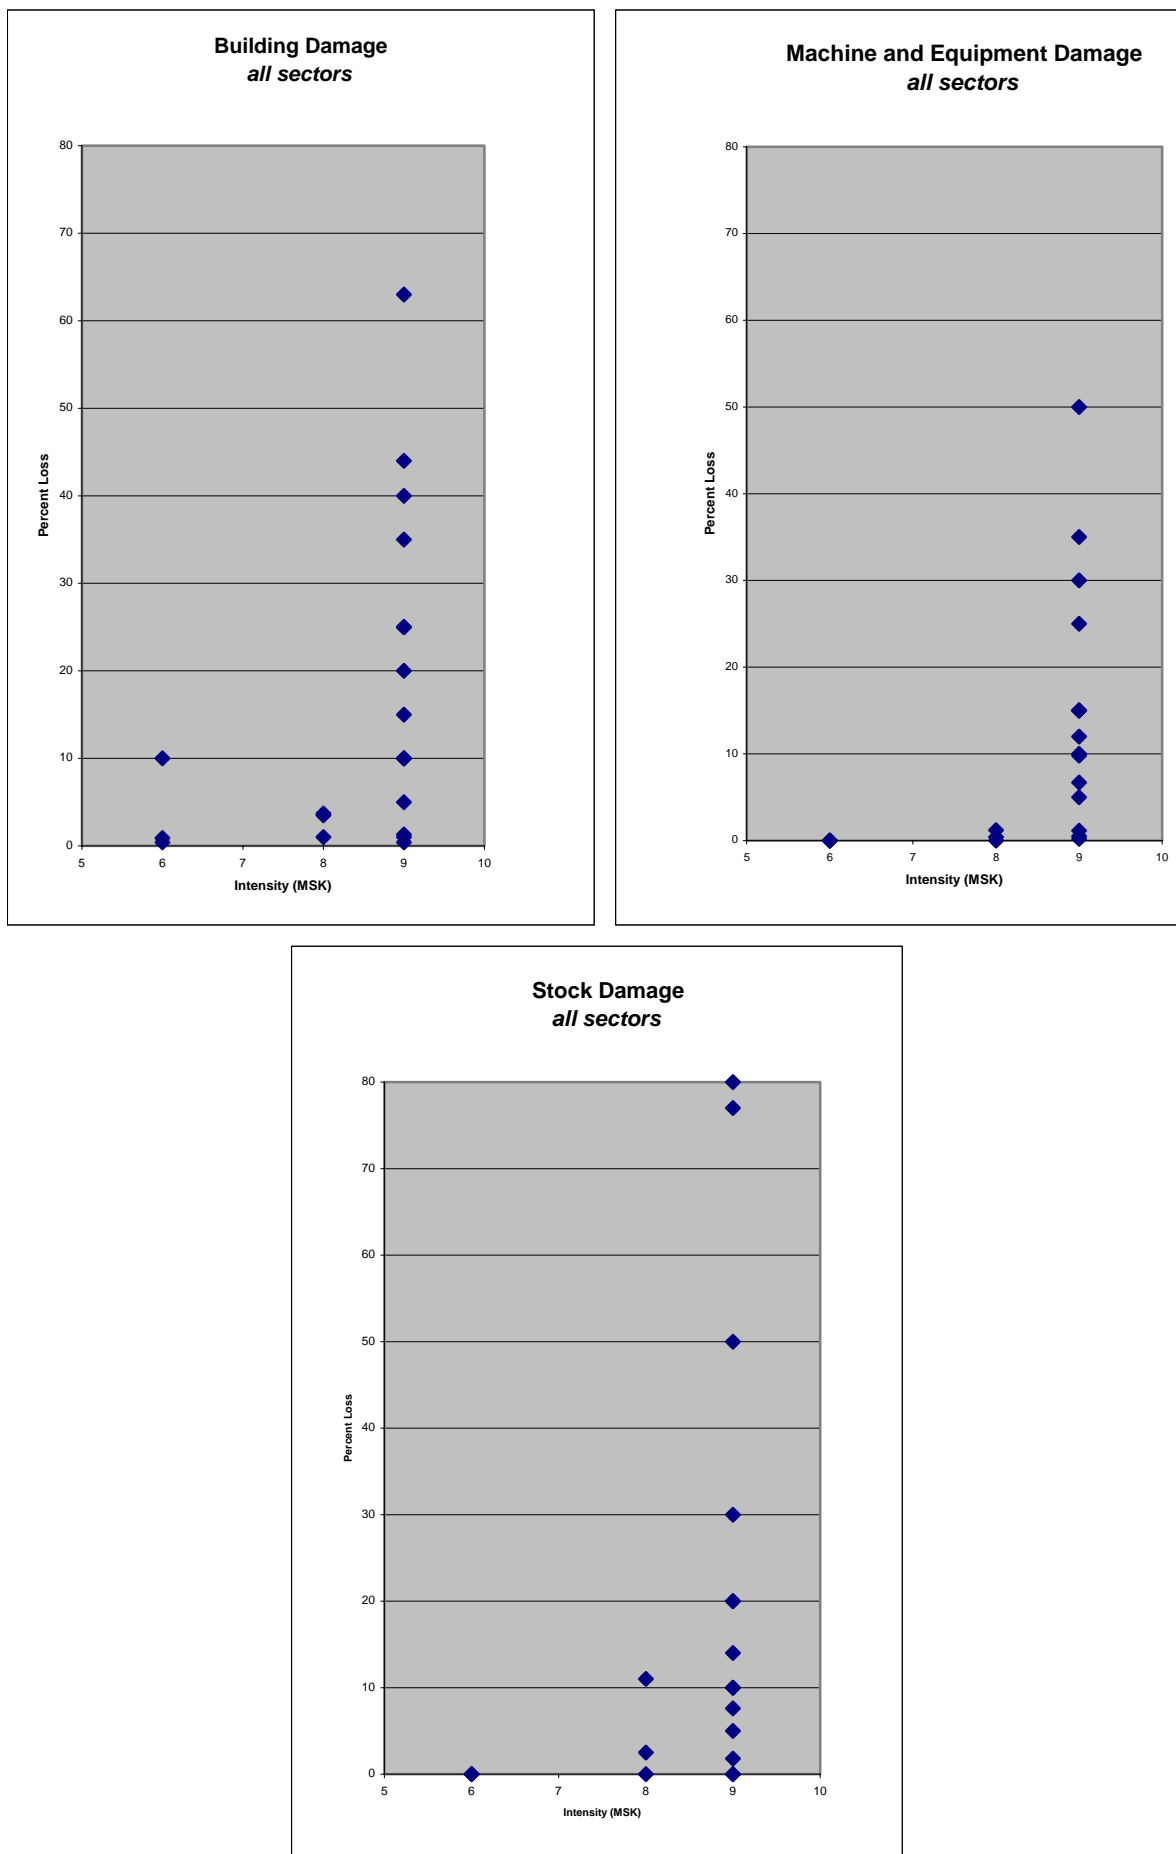
Figure 4.38. Percent losses to industrial facilities during the 1999 Kocaeli earthquake; building, machine & equipment, stock.

The percent losses sustained by facilities regardless of industrial sector can be seen in Figure 4.38 against intensity. In the figure we have also used the data provided by Moat et al (2000) on percent losses for a series of industrial facilities. Losses to buildings, machine and equipment and stock as a percentage of their total replacement value are provided in Figure 4.38. The majority of information available is from intensity zone IX. The sectoral breakdown of losses for intensity zone IX is presented in Figure 4.39.

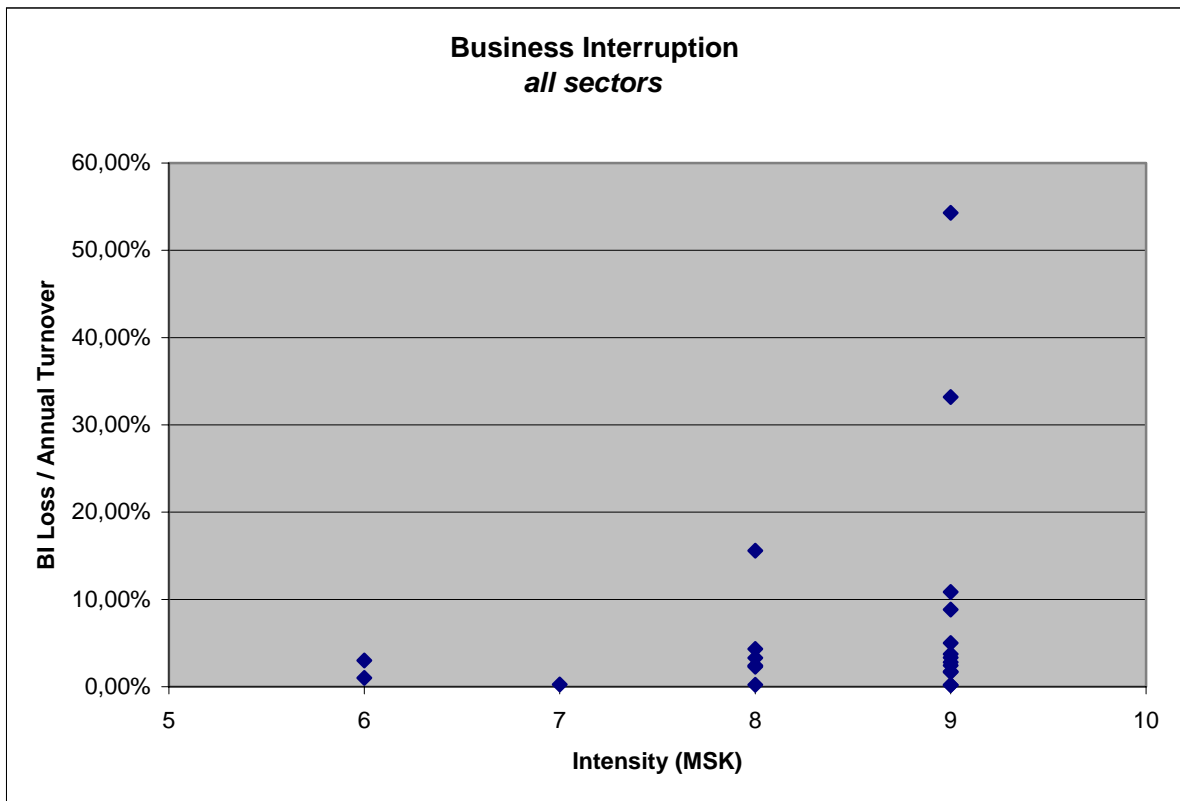
Figure 4.40. Business interruption losses in terms of BI Loss / Annual Turnover, all sectors

Business interruption losses as a percentage of the annual turnover are summarized in Figure 4.40 against intensity regardless of the sector. Time required for an industrial facility to return back to normal operation can be seen in Figure 4.41 with respect to intensity.

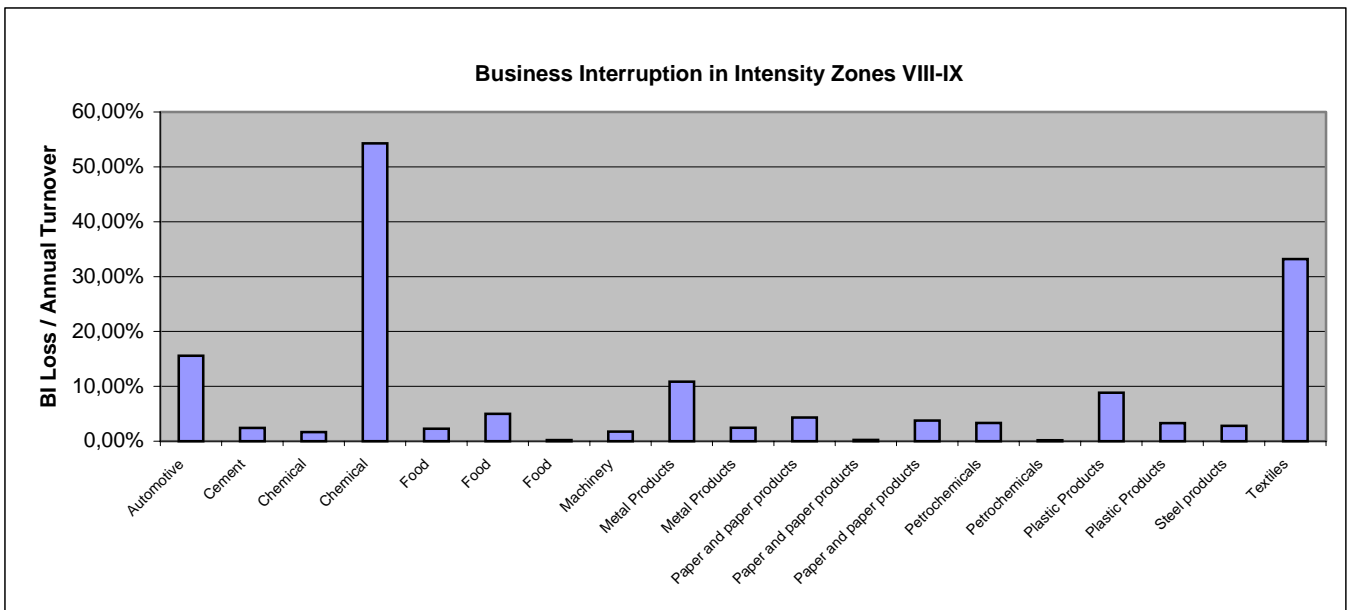
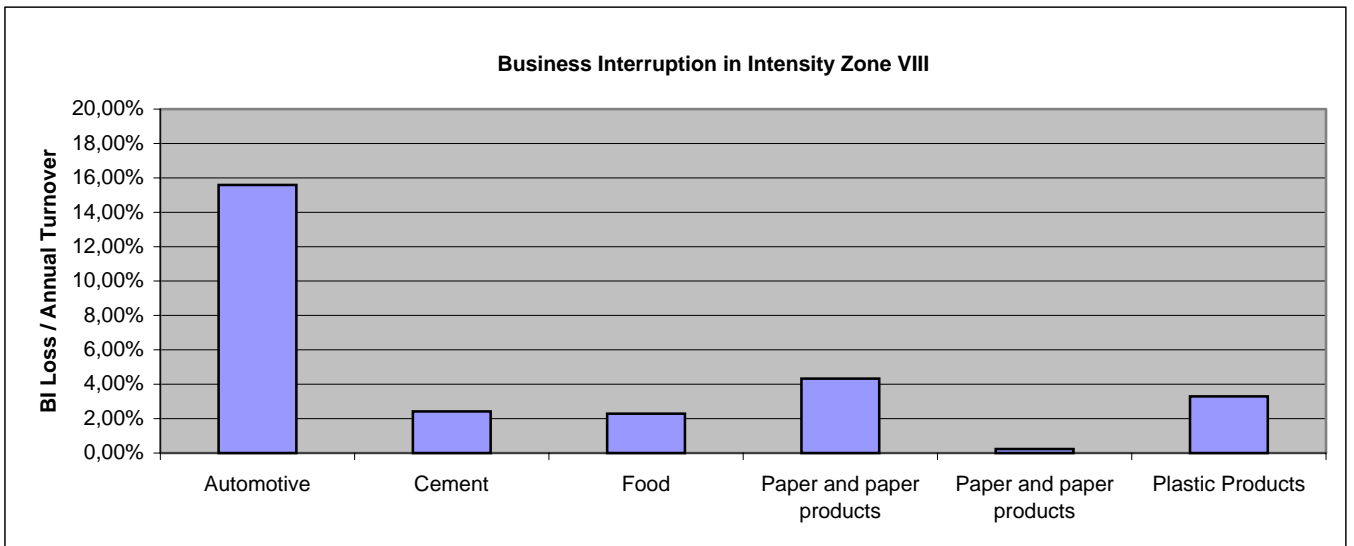
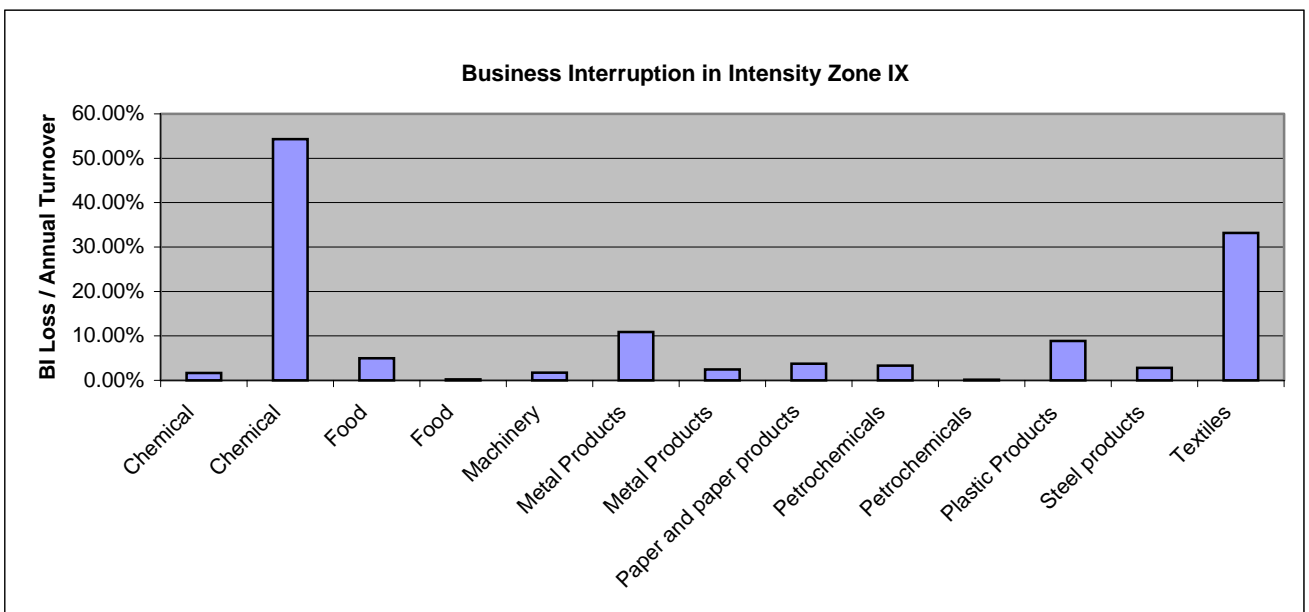
Figure 4.42. Business interruption losses on a sectoral basis for intensity zone VIII-IX (top), VIII (middle) and IX (bottom)

Losses due to business interruption for intensity zones for all intensity zones, that is VIII and IX, are shown in Figure 4.42, along with business losses in zone VIII only and zone IX only displayed separately. Time to normal operation is displayed in Figure 4.43 for facilities in intensity zones VIII, IX and X. The same information is given in Figure 4.44 for zone VIII and IX in two separate subfigures.
