Learning from Earthquakes

The Izmit (Kocaeli), Turkey Earthquake of August 17, 1999

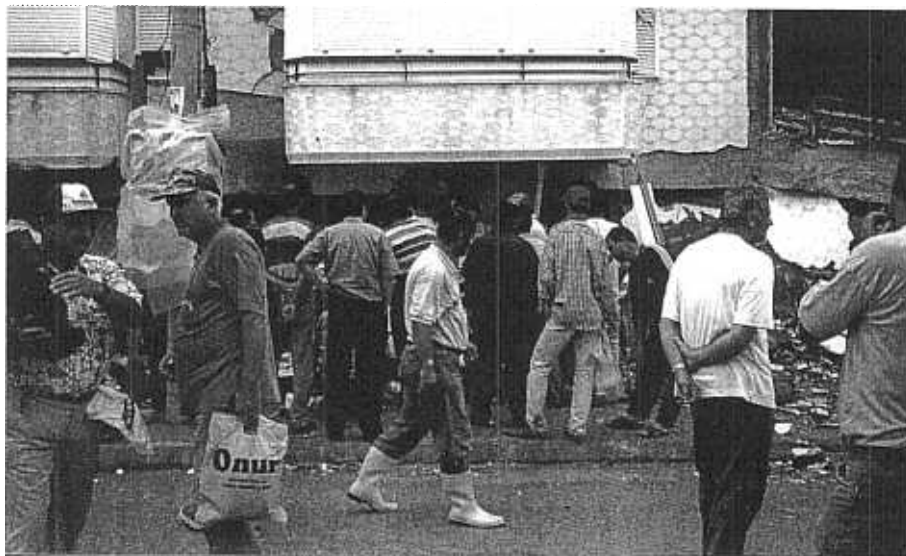
Figure 18 - Search and rescue continues on Day 8 in Yalova. (Photo: W. Mitchell)

Search and Rescue (SAR): Initial search and rescue was strongly criticized as slow and unorganized. This appeared to be the result of loss of communications, lack of command and control, shortage of equipment and materials, and an absence of disaster response training. Much of the initial response was by survivors. International search and rescue teams began arriving within 24 hours, and 65 foreign SAR teams saved 621 lives in intensive efforts that continued for four or five days following the earthquake. Initially there was friction between SAR teams and heavy equipment operators attempting to aid in the search. SAR workers were concerned that additional injuries would be caused by heavy equipment, but later realized the enormity of the task and accepted the method. Not until three days after the event did 50,000 soldiers arrive to assist in SAR and debris clearance.

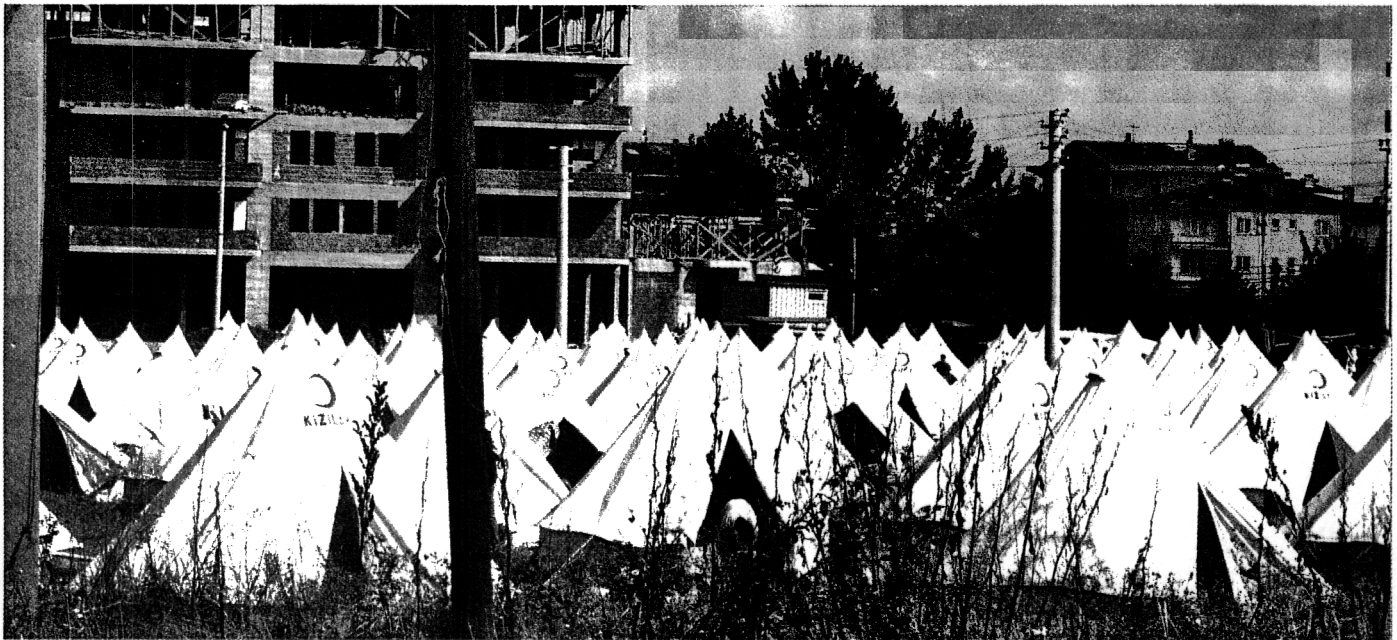
Figure 19 - Red Crescent temporary shelters at Degirmendere.
