Fire of Petroleum Tank, etc. by Niigata Earthquake

June 16th, 1964, Niigata, Niigata pref.

AKATSUKA, Hirotaka (High Pressure Gas Safety Institute of Japan)

KOBAYASHI, Hideo (Tokyo Institute of Technology)

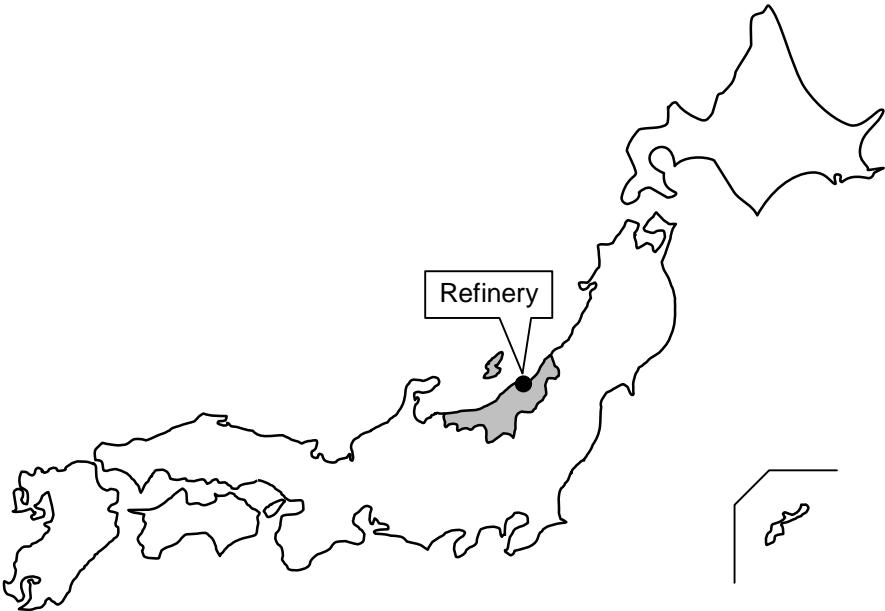
Fig. 1 Site of refinery.

Each tank in the refinery was shaken by the earthquake in the north and south direction, coinciding with the direction to the seismic center (Figures 1 and 2). The floating roofs of five crude oil storage tanks shocked, and shaking motion of one of them was complicated by its inclination to the west, which was caused by subsidence of the ground that was associated with the soil liquefaction phenomenon. "Sloshing" is defined as the phenomenon of vibration induced on the free surface of a liquid contained in a vessel by the shaking of the vessel itself (Figure 3). In the sloshing of large vessels such as petroleum tanks, the force of impact to the top and the negative pressure to the side wall are serious problems. As a result of the shaking of the floating roof, the crude oil flowed out of the top of the tank, fell down along the side wall, and was ignited by the sparks generated by the collision between the floating roof and the side wall. The crude oil storage tank yard was located adjacent to the main plant area. That is, the tank was within 40m of the plant area, and 48m away from the nearest equipment. A part of the crude oil flowed into the main plant
