**The Mudurnu Valley
(West Anatolia)
Earthquake**

of 22 July 1967

by N. N. Ambraseys
A. Zátpek
M. Taşdemiroğlu
A. Aytun

Serial No. 622/BMS.RD/AVS
Paris, June 1968

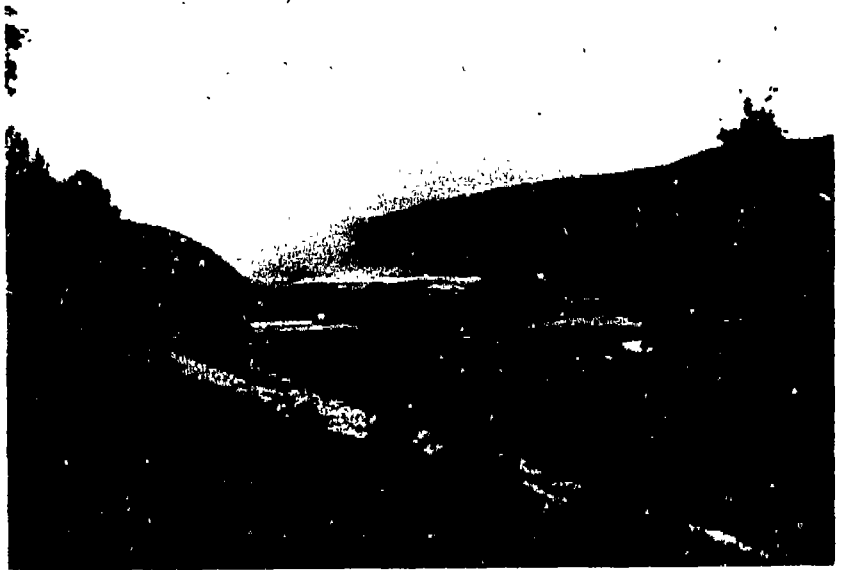
4

4. General view of fault zone from point 46,
looking west.

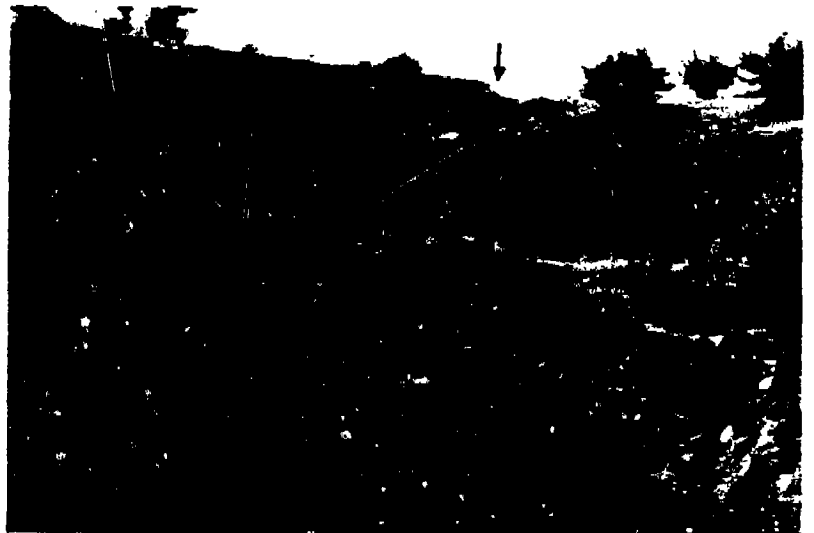
22

22. Fault trace and graben near point 68.

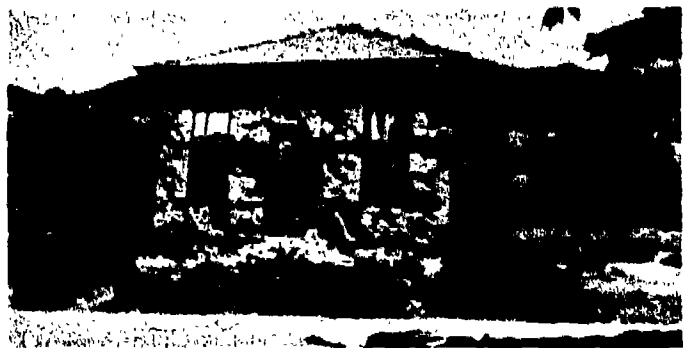
29

29. Small graben near point 4, looking east. Point A shows location of old fault scarp.

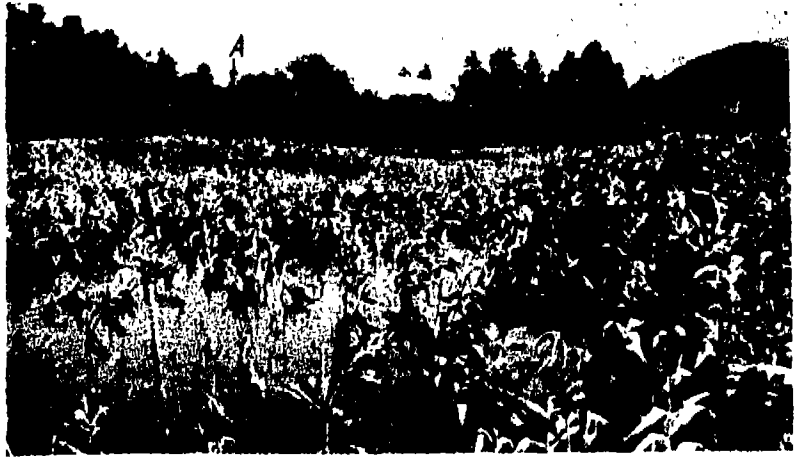
30

30. Strike slip of 145 centimetres near point 01, shown by thick root pulled apart. Matching markers show tips of broken root; axes of markers point north.

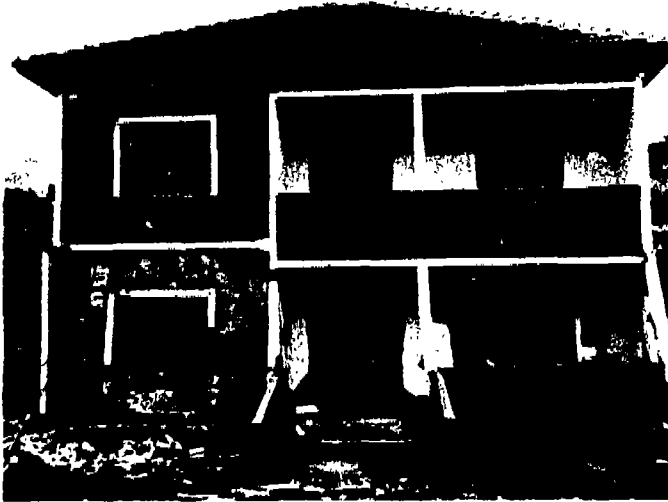
32

32. House straddling a branch of the main rupture 80 metres north of fence shown in Figure 31, looking south.

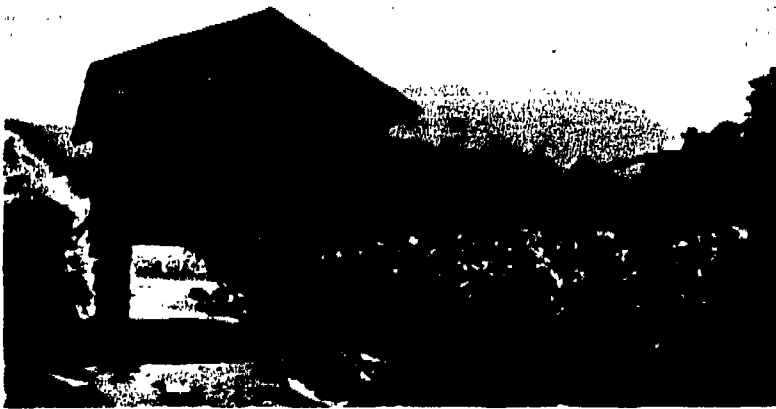
47

47. Elevated barn 40 metres from main fracture. In the background, water-mill offset 100 centimetres by main fracture; point 19.

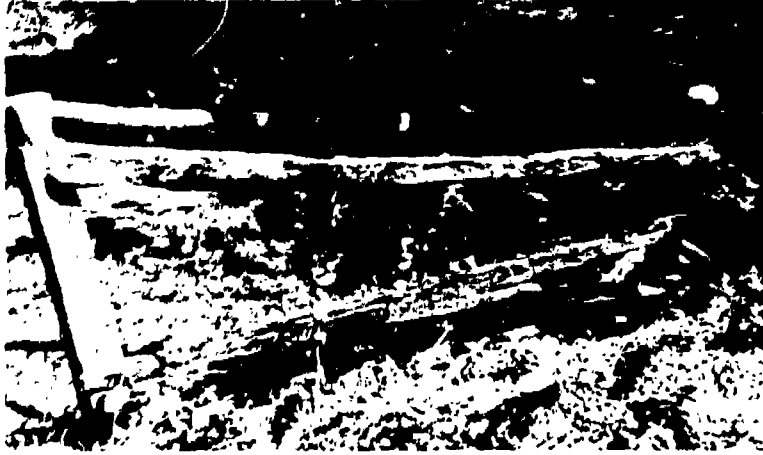
62

62. Deformation of fence straddling fault trace near point 56.
63. Arrow shows eroded scarp, reportedly associated with 1957 earthquake. Smaller arrows show fresh ground rupture near locality 33.
64. Panoramic view towards point 34 taken from point 36. Arrows shown main ground ruptures.

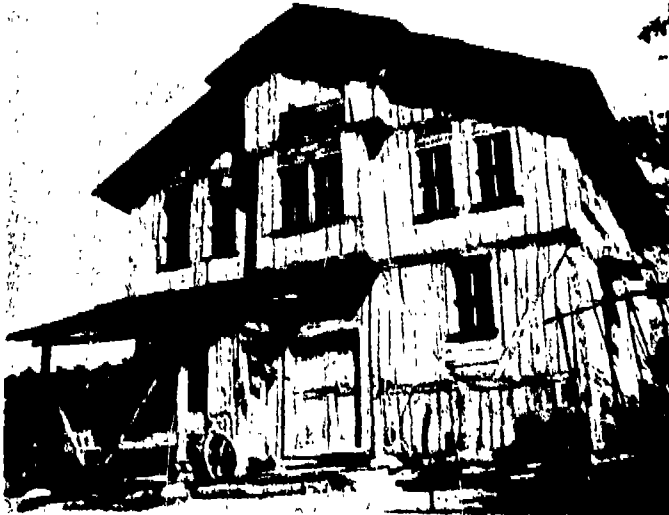
68

68. Typical timber house at locality 40. Only slight damage to central trestles.

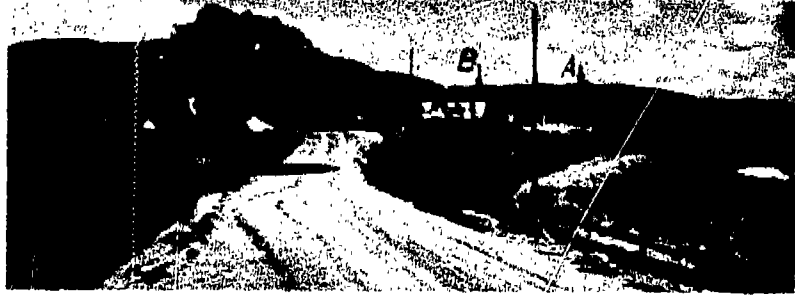
of a series of soil plates humped up 100 to 150 centimetres high (Figure 75). The trace winds along the crest of a gentle slope, showing right-lateral displacements exceeding 150 centimetres (Figure 76). At point 30 it offsets the main road by 180 centimetres (Figure 77), and continues towards the river. No proof of vertical movement was found along this part of the trace. After crossing the road the trace passes between a wooden cabin and a house shown in Figure 77. Here the trace is on flat ground and shows a right-lateral strike slip movement of 70 centimetres, measured on roots, and a throw to the north of 40 centimetres (Figures 78 and 79). The cabin, five metres from the fault, was distorted and lost a few tiles. The house on the other side of the trace had its chimney thrown down but otherwise suffered little damage.

77. Offset of road axis at locality 30. Points A, B, C and D shown in Figure 85, 79, 78 and 82 respectively.

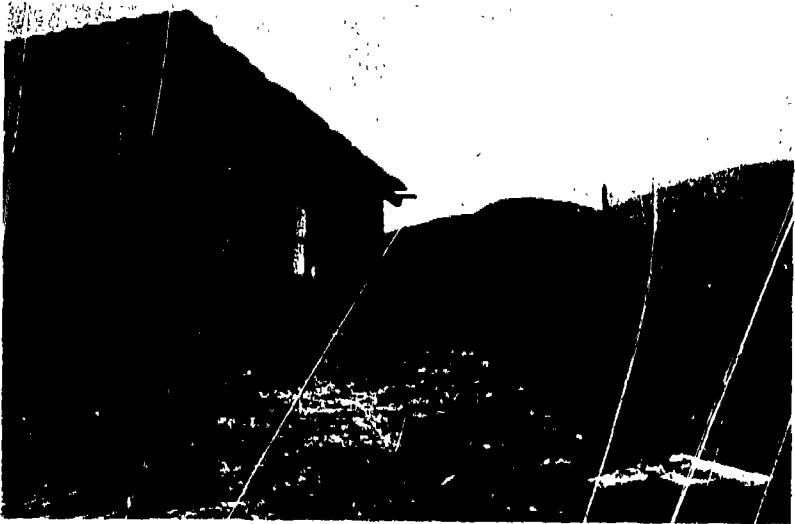
78

78. Fault scarp between points B and C of Figure 77; looking east-southeast.

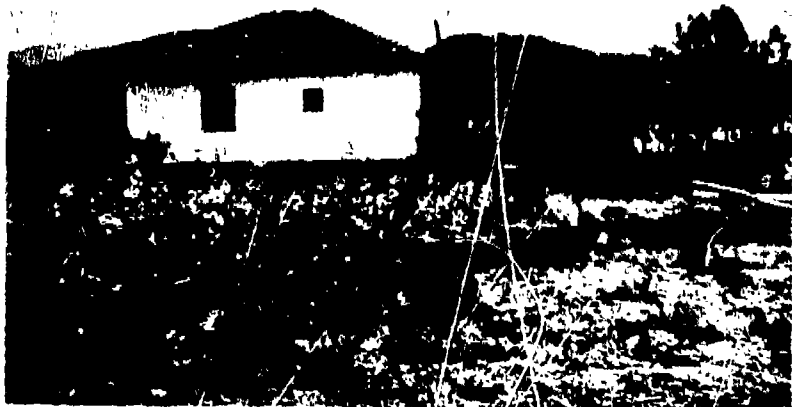
79

79. Fault scarp between points B and C of Figure 77; looking west; note lack of damage to local house.

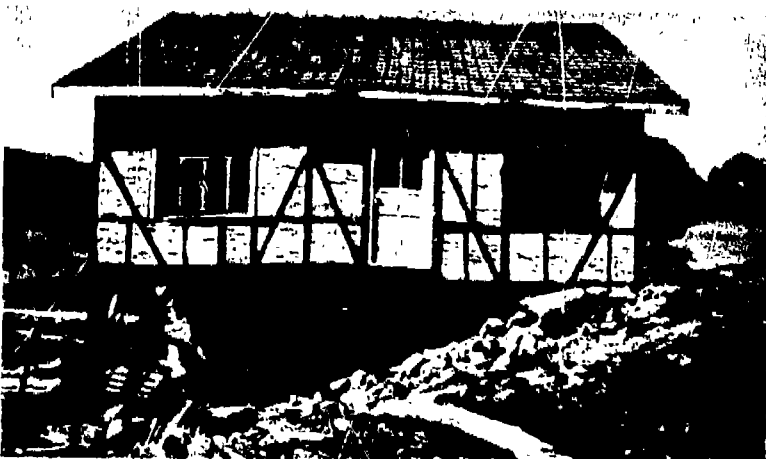
85

The shock at Arpaseki and Taskeste was severe, throwing down people and burden animals. At Arpaseki three out of the 20 houses of the village were heavily damaged. At Taskesti the damage was very slight; a house partly on stilts, shown in Figure 85, was damaged. This house is situated about 15 metres from the fault break.

85. Typical local house at point A of Figure 77; situated 10 metres from fault-trace.

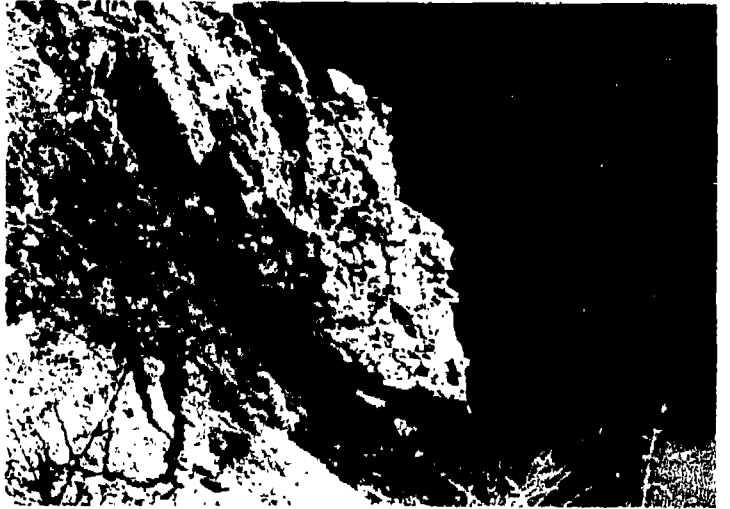
96

96. Fault scarp at point 50, looking north; strike slip displacement 190 centimetres in marls.

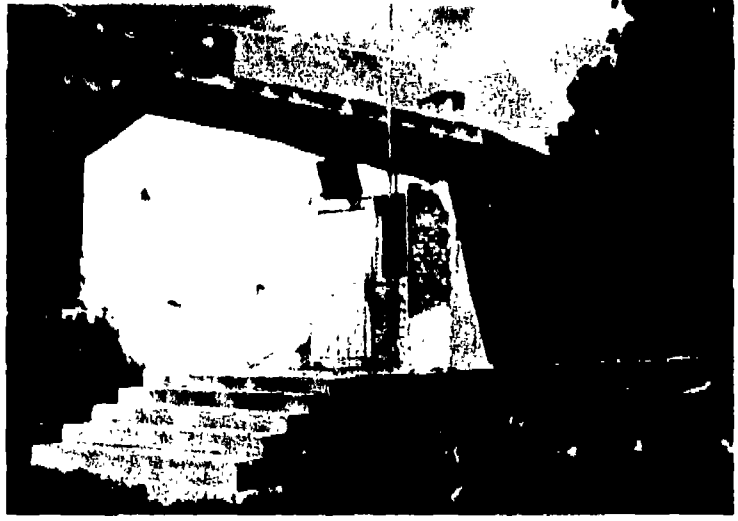
94

94. Brick building at Yegendere.

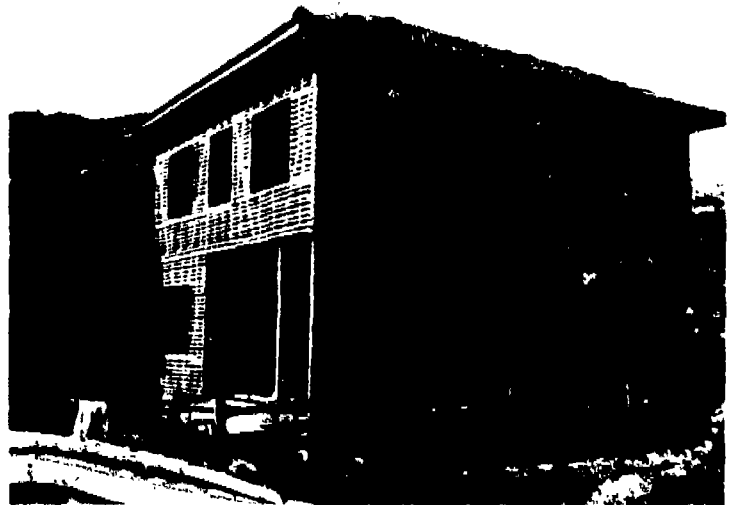
106

106. Typical new "bagdati" construction at Dokurcun,

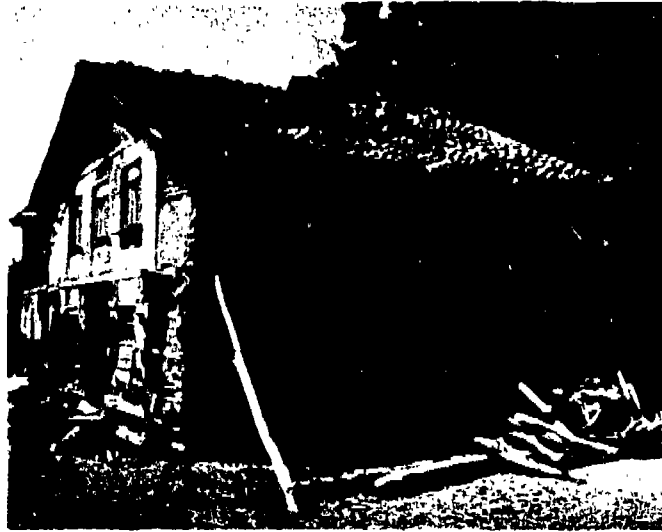
107a

107a. Similar old construction in Samanpazari 50 metres from fault.
Note cornerstone.

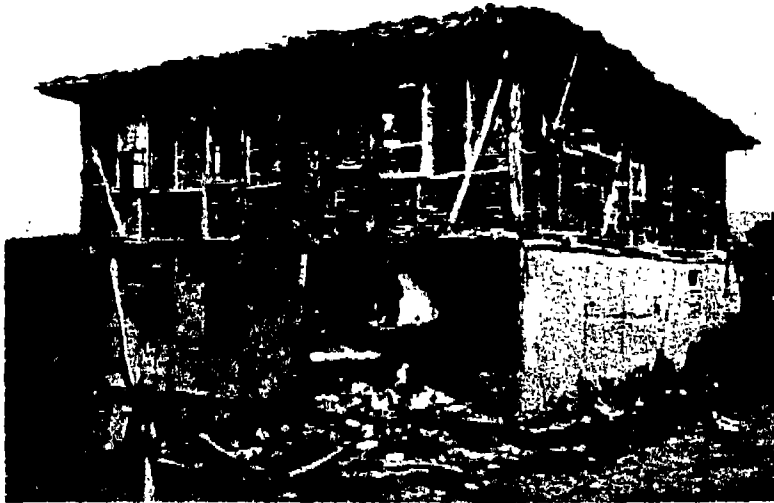
109

109. Heavily damaged old timber-frame construction at Kislacaykoy, 50 metres to the east of adobe house shown in Figure 108.

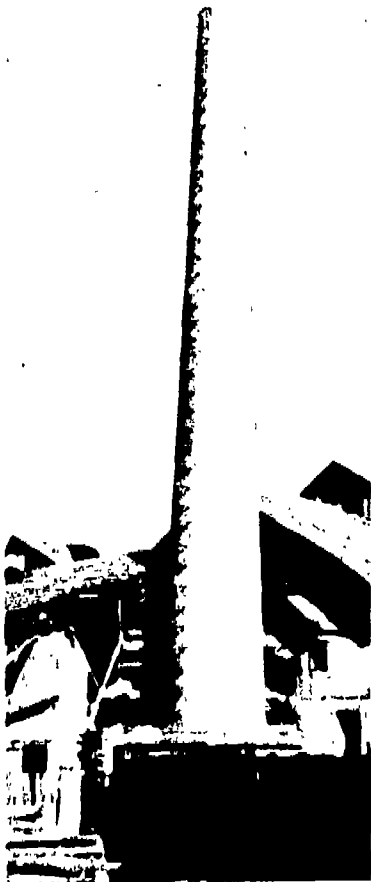
116

116. Boztepe mosque, stone masonry completely destroyed. Timber minaret help up by central timber pole.

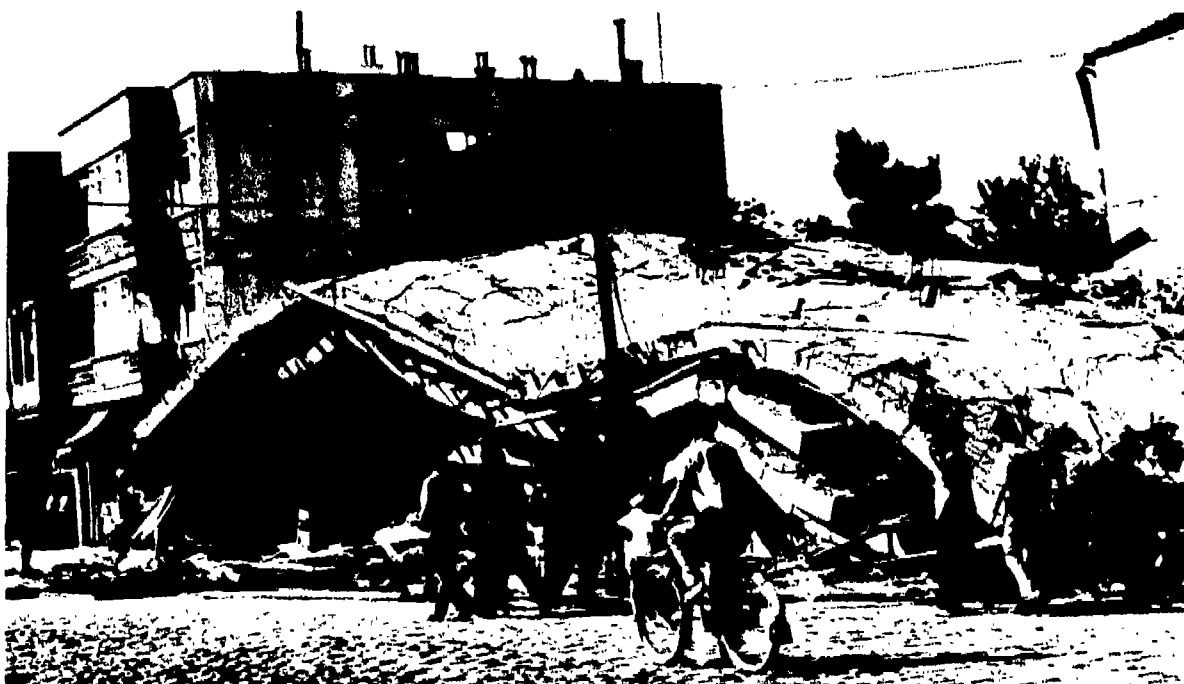
124a

124a. Collapse of five-storey reinforced concrete block of flats, under construction at the time of earthquake.
